National Transportation Safety Board

WPR22FA068

OPERATIONAL FACTORS

Group Chair's Factual Report

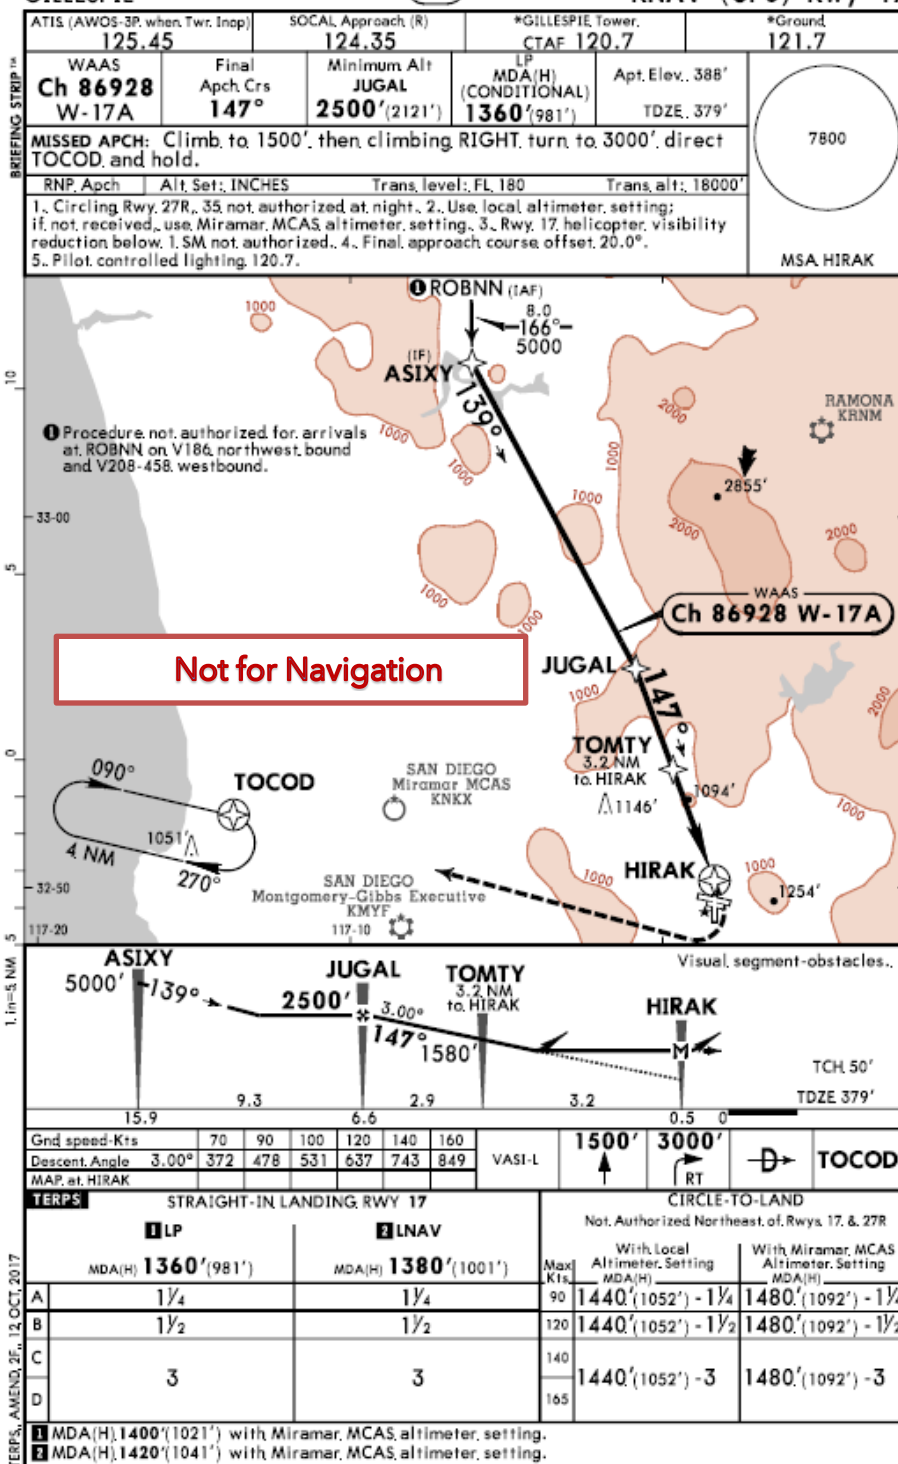
Figure 5: Jeppesen SEE 22-2 RNAV (GPS) Rwy 17 approach.

On the SEE 22-2 Jeppesen Approach chart that was current at the time of the accident for the RNAV (GPS) RWY 17, there was Note 1 that indicated "Circling RWY 27R, 35 not authorized at night." There was also a note in the profile view that indicated, "Circle-to-Land not Authorized Northeast of Rwy 17 & 27R." See figure 5, below.
