National Transportation Safety Board

WPR22FA160

ACCIDENT SITE EXAMINATION

Location: Sylmar, California
Date: April 20, 2022
Time: 1226 Pacific daylight time (PDT)
Airplane: Textron Aviation Cessna 337; N13JB

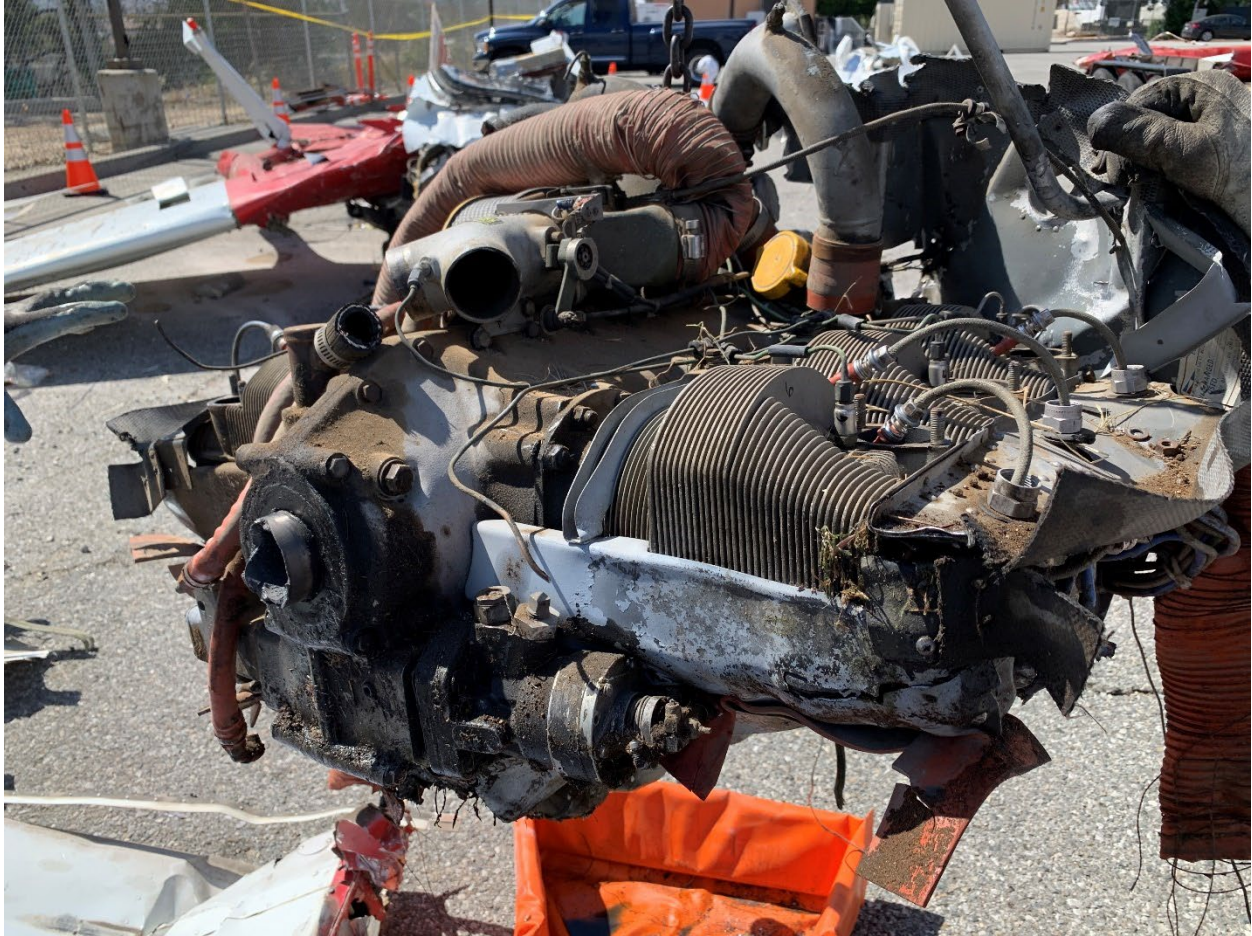
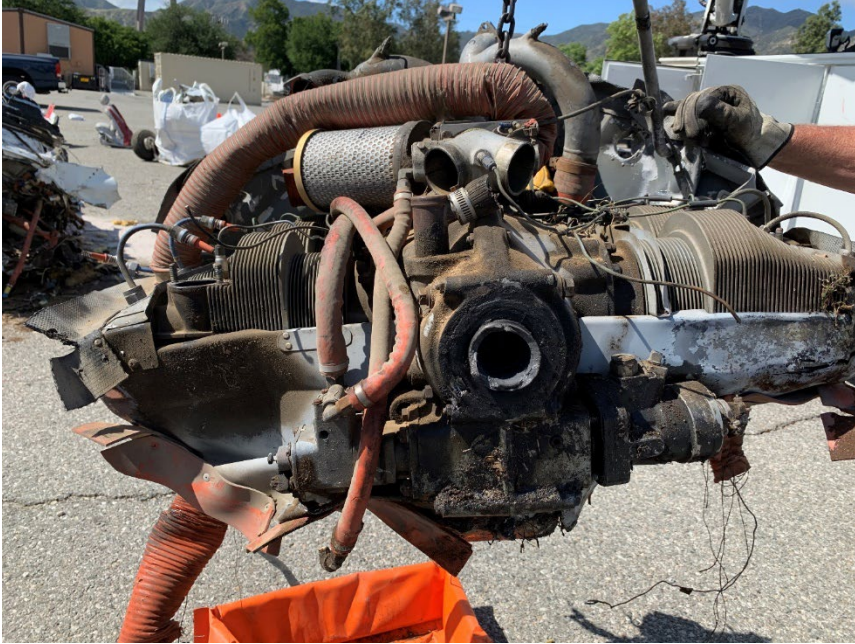
Figure 18 - View of Forward Engine

The forward engine had separated from the airframe; the engine case remained intact with no visible holes in the case. The propeller blade assembly separated from the engine crankshaft flange.

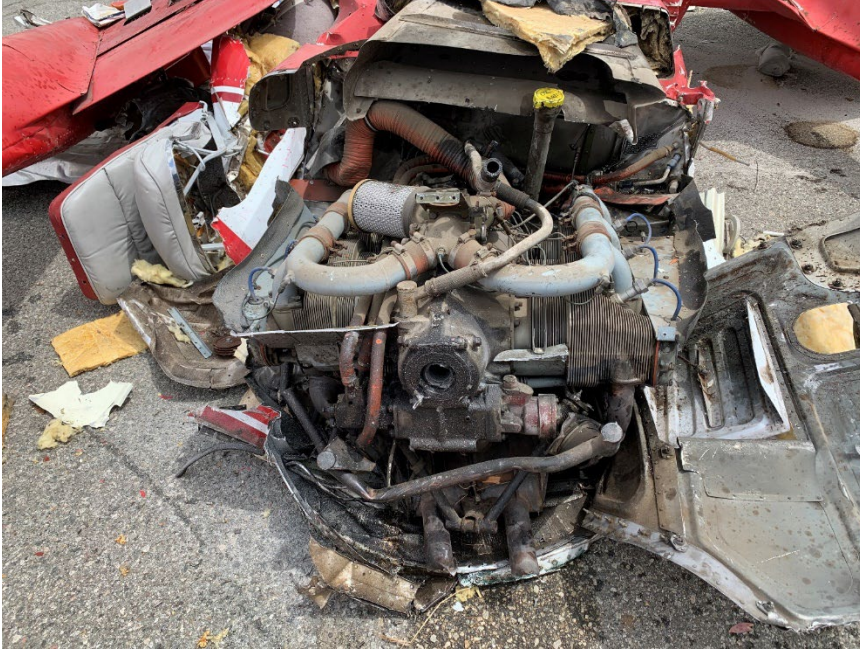
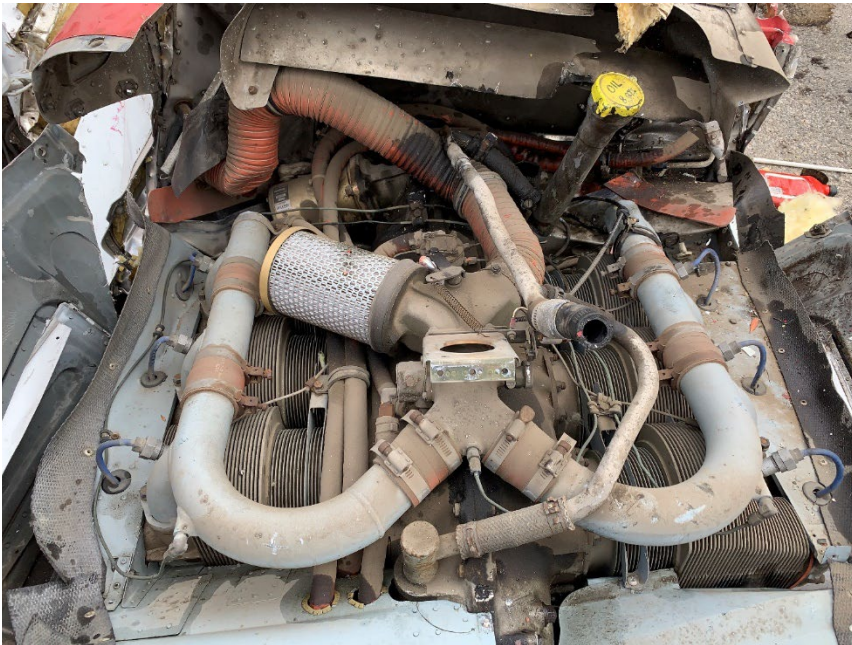
Figure 21 - View of Rear Engine

The rear engine remained attached to the airframe; the engine case remained intact with no visible holes in the case. The propeller blade assembly separated from the engine crankshaft flange.

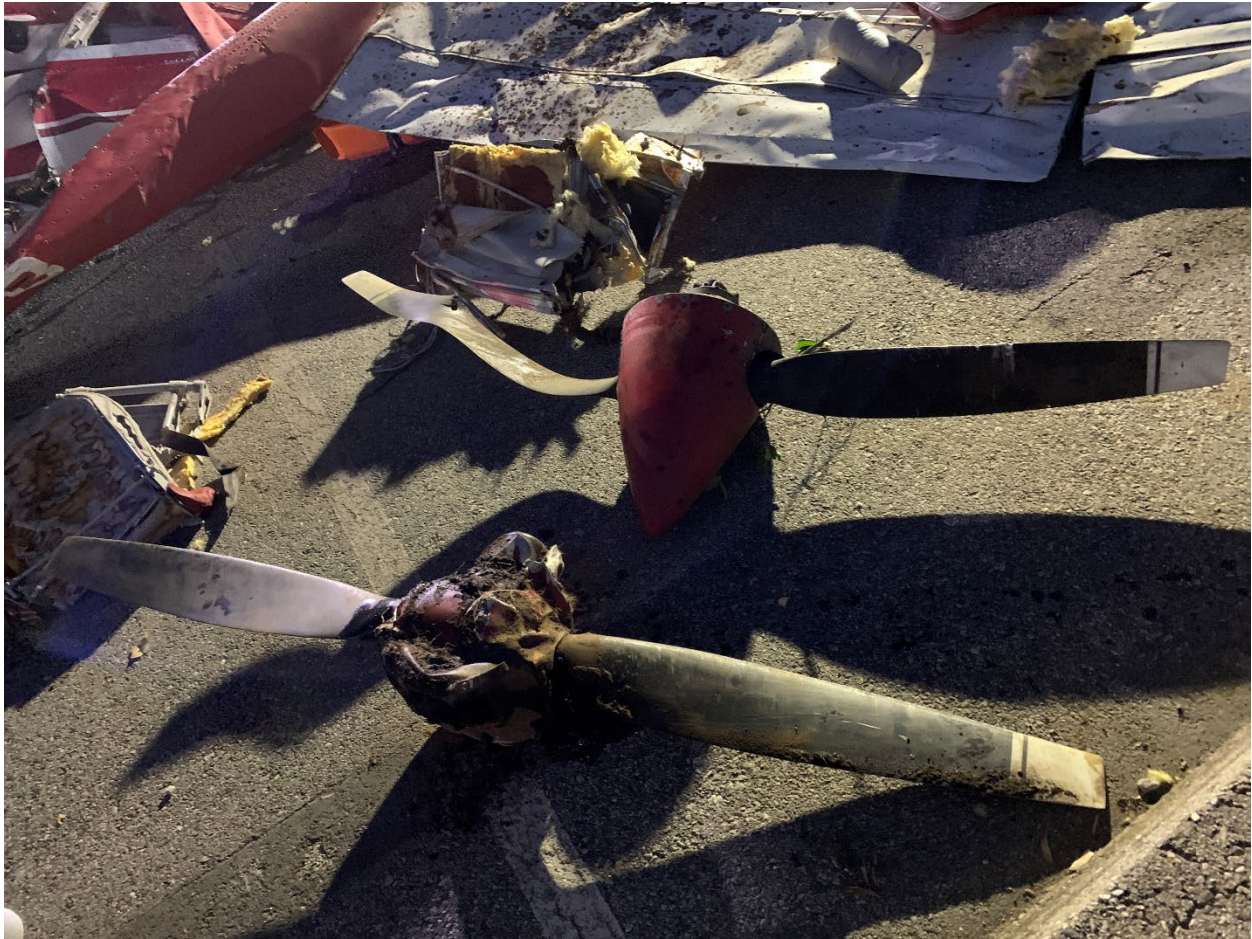
Figure 26 - Propeller assemblies for Both Engines

The forward engine propeller assembly had separated at the engine crankshaft propeller flange, with the propeller blades remaining attached at the hub. It was located underneath the engine in its relative normal position. The propeller blades were relatively straight with chordwise scratching the full length of the blades to include the cambered and face sides. The spinner showed rotational damage. The tip section of one of the propeller blades had separated.

The rear engine propeller assembly separated at the engine crankshaft propeller flange, and the spinner remained intact with minimal postcrash damage. It came to rest just forward of the right wing. The propeller blades remained attached at the hub. One propeller blade exhibited S-bending and was bent aft about mid-span; the remainder of the blade was bent forward with a tear at the leading edge.
