National Transportation Safety Board

WPR23FA034

AIRCRAFT PERFORMANCE & SIMULATION STUDY

April 11, 2024

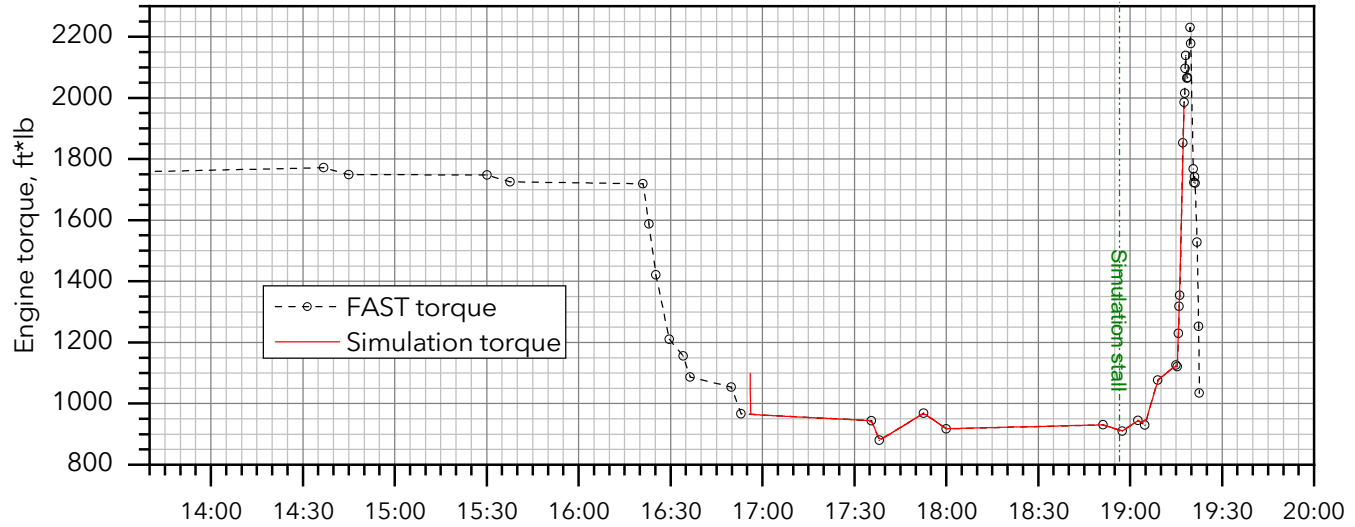
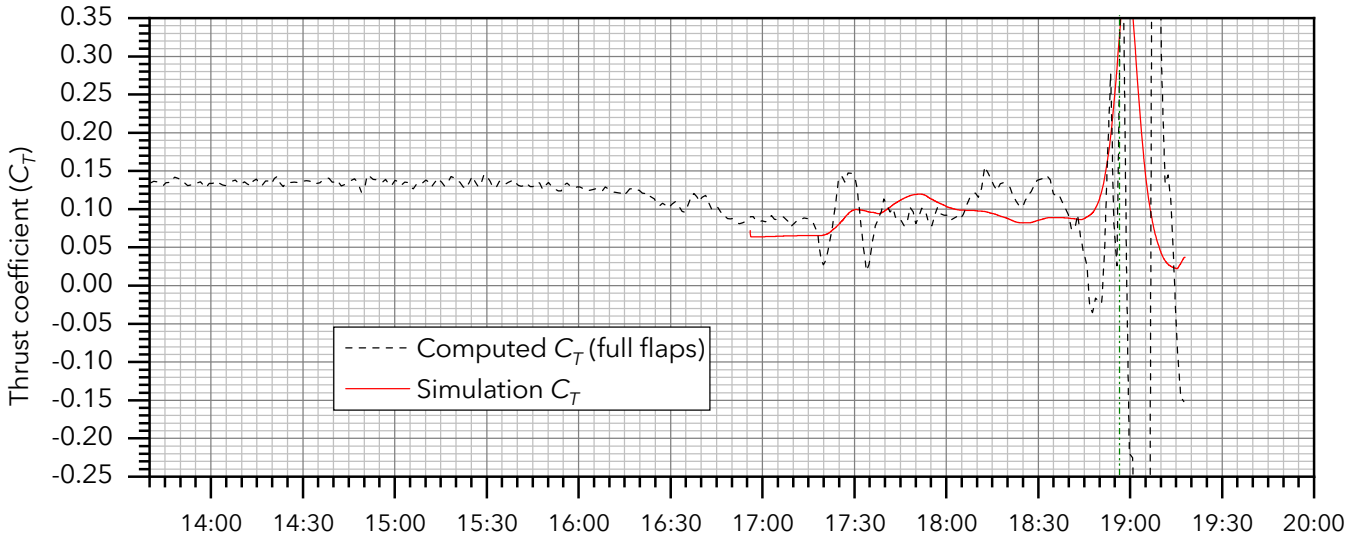
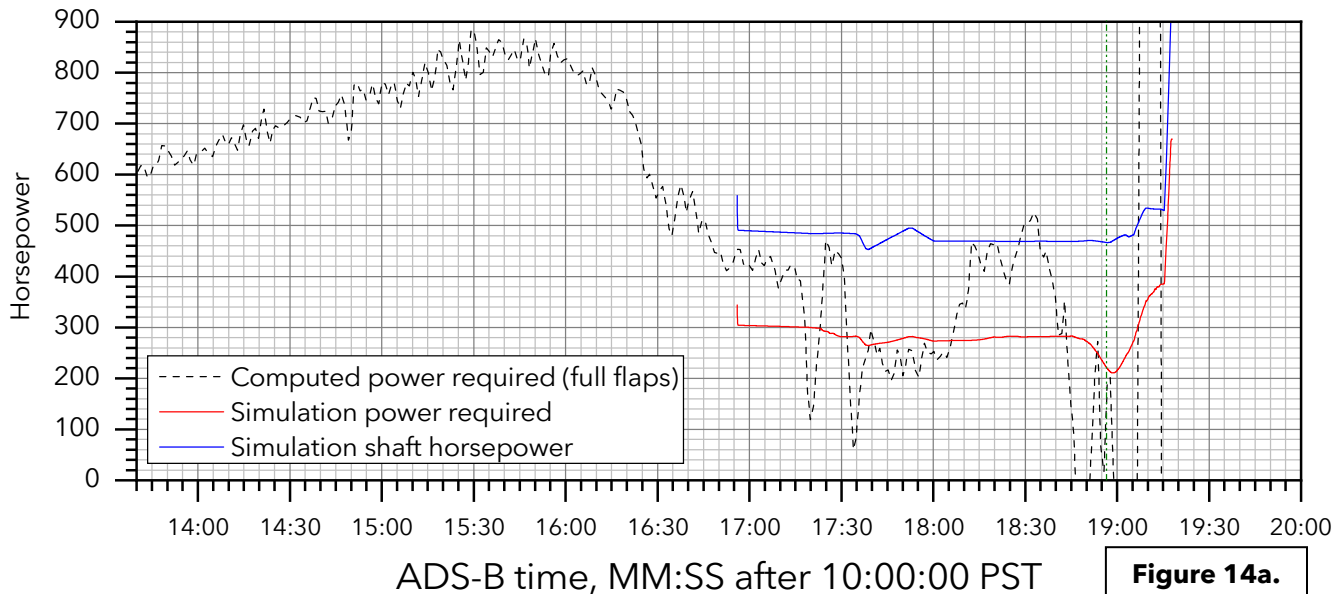
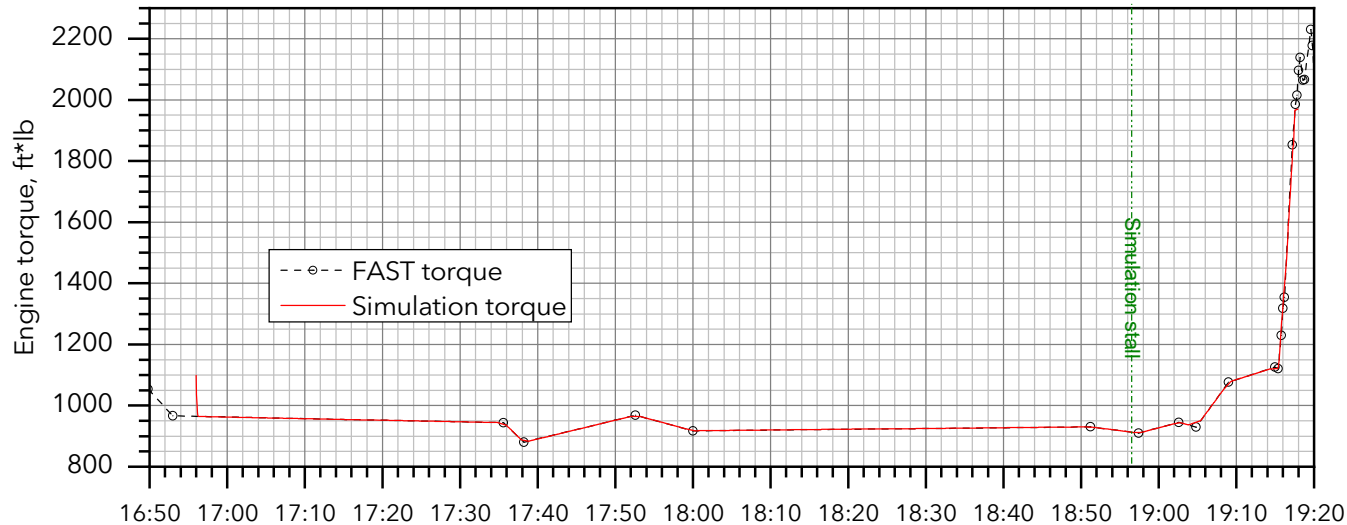
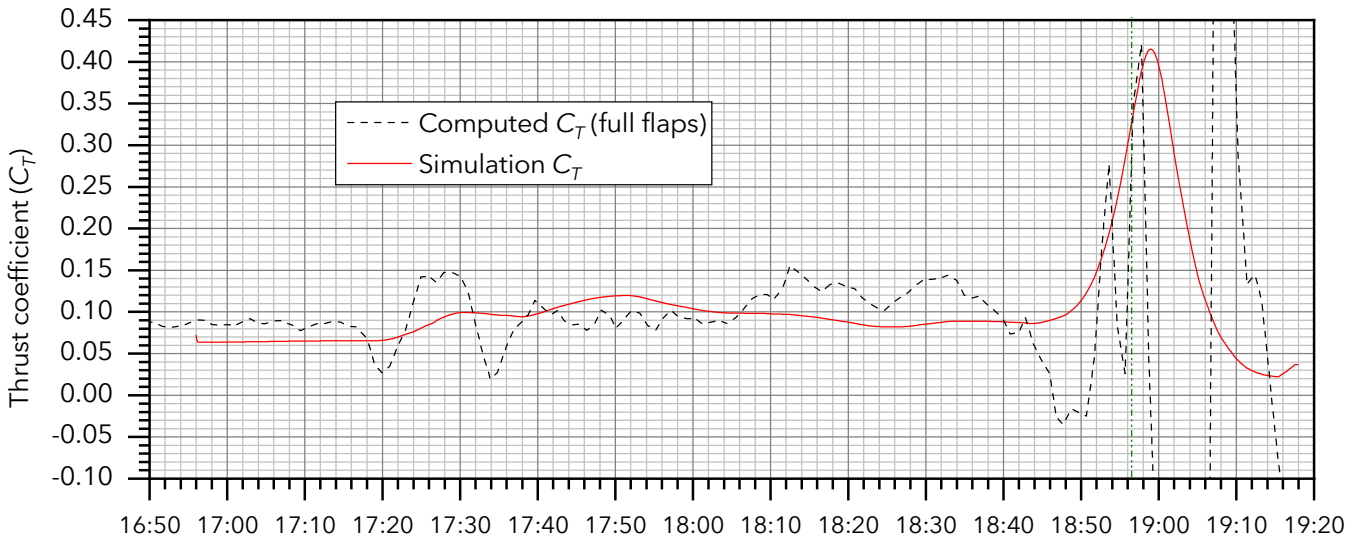
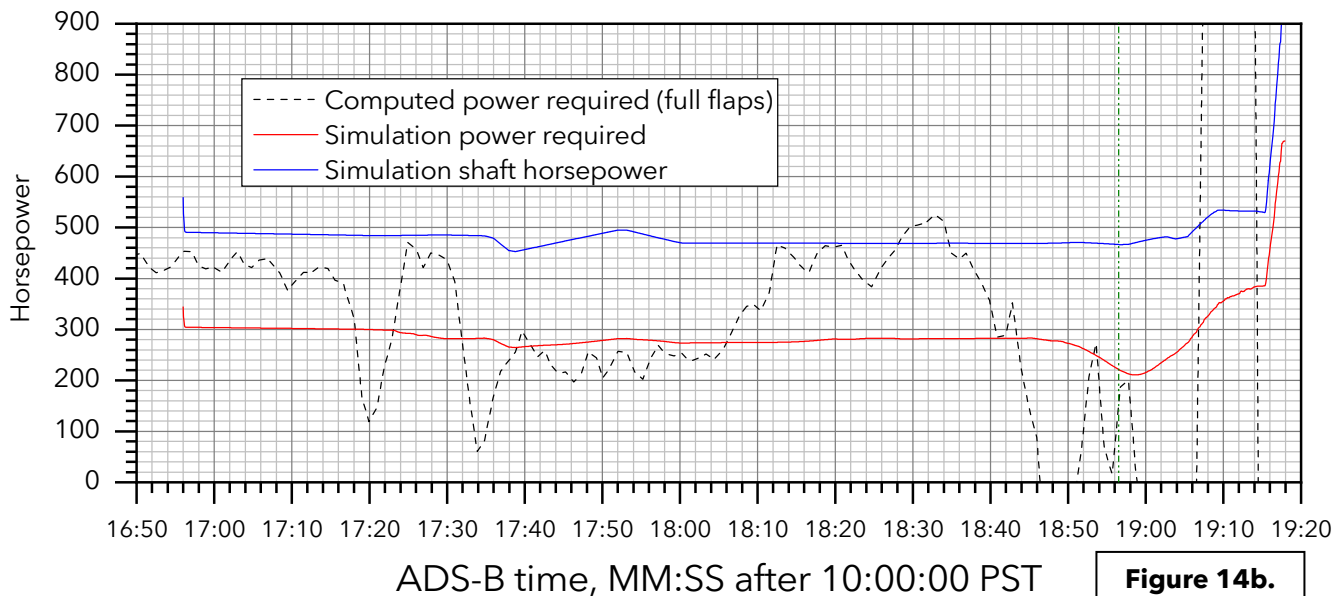
Figure 14a.

Figure 14 presents the engine torque recorded in the FAST data (which is used by the math pilot to drive the simulation throttle) and the resulting thrust coefficient (C_T) and horsepower computed by the simulation. The horsepower delivered to the airframe (the required engine thrust multiplied by the true airspeed) computed from the ADS-B data at full flaps is depicted by the dashed black line in Figure 14. The corresponding simulation parameter (simulation thrust multiplied by simulation true airspeed) is depicted by the red line, and the engine shaft horsepower computed by the simulation, corresponding to the engine torque that matches the FAST data, is depicted by the blue line.

Note in Figure 14 that after the stall the FAST torque data does not decrease, but increases from about 907 ft.-lb. at 10:18:51 to 1,075 ft.-lb. at 10:19:09 (just after the pitch and roll angles reach their most extreme values), and then increases dramatically from 1,122 ft.-lb. at 10:19:15 to 1,970 ft.-lb. at the end of the ADS-B data at 10:19:18. The FAST torque peaks at 2,230 ft.-lb. at 10:19:20 before dropping suddenly to 1,033 ft.-lb. at 10:19:22.7 (the last recorded data point).

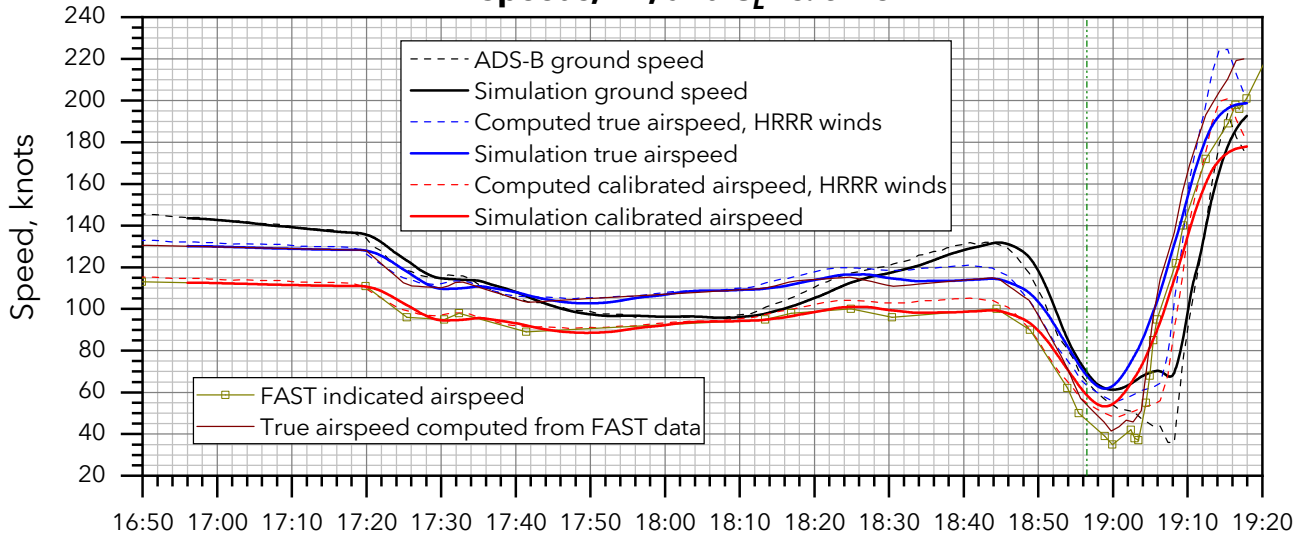
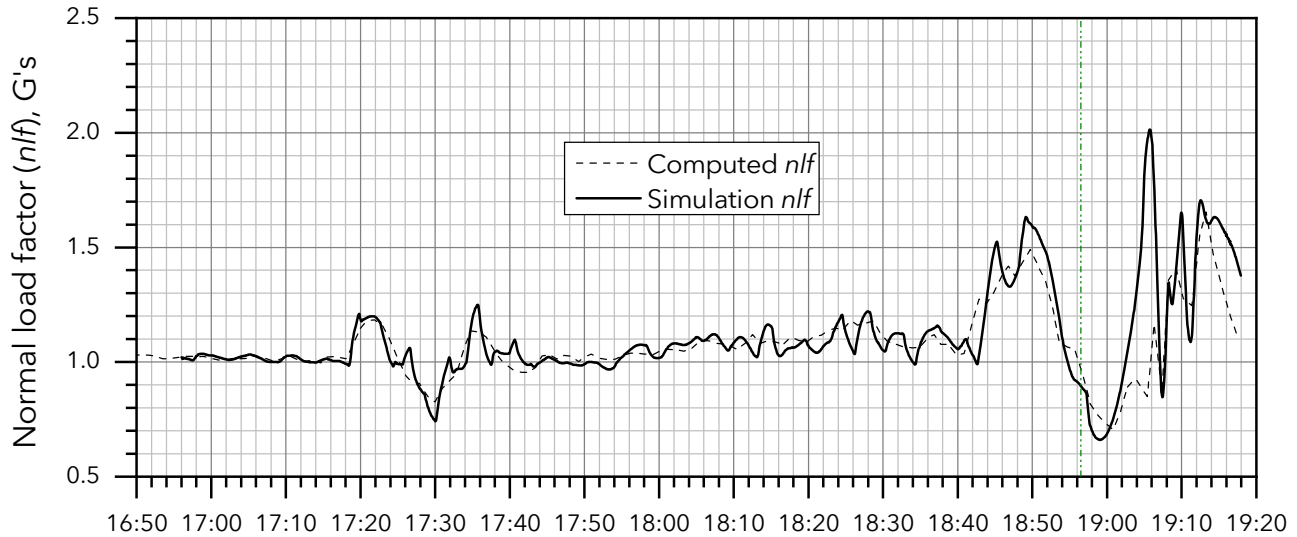
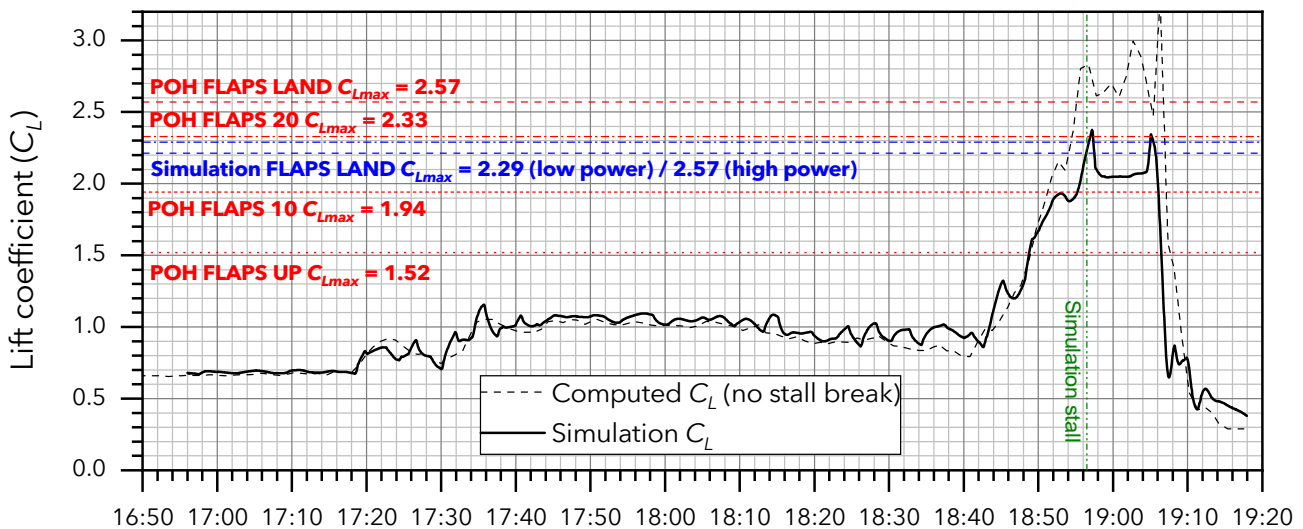
Figure 15.

Figure 15 plots the speed, normal load factor, and lift coefficient (C_L) during the last 2.5 minutes of flight (the airspeed and load factor dictate the C_L that is required). Various values of C_{Lmax} (the maximum C_L that can be produced by the wing, achieved just before the stall) corresponding to different flap settings and data sources are also shown. The red lines correspond to the C_{Lmax} computed from the published stall speeds in the 208B POH (Reference 1). The blue lines correspond to the basic wing landing flaps C_{Lmax} in the KSR 208B aerodynamic model. The simulation C_{Lmax} value varies a little based on engine power, but lies below the both the flaps 20° and landing flaps C_{Lmax} values computed from the POH stall speeds. The reasons for this difference in C_{Lmax} between the simulation aerodynamic model and the POH are unknown.

The black dashed line in Figure 15 is the C_L computed from the ADS-B and winds aloft data. This calculation appears to match the POH landing flaps C_{Lmax} relatively well, and is evidence that the flaps were likely fully deployed at the time of the stall.

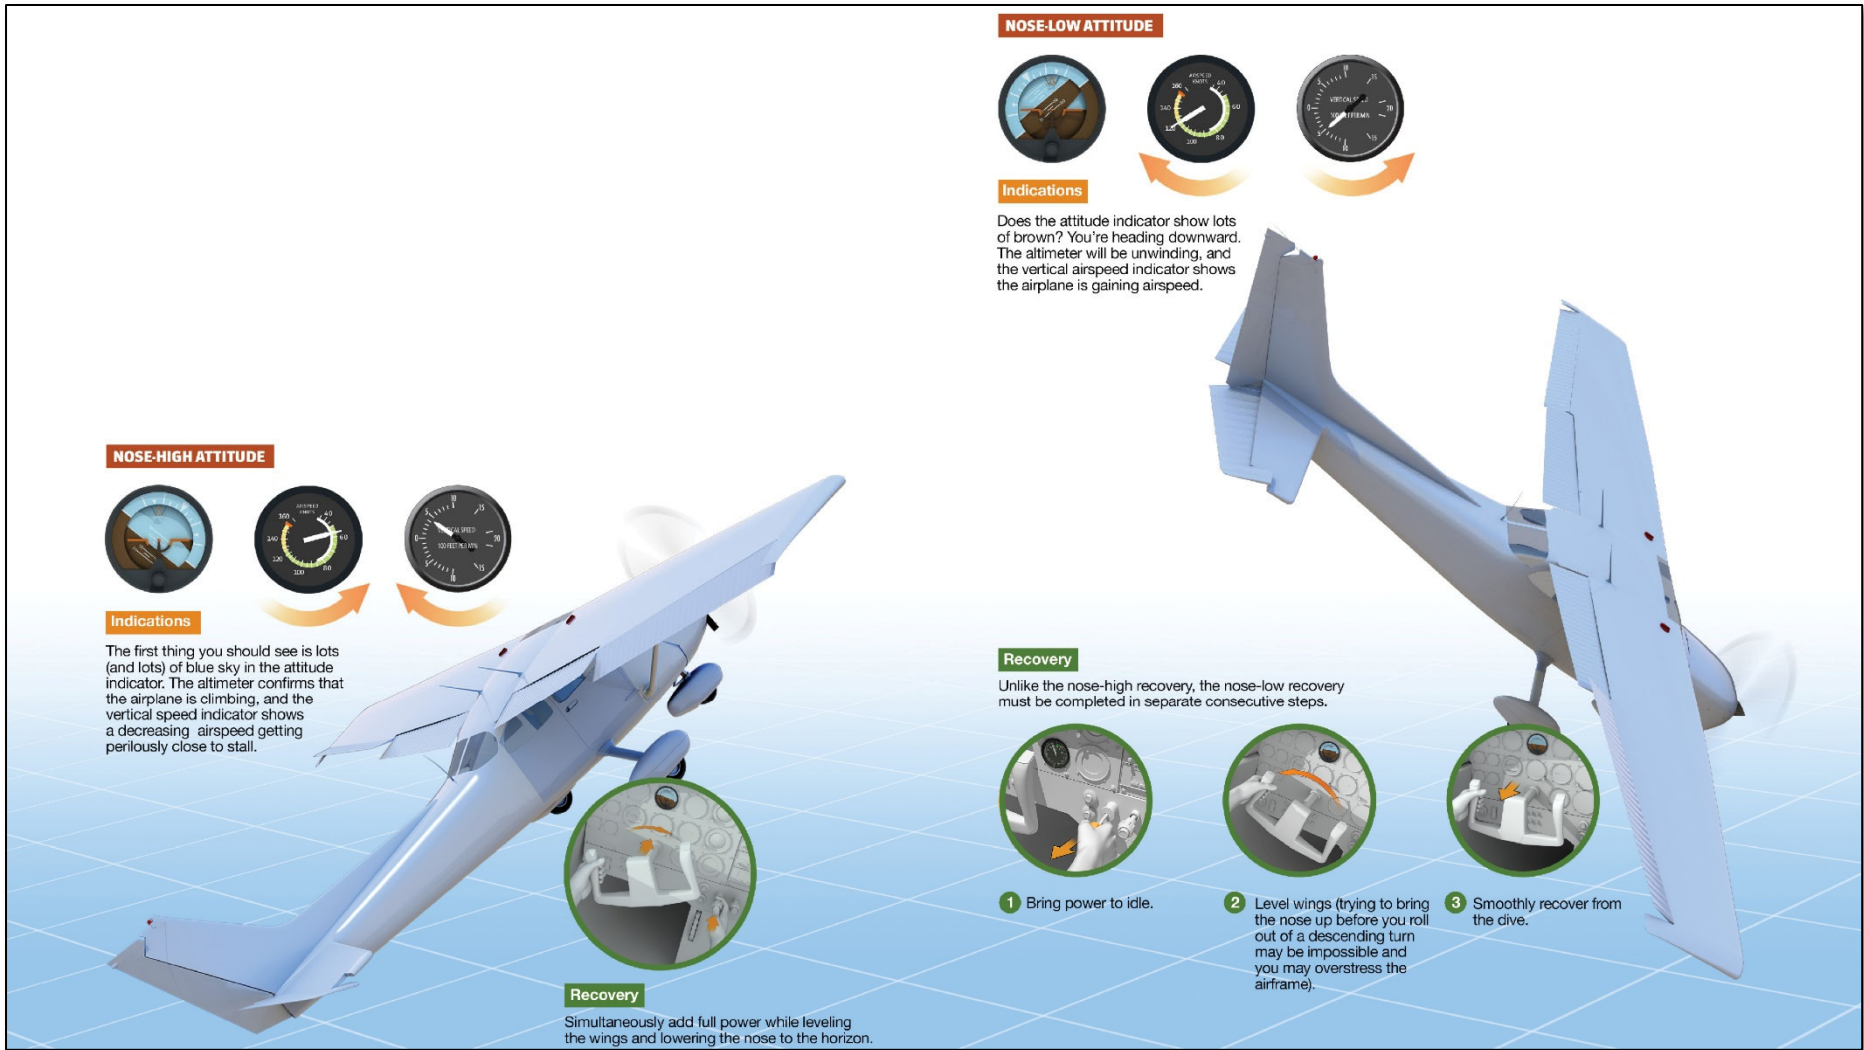
reproduced here as Figure 21. Note that the graphic states that the first step in the recovery technique from a nose-low attitude is to “bring power to idle.” The second and third steps in the recovery are the leveling of the wings and the raising of the nose, respectively.

The FAA *Airplane Flying Handbook* identifies the risk of an airplane upset associated with stall maneuvers, and advises pilots to avoid accelerated stalls (where the stall break occurs at a load factor greater than 1-G) with the flaps deployed because the airplane limitations in this configuration are more restrictive and hence more easily exceeded. Both the *Handbook* and the *Airplane Upset Training Aid* note that proper management of engine power / thrust is required during upset recoveries in order to avoid exceeding airspeed limitations. In addition, a graphic AOPA published as a guide to unusual attitude recovery (Figure 21) notes that the first step in recovering from a nose-low attitude is to "bring power to idle."

Figure 21. Graphic accompanying AOPA online article regarding unusual attitude recovery.
