# Hazardous Liquid Pipeline Strike and Subsequent Explosion and Fire Aboard Dredging Vessel Waymon Boyd

Corpus Christi, Texas August 21, 2020

Accident Overview: Hazardous Liquid Pipeline Strike and Subsequent Explosion and Fire Aboard Dredging Vessel Waymon Boyd

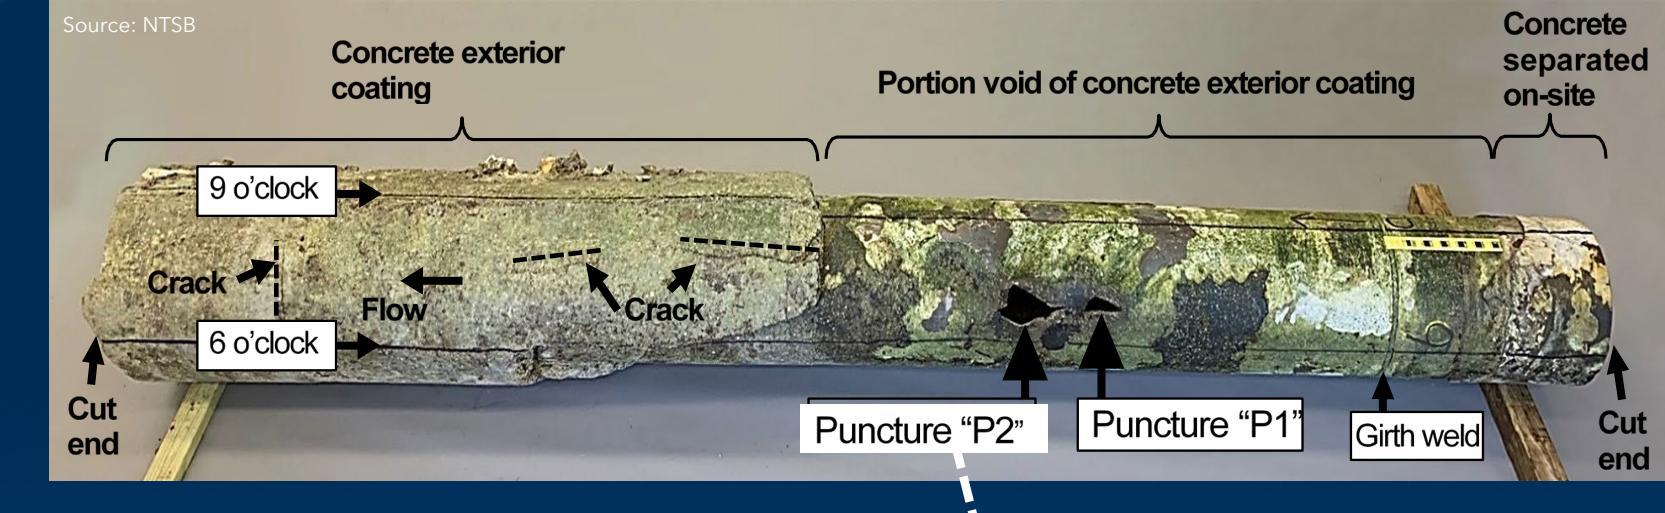
# Damages

- TX219 \$2.09 million
- Waymon Boyd \$9.48 million
- EPIC Facility -\$120,000

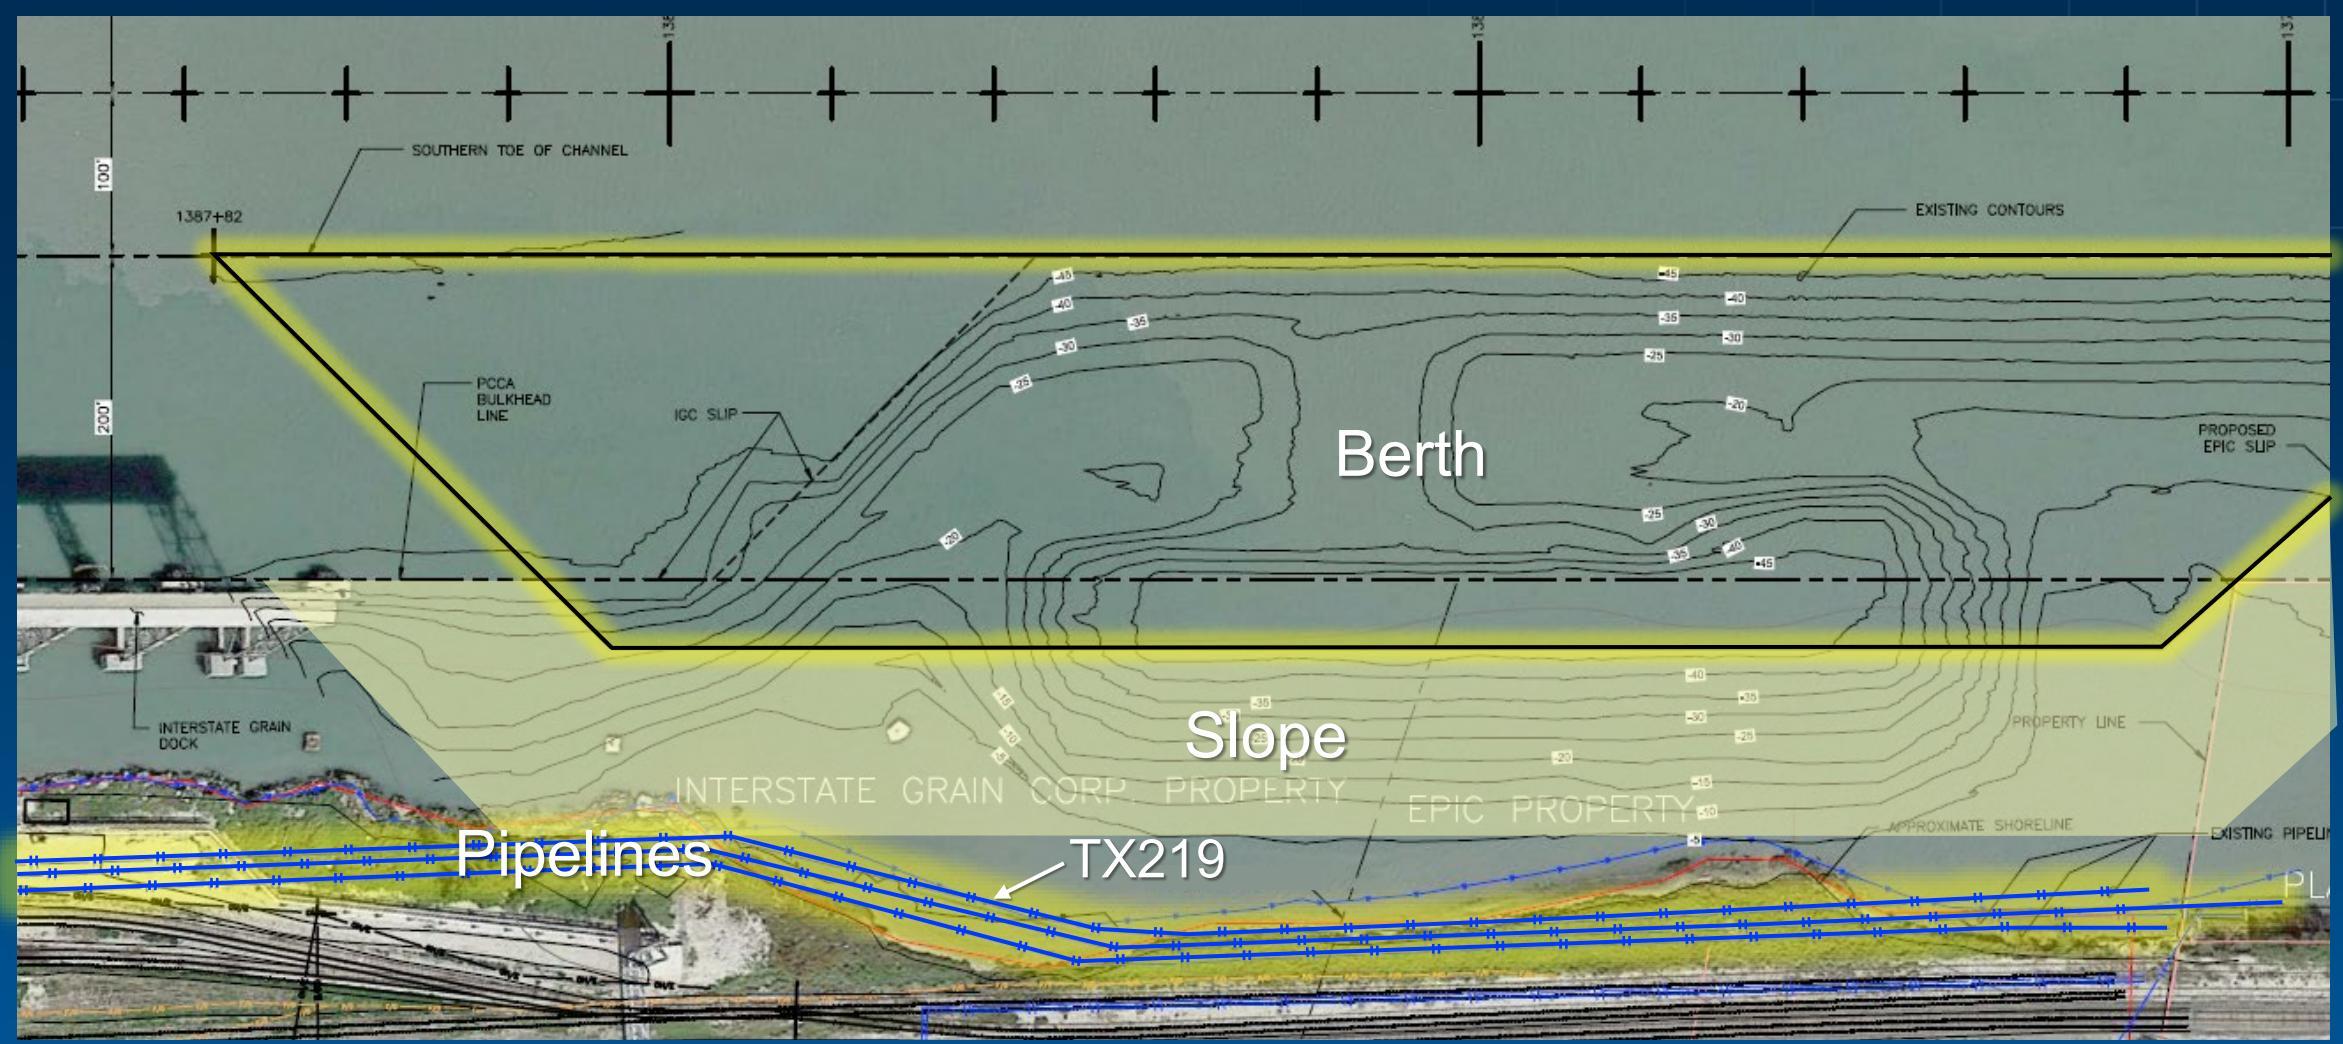
#### Dredge Project Engineering Plans

- Plans for the EPIC dock project did not clearly reflect the proximity of the pipeline to the full dredging area
- Schneider Engineering and Consulting did not have specifications, quality control measures, or best practices for including pipeline hazards and tolerance zones in engineering plans and drawings
- What we propose:
  - One recommendation to Orion Group Holdings
