# National Transportation Safety Board

HWY23MH004

## **TECHNICAL RECONSTRUCTION**

Group Chair's Factual Report

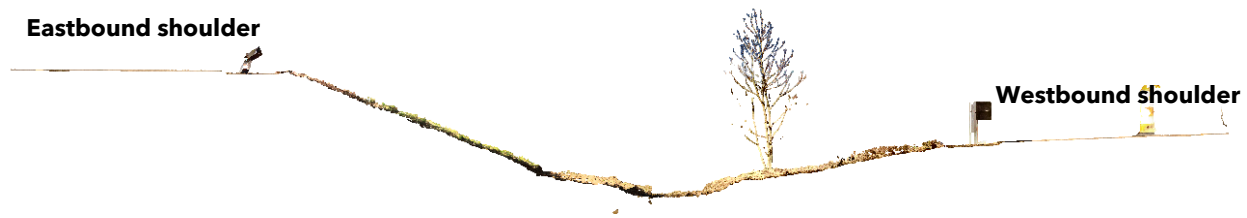
**Figure 2:** Cross-sectional image of median within the area traversed by the Freightliner combination as rendered in the 3D point cloud.

The east- and westbound roadways are divided by an earthen median that in the area traversed by the Freightliner combination have descending embankments from the respective roadway pavements thereby creating a wide ditch at the bottom. The descending embankment from the eastbound roadway exhibits a slope of about 24° and descends about 8½ feet below the left shoulder pavement edge. At this location, the westbound roadway is about five feet lower than the eastbound roadway. The overall median width in this area measured about 44 feet.<sup>1</sup> **Figure 2** depicts a cross section of the 3D point cloud.

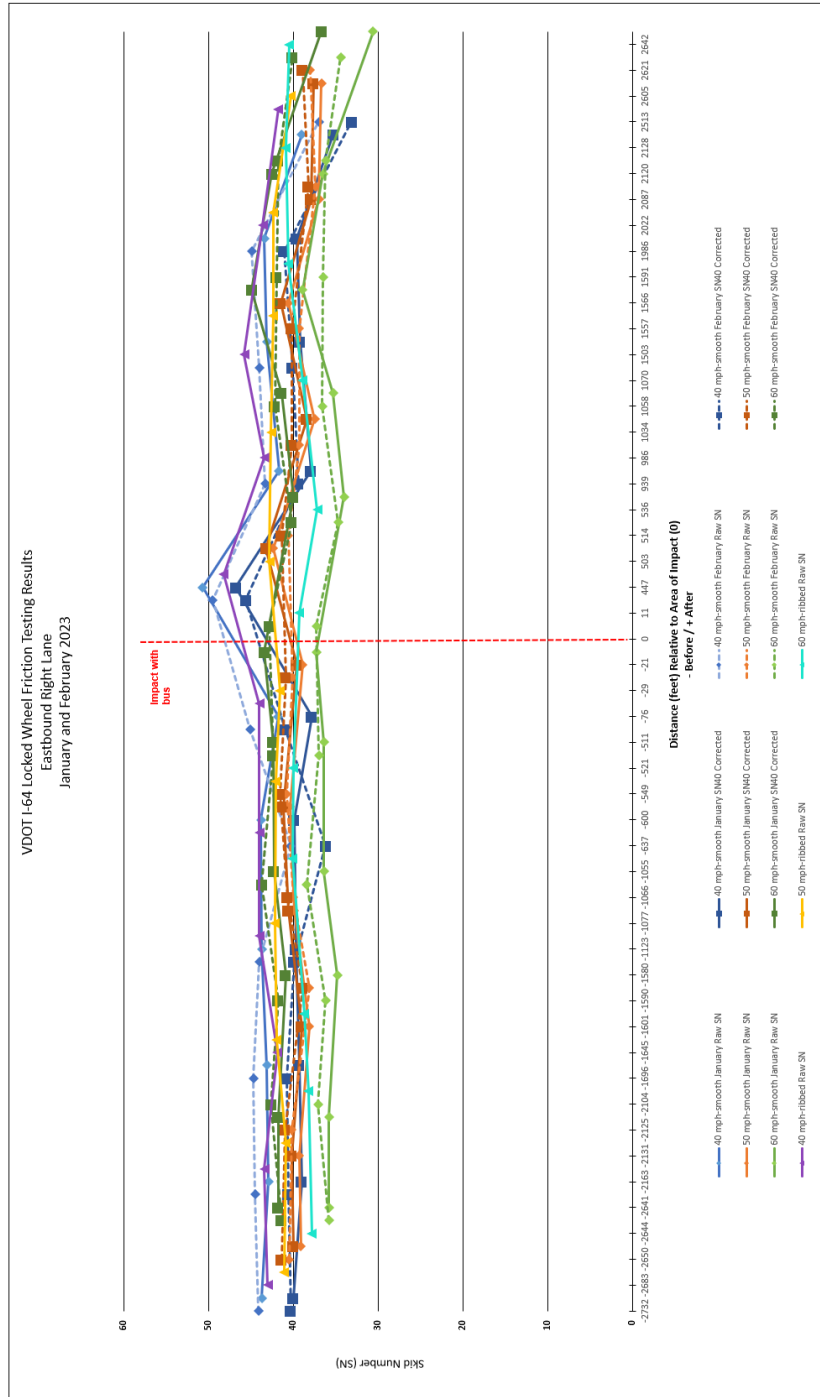
## Appendix B VDOT Skid Resistance Testing Results

As provided in the NTSB *Highway Factors Group* factual report, VDOT conducted a series of skid resistance tests along a portion of eastbound I-64 that encompassed the crash location. While the results are cited in that NTSB report, a graphical representation of the acquired data relative to the area of impact is provided below. Refer to the NTSB *Highway Factors Group* factual report for the data table.
