National Transportation Safety Board

HWY23MH004

SURVIVAL FACTORS

Group Chair's Factual Report

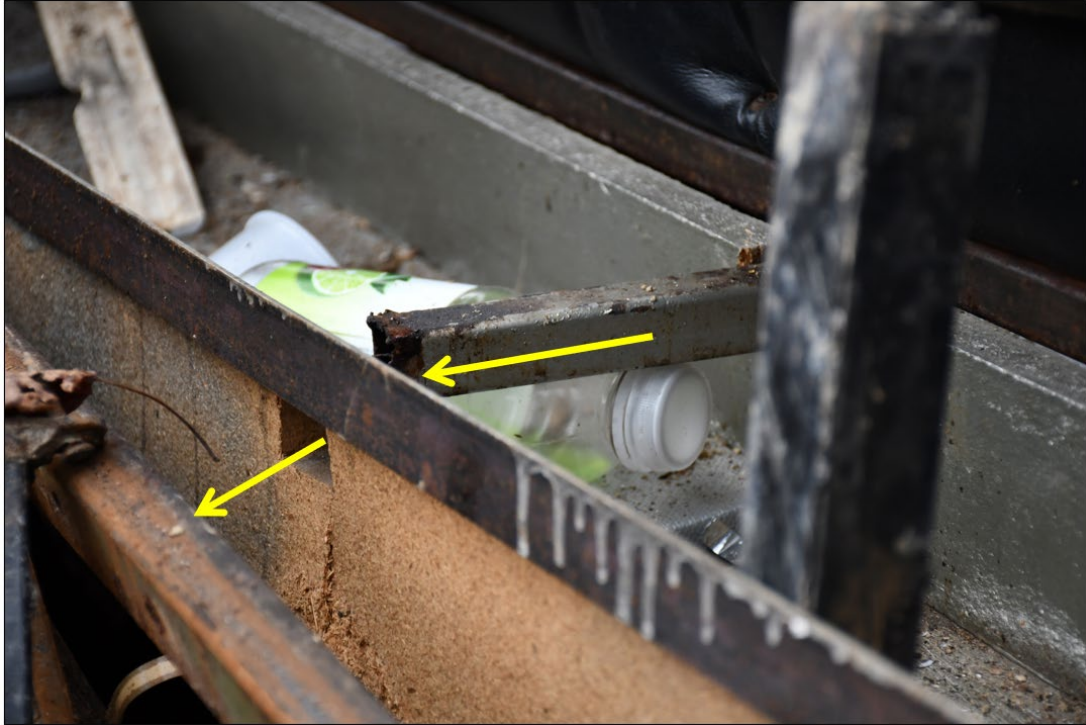
Figure 15: Bus - Seat Frame Extension

The bench seats that are visible in Figure 14 are the only seat frame and seat pan that did not separate from the bus during the collision sequence. The outboard side of the seat rail contained slotted holes that allowed the exterior skin of the vehicle to be attached and secured (Figure 14 - green arrows). All perimeter seat pans were affixed to a custom metal frame comprised of 1-inch by 1-inch steel. The red arrow in Figure 14 accents an approximate six-inch metal extension that was welded to the custom seat frame below the bench seat pans. In Figure 15, a closer view of the metal-extension can be observed. The metal extension was welded to the custom seat frame and the other end of the metal extension appears to have once been welded to the inboard C-channel of the seat rail as a connection or anchor point.

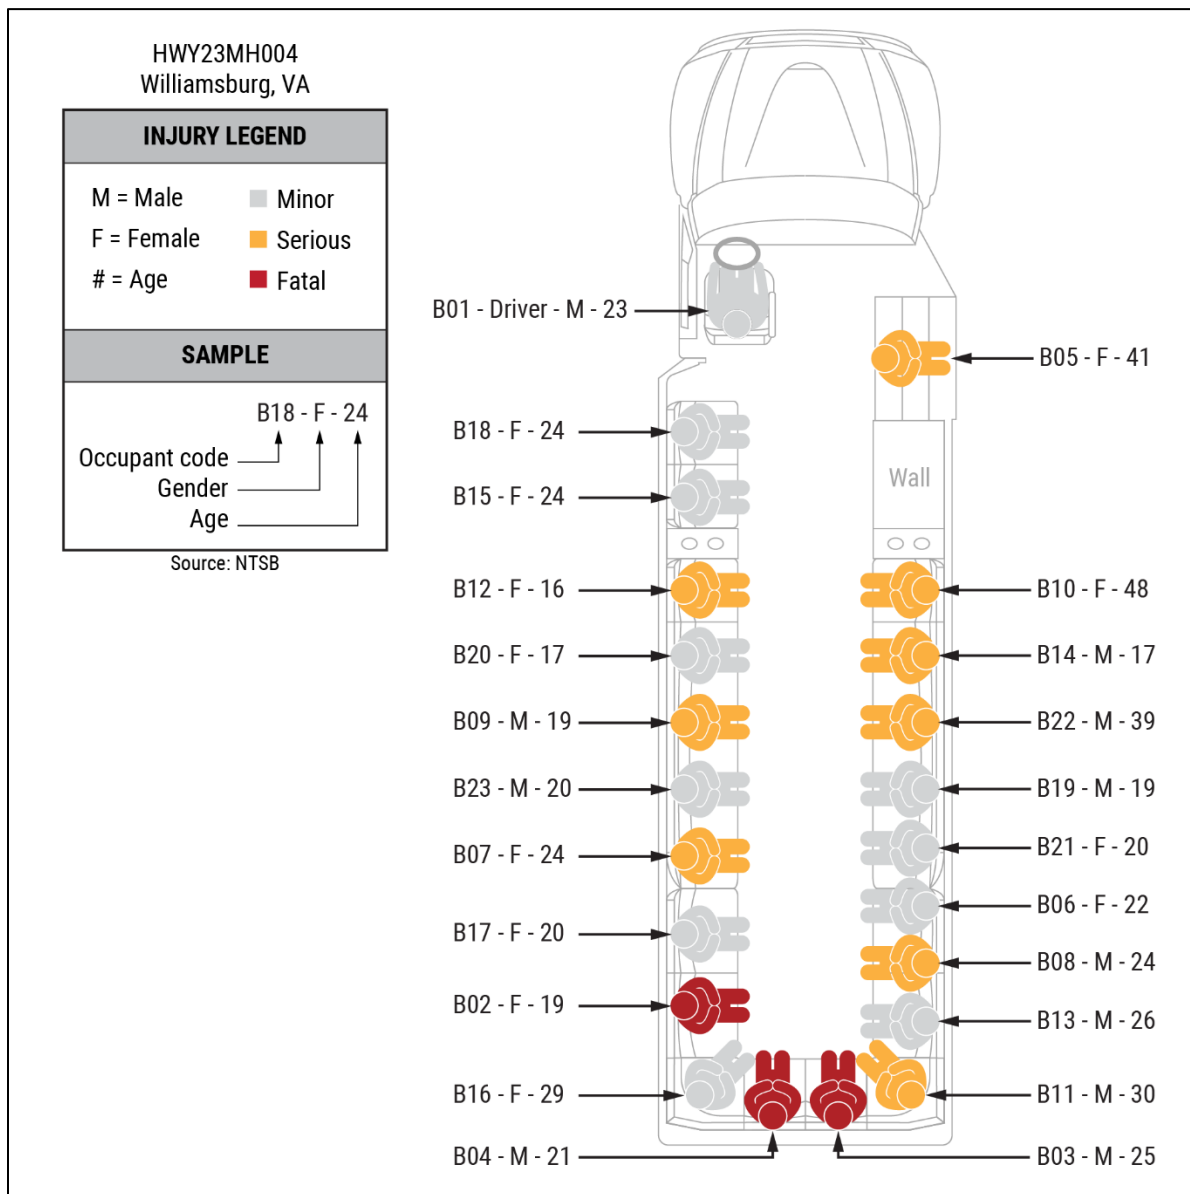
Figure 19: Bus - Seating Chart and Corresponding Injuries of Occupants

For identification purposes, all bus (B) occupants were assigned an occupant code B01-B23. All passengers were ejected from the bus during the collision. There was no known official passenger manifest or documented seating arrangement. At least one bus passenger, B09, reportedly left the collision scene, on foot, flagged down a passing motorist, and was driven to Riverside Doctors' Hospital (RDH) by the unknown motorist. It is unknown if any other occupants left the scene on foot or by any other undocumented methods. Through interviews with bus passengers at Riverside Regional Medical Center (RRMC), a seating chart with corresponding injuries was developed, which can be seen below in Figure 19.⁸

⁸ Seating chart does not depict the actual postures of the occupants, which is unknown.

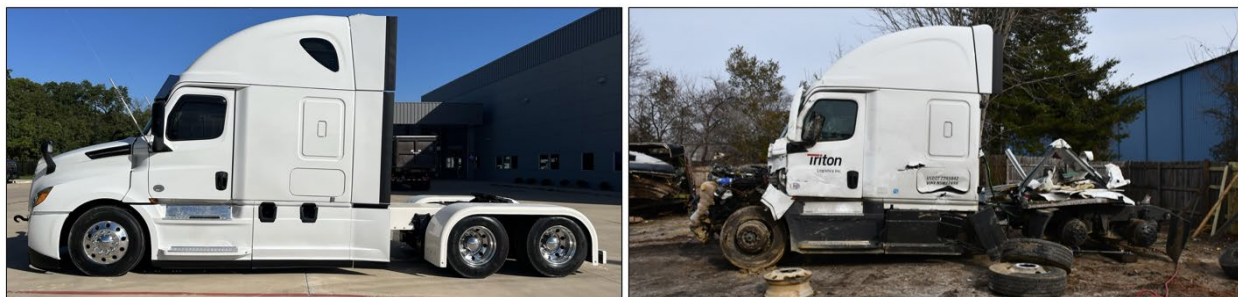
Figure 20: Truck-Tractor - Exemplar (Left)¹⁰ and Subject Vehicle (Right)

An undamaged exemplar truck-tractor and the damaged subject truck-tractor can be observed in Figure 20. Regarding the truck-tractor's orientation, "left" refers to the driver's side of the vehicle, while "right" refers to the passenger side of the vehicle.

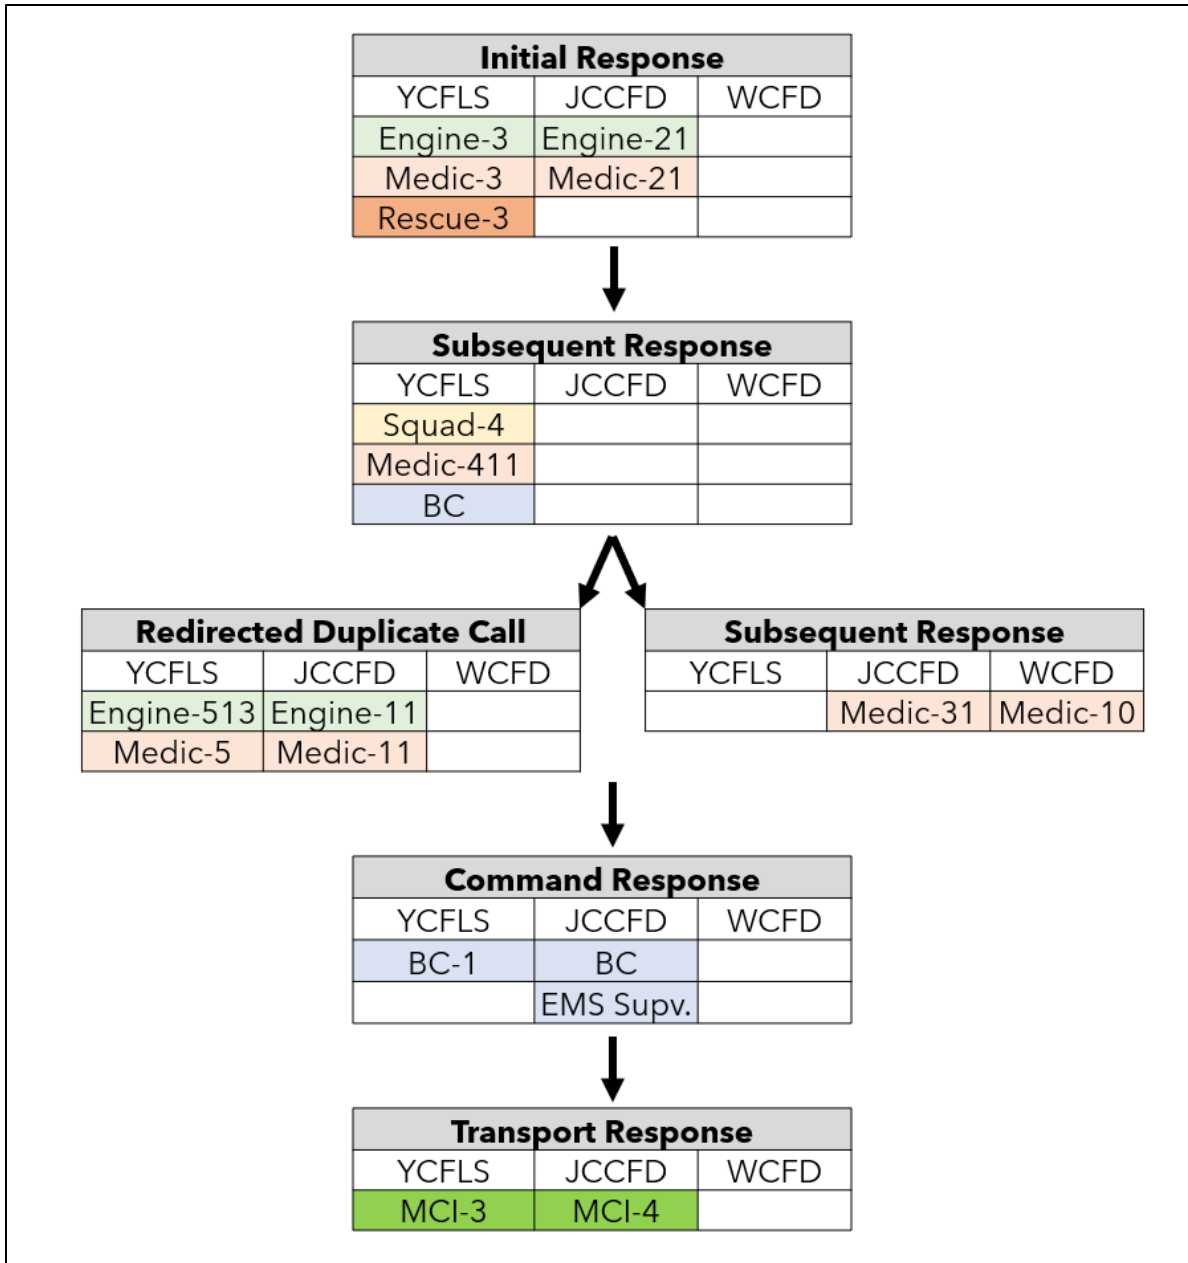
Figure 25: Rescue and EMS Response Overview

At this time, four engines, seven medics, one rescue, a combo engine/rescue, and YCFLS BC were enroute or already arrived at the scene. Due to the large number of response personnel, YCFLS BC-1 (BC/IC counterpart) JCCFD's BC and EMS supervisor self-initiated a response to assist. YCFLS BC/IC arrived on scene and requested a mass casualty bus to respond. Bus MCI-3 responded from Station 6, which is located at the lower portion of the county. JCCFD's BC also requested bus MCI-4, which was located at RDH, to respond to the scene. The mass casualty buses (MCI-3 and MCI-4) were equipped with cots and seats to assist with transporting persons with minor injuries and the walking wounded. YCFLS began creating a transport plan and per the regional mass casualty plan, BC-1 contacted the closest hospital, RDH, and informed them of the mass casualty event, number of patients, and triage color total.
