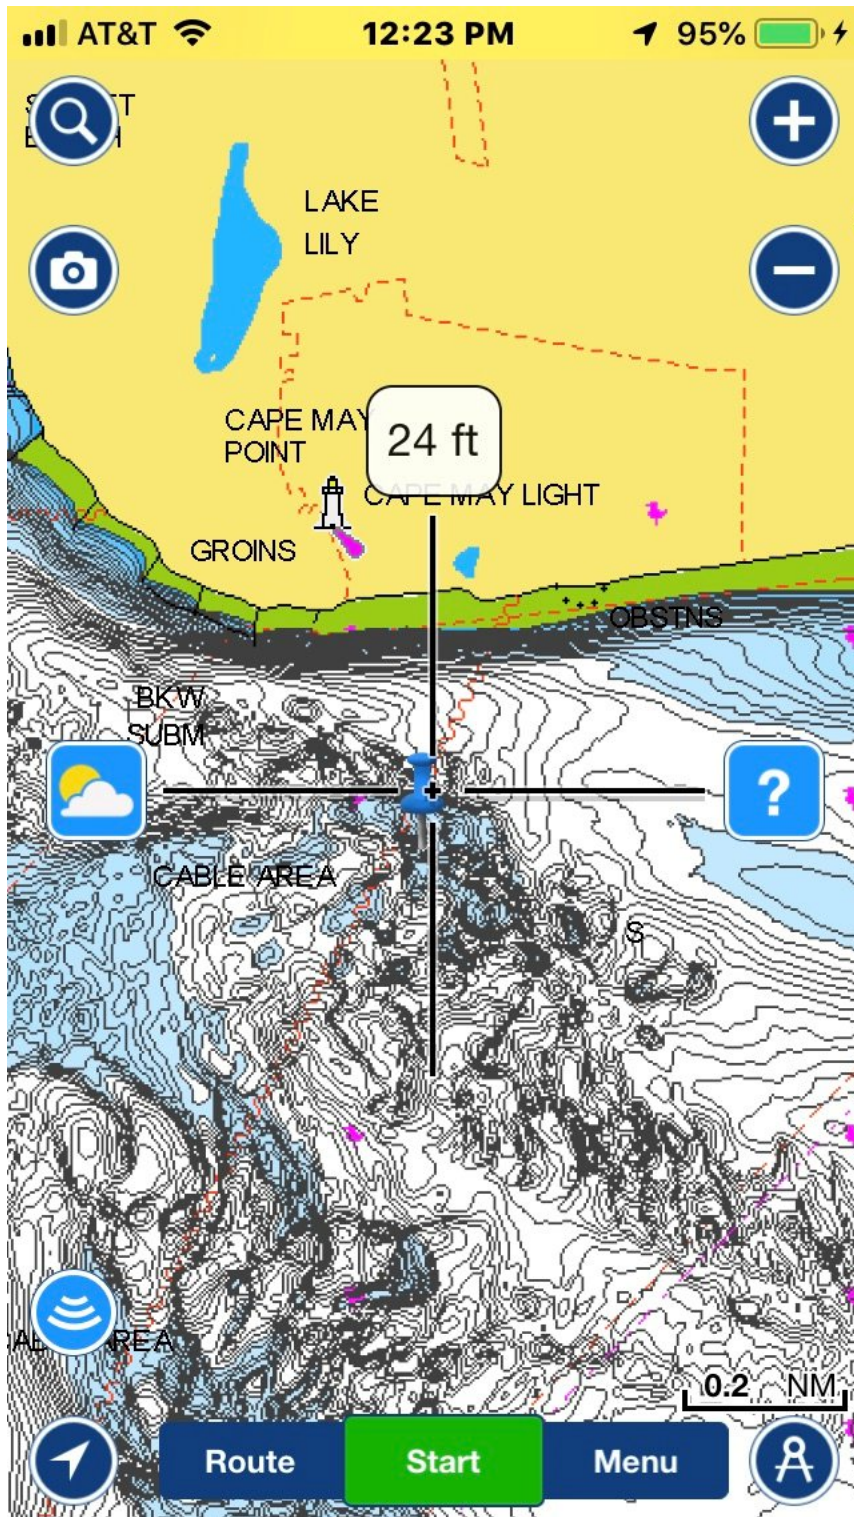
Image3- Position of crash site on nautical chart.

At this time the NJSP helicopter confirmed the source of the sheen from the air. A solid target was then located on the bottom and marked with sonar and a visual marker on the surface of the water
