# National Transportation Safety Board

WPR21FA265

## INVESTIGATION MATERIALS SUPPLEMENT

Location: Albany, Oregon  
Date: 07/09/2021  
Time: 2051 Pacific standard time  
Airplane: Northwing Mustang 3

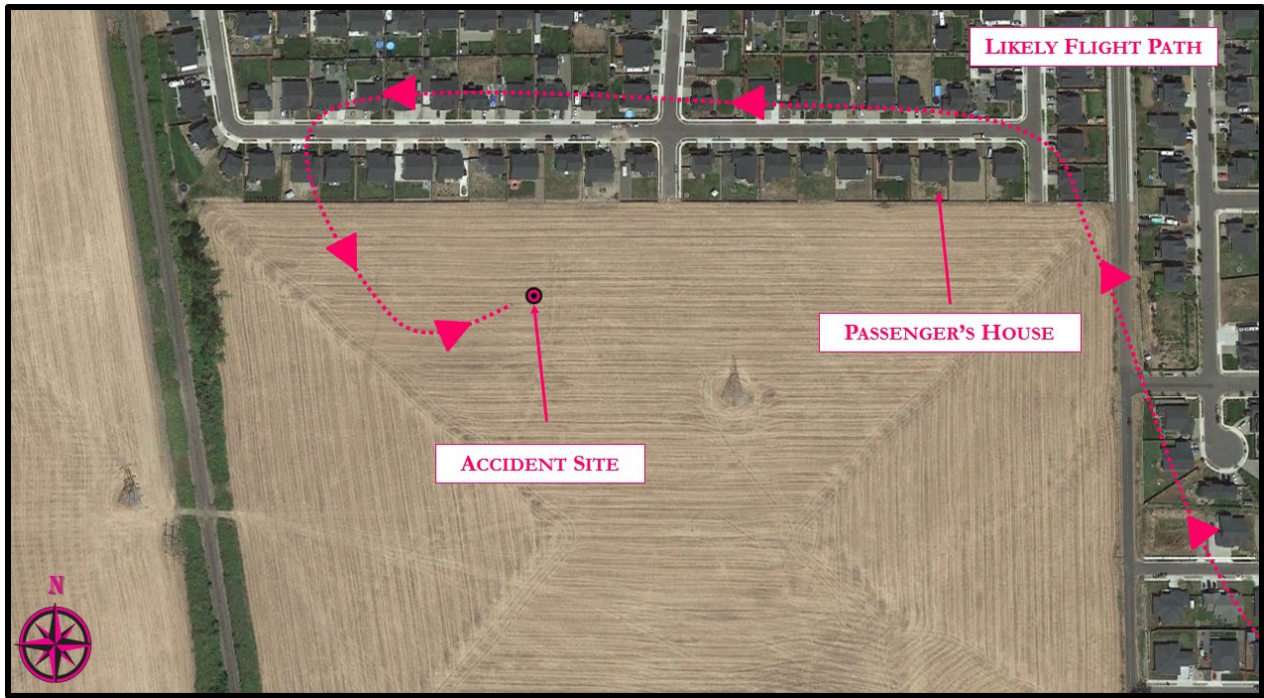
*Figure 2: Likely Flight Path Prior to Impact*

Several witnesses on the ground recorded the airplane maneuvering on their mobile phone devices. A review of those videos disclosed that the airplane banked to the left to a near 90° turn. The left wing continued to drop down and the aircraft descended toward the ground as the turn tightened. The aircraft impacted the terrain in a left-wing low attitude (see picture 2).

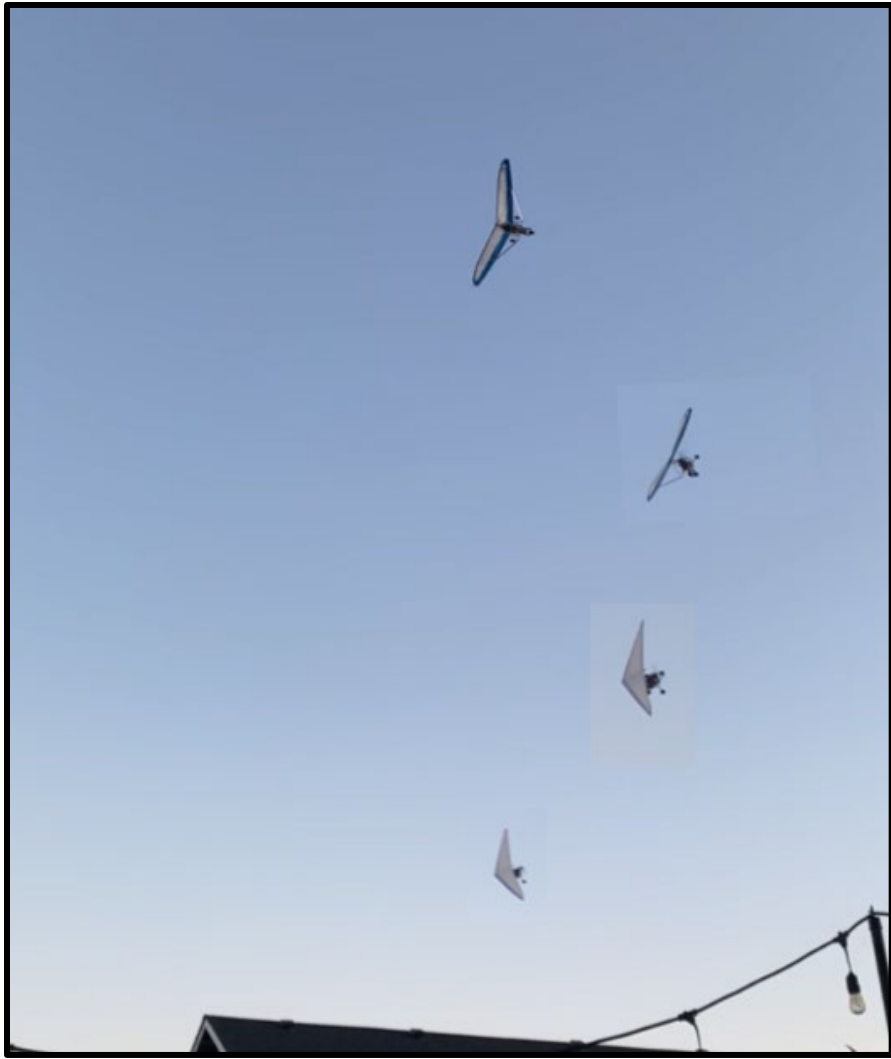
Figure 4: Excerpts of Video Passing Over House

After overflying the pilot's home, located about 4,000 ft north of the airport, the flight continued northeast for about 3.3 miles. The aircraft then turned left and overflew close to the passenger's home (see picture 1).
