## EXAMINATION NOTES

### WRECKAGE AND IMPACT

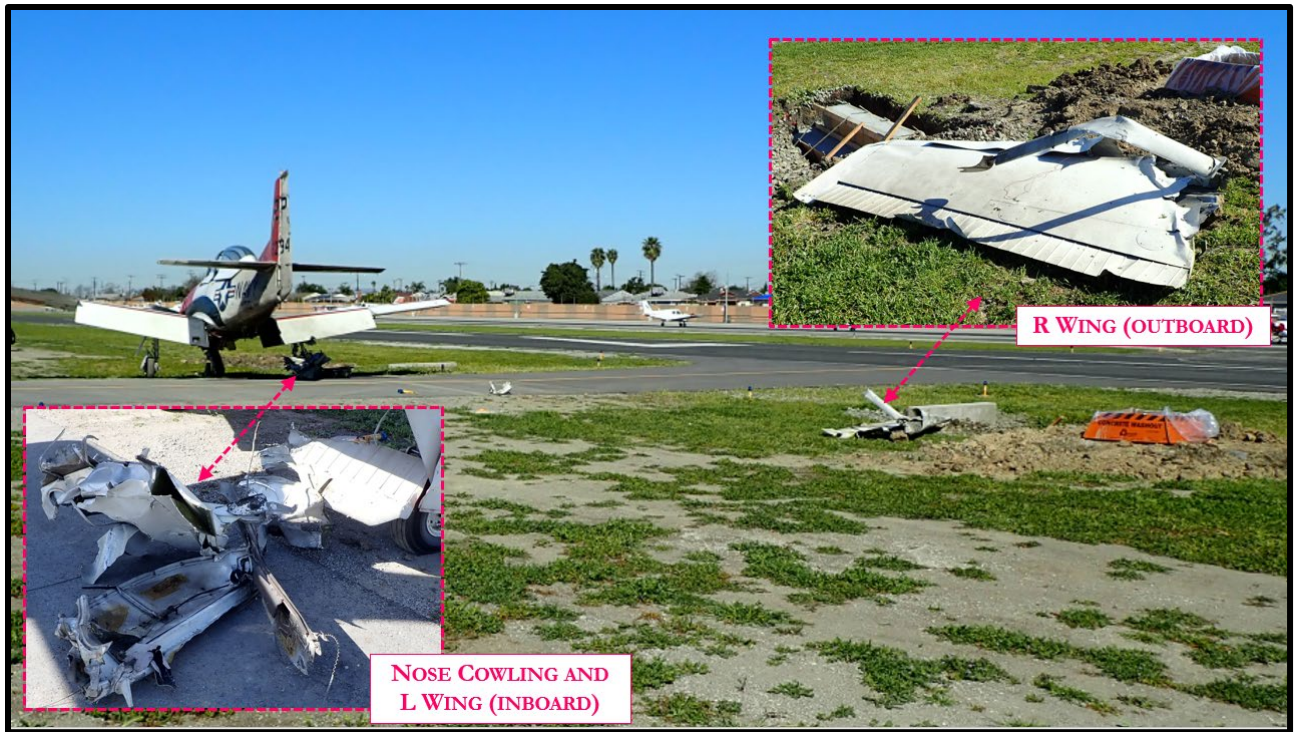
Figure 5: T-28 Debris Field

The C-152 was consumed by fire. The T-28 had damage to the lower right nose cowling. A portion of the nose cowling and inboard left flap were entrapped on the right wheel pant of the T-28.

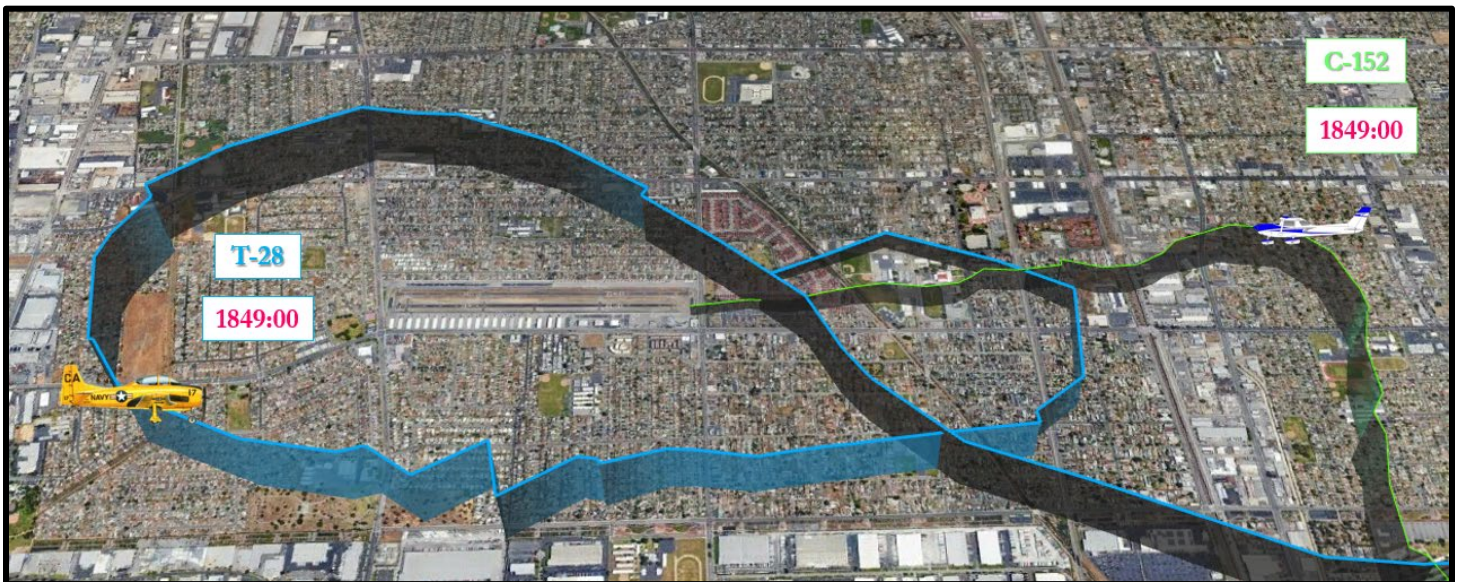
Figure 11: Airplanes' Positions at 1849:00

The radar data from Long Beach to Compton consisted of about 19 minutes of returns from 1831:47 to 1850:14. The returns were consistent with the C-152 departing the airport and heading northwest, continuing in that direction for about 5nm west of Compton Airport at which point it turned right heading southeast. The track then turned north and at 1847:33, adjoined the left downwind about 950 feet agl. The returns showed a northerly track again starting about 1848:11 and then a westerly track about 1848:58 until it ended at the airport perimeter at 1850:12; this was consistent with the C-152 making a base and final leg of the traffic pattern to runway 25L. The radar data consistent with the T-28 starts around Monrovia, California and proceeds to Compton containing about 13 minutes of returns from 1837:36 to 1850:20. The returns were consistent with the T-28 approaching Compton from the east. As the returns approached the airport, they were consistent with the airplane then circling the airport at an altitude of about 700-750 feet above ground level (agl) starting at speeds over 170 kts and while adjoining a left base for runway 25L reduced down to 130 kts.
