## WRECKAGE AND IMPACT

On May 01, 2019, about 1100 Pacific daylight time, a Cessna T182P, N7302S, experienced a loss of power and collided with a powerline while making an emergency landing to grassy marsh in Mill Creek, California. Air Carriage, Inc.,<sup>1</sup> the registered owner, was operating the airplane under the provisions of 14 *Code of Federal Regulations* (CFR) Part 91. The certified flight instructor (CFI) and front-seated passenger sustained serious injuries; the rear-seated pilot-rated passenger sustained fatal injuries. The airplane sustained substantial damage. The personal local flight departed from Chino Airport, Chino, California, about 1010. Visual meteorological conditions prevailed and no flight plan had been filed.

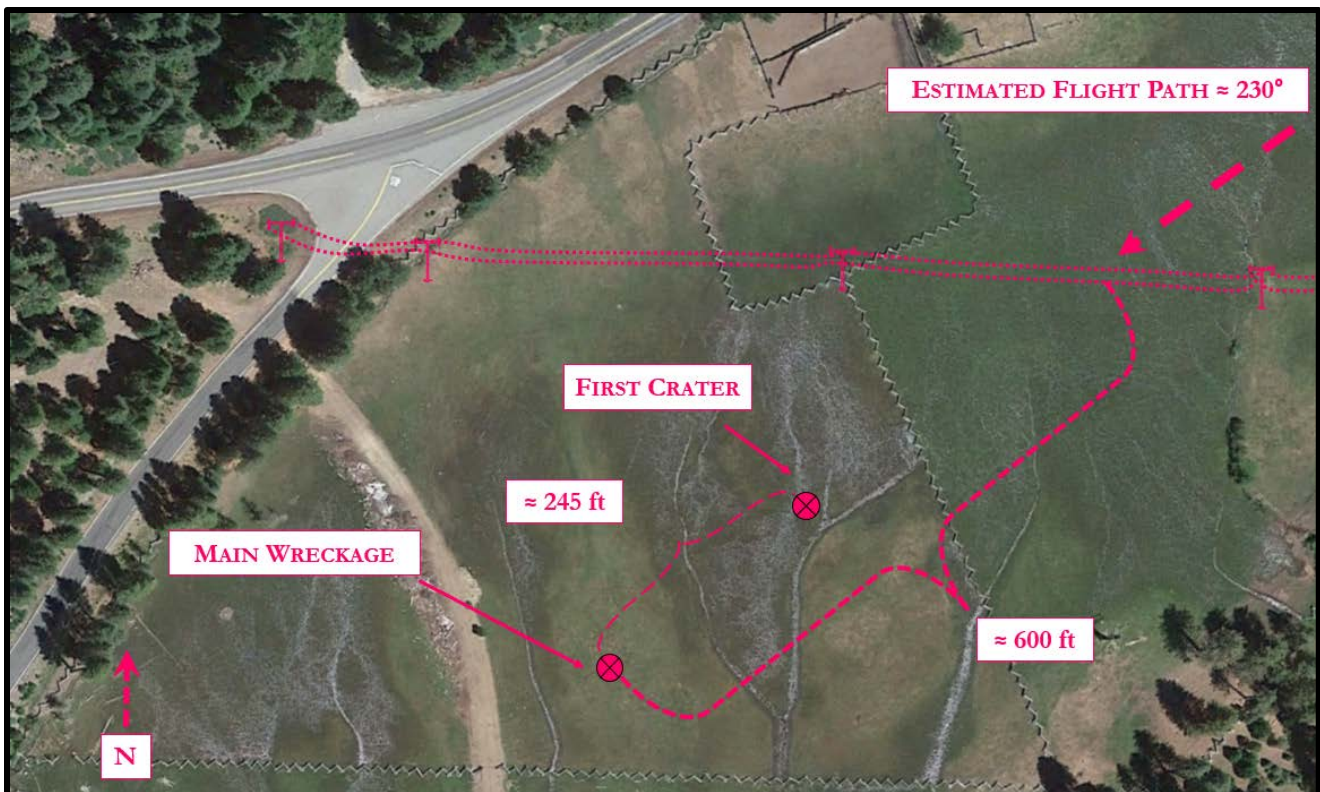
Picture 09: Debris Field in Reference to the Powerlines

The first identified points of contact consisted of disrupted mud and grass in the marsh making up the far northeastern end of the debris field. The markings started as two nearly parallel indentations in the vegetation and dirt spaced about 6 feet apart. There were deep craters after the indentations and disrupted grass that continued southwest toward the main wreckage. The craters were consistent in size and orientation to that of vertical stabilizer and rudder, consistent with the airplane impacting terrain inverted.

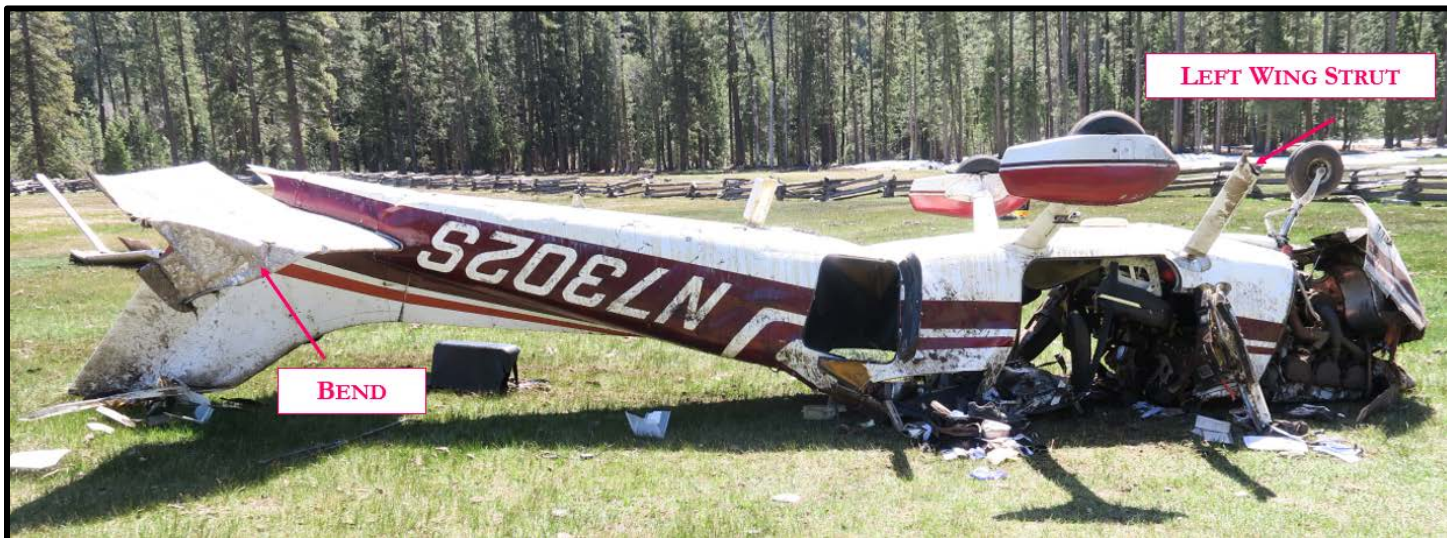
Picture 12: Main Wreckage

The fuselage came to rest inverted. A 2.5-foot portion of the left-wing strut remained attached to the fuselage and the fracture surface was consistent with the fracture surface on the portion attached to the left wing. The doors had been removed by first responders. There was an oil sheen on the entire belly of the fuselage and lower surface of the horizontal stabilizer and elevator control surfaces. The lower left cowling contained a rub mark consistent with contact with a wire.

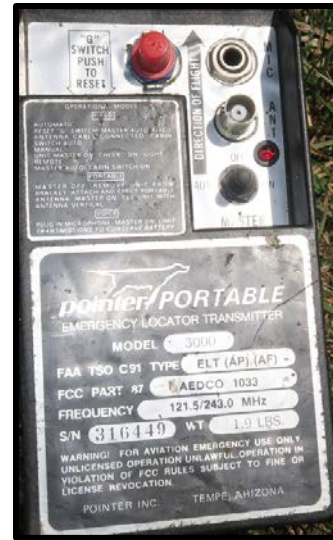
Picture 17: ELT

The rudder control surface remained affixed to the vertical fin structure. The horizontal stabilizer and elevator remained attached to the empennage. The Cessna representative confirmed control continuity from the cockpit controls to the control surfaces. The 121.5 Emergency Locator Transmitter (ELT) was activated during the accident.

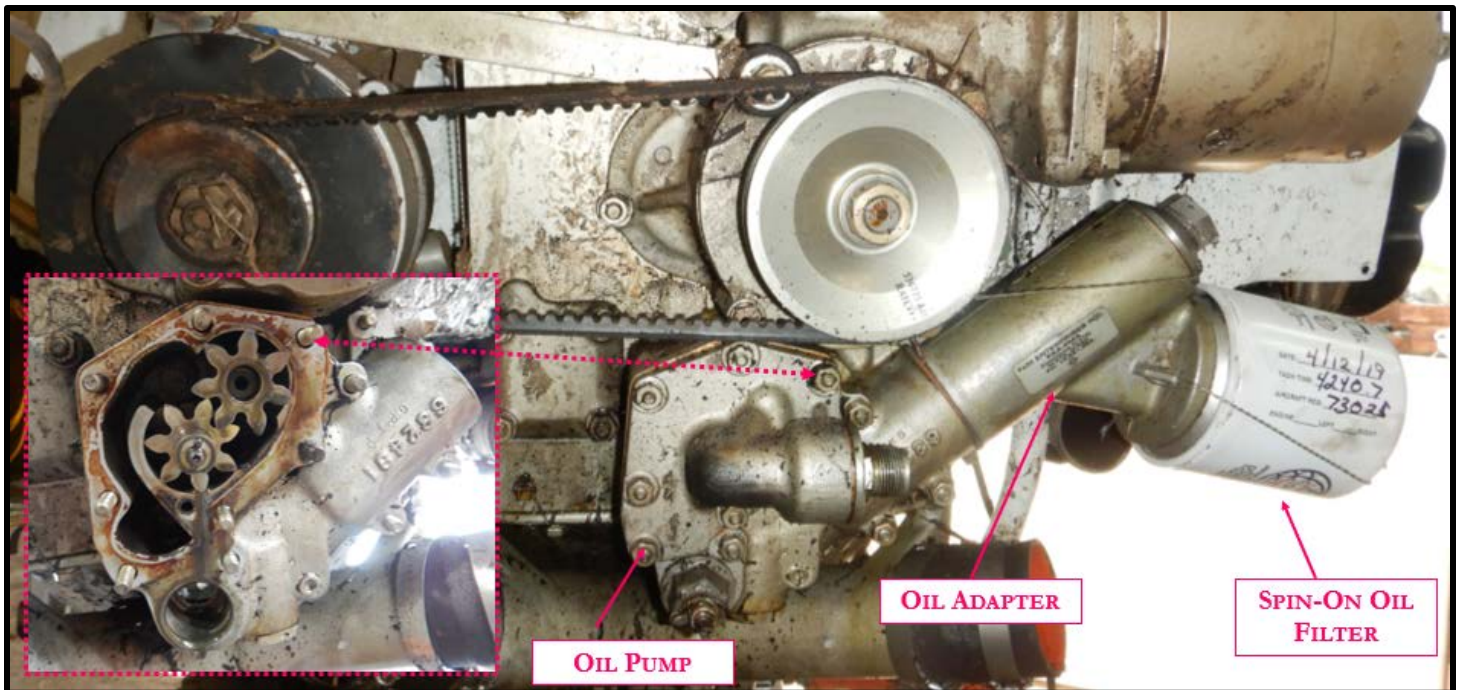
Picture 22: Accessory Gear Case Showing Location of Oil Filter Adapter

The engine was equipped with an F&M Enterprises Inc. engine oil filter adapter, model C6LC-S (s/n 60399). The purpose of the adapter was to enable the engine to use a conventional spin-on oil filter. As manufactured, the oil pump has a brass oil screen mounted to the casing and the filter adapter uses the oil screen bore to attach to the engine. According to the patent<sup>5</sup> the adapter included a tee casting (housing) and a hub (shaft) which was threaded to screw into the oil screen hole on the oil pump casting. The tee casting had a sleeve with a through bore and a mounting base with an end for receiving a spin-on oil filter. When installed, the hub was journaled into the bore of the sleeve and screwed into the oil screen hole, which had two oil passage openings. A crown (1-inch bolt head) at the outer end of hub secures the tee casting against the oil pump casing. Oil inlet and oil outlet passages are provided through the hub and the tee casting to circulate oil from the oil screen hole into the spin-on filter, and back into the oil screen hole from the spin-on filter.

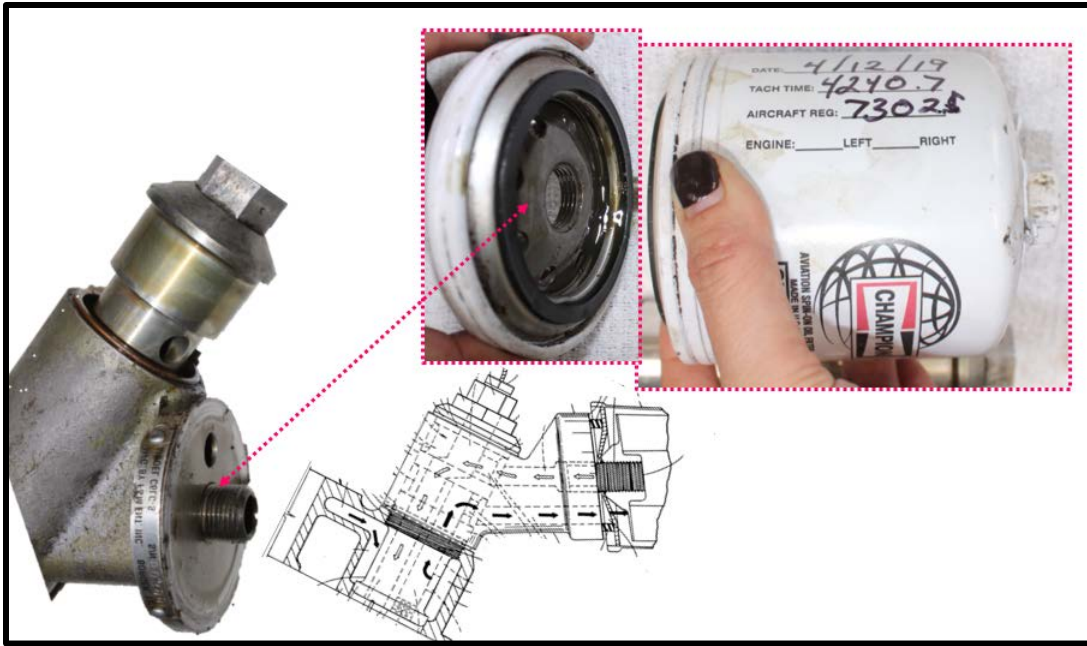
Picture 23: *Oil Filter Adapter Mounting Pad*

An external examination of the engine at the accident site, revealed that the filter adapter was loose, and the adapter housing could be rotated about the shaft.<sup>6</sup> The crown head of the shaft and the oil filter screen bolt head both remained saftied. There was a concentration of oil in the area of the adapter and adjacent firewall.
