GARMIN 1000NXi SUPPLEMENTAL MATERIAL

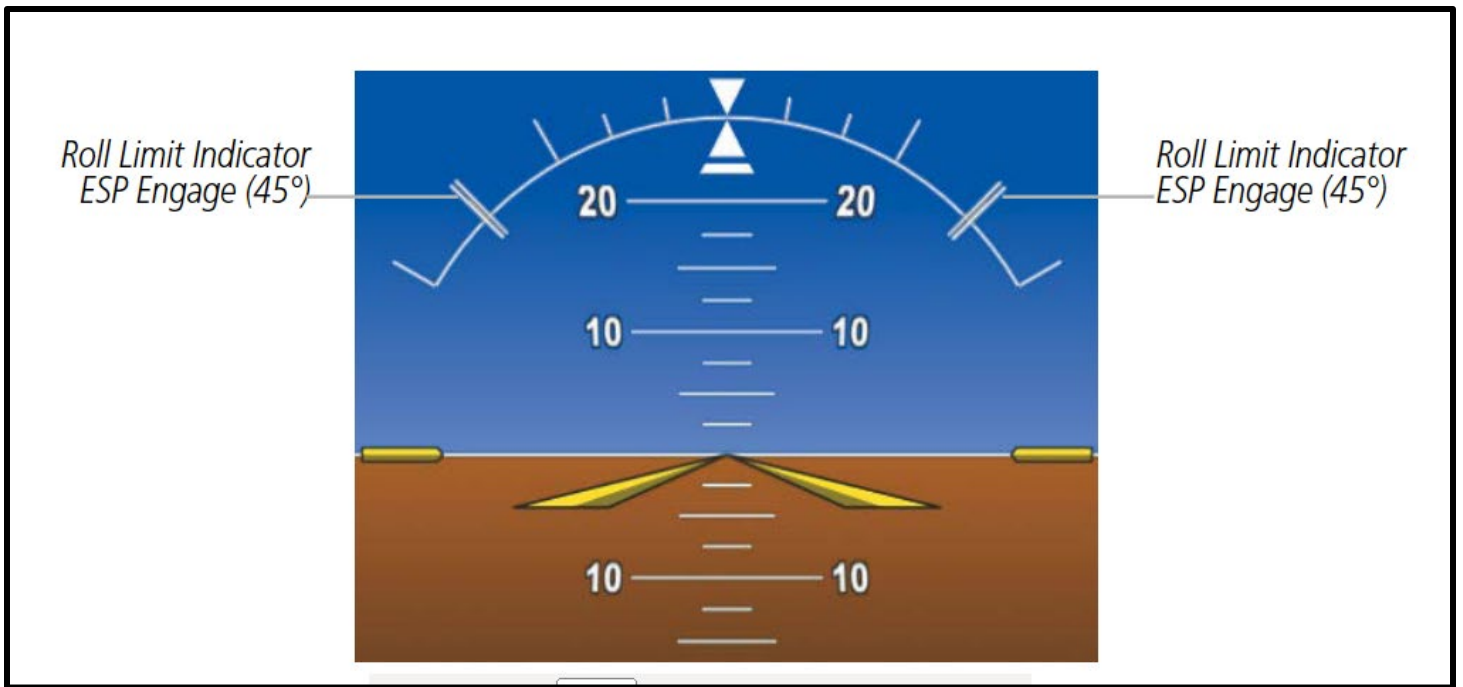
Figure 6: ESP roll engagement indication (ESP not engaged)

Roll Limit Indicators bars are displayed on the attitude indicator where the 45° left and right bank hash marks are located. This indicates that the ESP will engage as the roll exceeds 45° and the Roll Limit Indicator bars will move to the 30° and 75° degree positions, which shows where ESP will disengage as roll attitude increases/decreases (i.e., ESP will disengage once roll is returned to 30° or beyond 75°). Once engaged, ESP force varies up to a maximum force of 7.5 lbs. The force increases as bank angle increases with maximum servo torque attained at 60°.

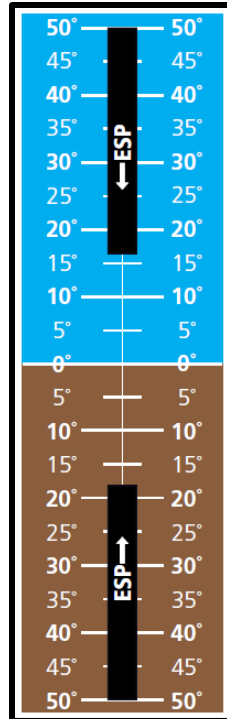
Figure 8: ESP Pitch operating range when engaged

The ESP system engages at 19° nose-up and 20° nose-down. Once engaged, it applies opposing force between 17° and 50° nose-up and between 18° and 50° nose-down. Maximum opposing force is applied between 24° and 50° nose-up and between 25° and 50° nose-down. The opposing force increases or decreases depending on the pitch angle and the direction of pitch travel.

There are no indications marking the pitch ESP engage and disengage limits in these nose-up/nose-down conditions, nor is there an indication when it is activated.

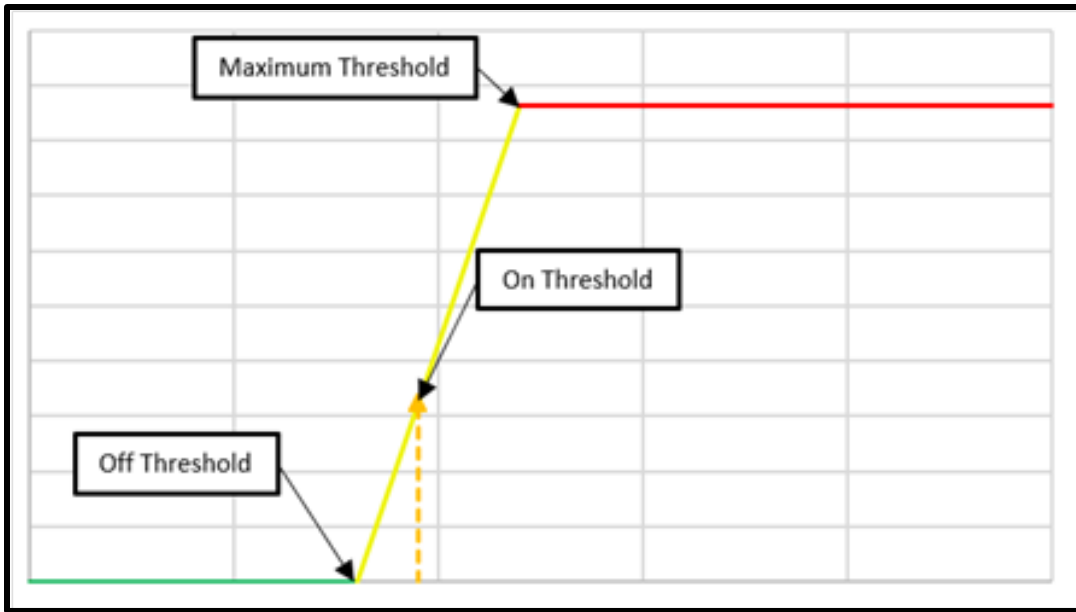
Figure 12: Textron provided graph of force from ESP

According to Textron Aviation, there are three main types of ESP for the 208B: pitch, roll, and high speed. For each of these, the starting torque is 0 in-lbs and the maximum torque is 43.2 in-lbs. There are curves that define the strength of the force based on how the aircraft is maneuvering.
