National Transportation Safety Board

WPR22FA055

INVESTIGATIVE SUPPLEMENT

Location: Medford, Oregon
Date: 12.05.2021
Time: 1652 Pacific standard time
Airplane: Piper PA-31-350 Navajo Chieftain

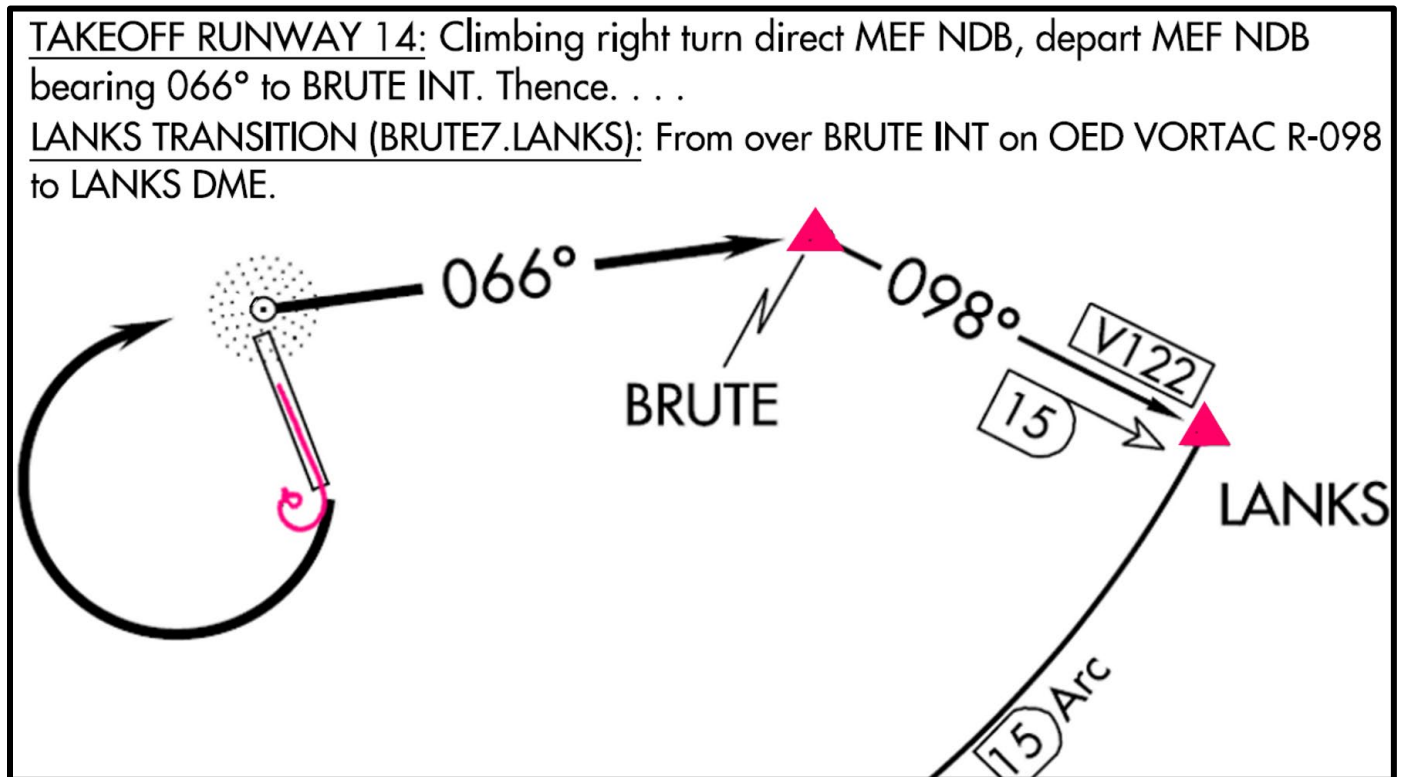
The radio communication times could not be confirmed. The pilot received an instrument flight rules (IFR) clearance and was issued the BRUTE7 departure procedure with the LANKS transition. During the exchange of the clearance instructions, the pilot requested the controller read back the departure procedure and transition phonetically. The pilot's family and a business associate stated this was very normal for the pilot and he would often have people clarify names and instructions. The published BRUTE SEVEN Standard Instrument Departure (SID) with a takeoff from runway 14 consisted of a "climbing right turn direct MEF [Medford] NDB [nondirectional beacon]," and continue to the BRUTE intersection on a bearing of 066°.

After receiving the clearance, the controller informed the pilot the overcast layer base was at 200 ft above ground level (agl) the tops of the layer was at 2,500 ft. After the airplane departed the pilot made a radio communication to the controller asking "will you be calling my turn for the BRUTE7?" The controller replied that he would not be calling his turn and that the pilot should fly the departure as published making a climbing right turn to overfly the approach end of runway 14 before proceeding to the BRUTE intersection (see Figure 1 below). The pilot acknowledged the communication, which was his last transmission. Several seconds later, the controller stated that he was receiving a low-altitude alert that the airplane's altitude was showing 1,700 ft. He made several attempts to reach the pilot with no response.

Figure 3: The Airplane's Flight Track Overlayed a Visual Depiction of The BRUTE7 Departure

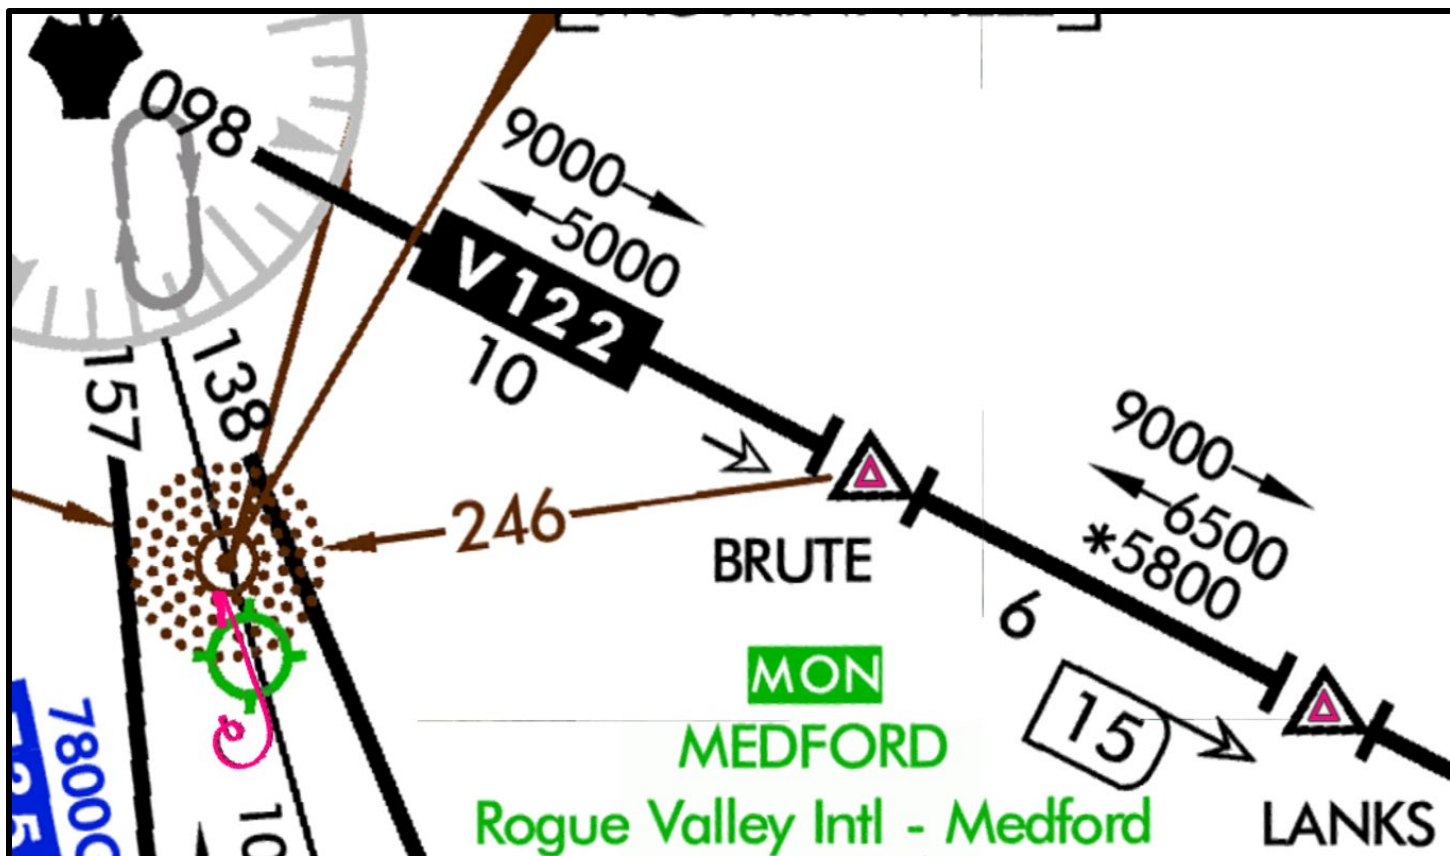
Figure 4: The Airplane's Flight Track Overlaid the Departure

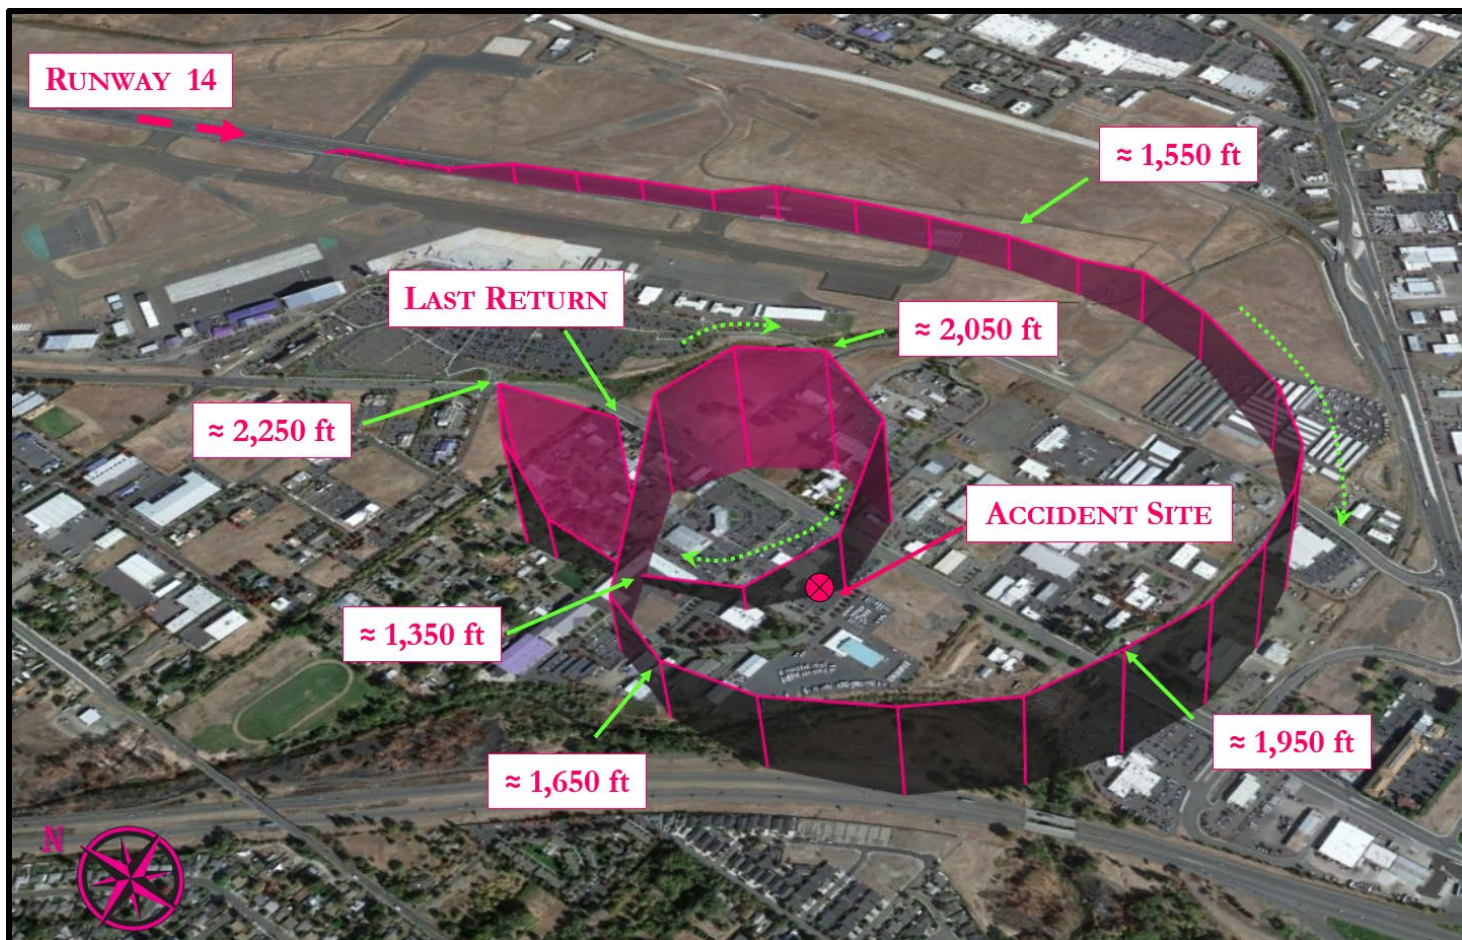
The radar and automatic dependent surveillance-broadcast (ADS-B) information disclosed that the airplane arrived in the run-up area for runway 14 about 1643 and then continued onto the runway about 6 minutes thereafter. The airplane departed about 1649:30 and after crossing over the south end of the runway, it climbed to about 1,550 ft mean sea level, equivalent to 200 ft agl (see Figure 2 below). The airplane then began a gradual right turn and climbed to 1,950 ft maintaining an airspeed between 120-130 kts. As the airplane turn continued to the north the altitude momentarily decreased to 1,650 ft (about 350 ft agl) with the airspeed increasing to 160 kts. Thereafter, the airplane then increased the bank angle and made a 360-degree turn initially climbing to 2,050 ft. At the completion of the turn, the airplane descended to 1,350 ft, consistent with it maneuvering below the cloud layer. The airspeed increased to about 160 kts and several seconds later, the airplane climbed to 2,250 ft with the derived airspeed showing below 15 kts. Six seconds later was the last radar return, located about 990 ft north-northwest of the accident site.

Figure 5: The Airplane's ADS-B Flight Track

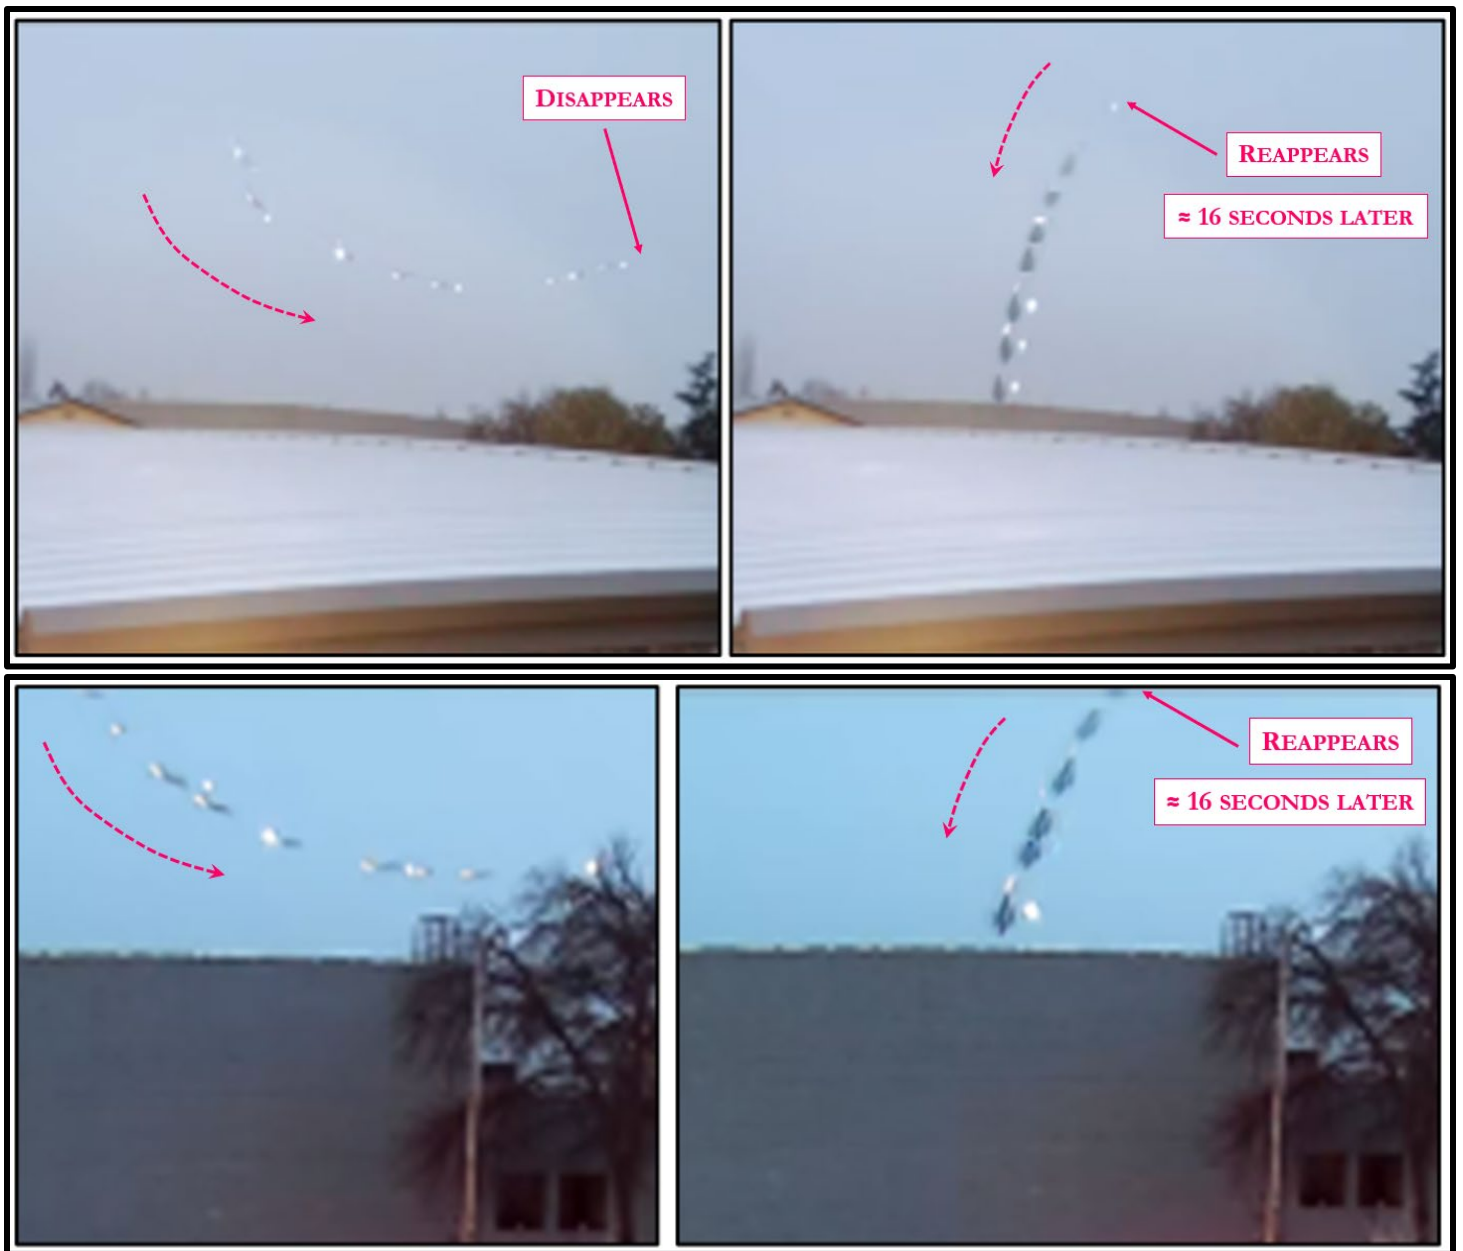
Video footage was obtained from several fixed security cameras on buildings around the accident site. A review of the footage revealed that the airplane descended below the cloud layer and then climbed back up. About 16 seconds thereafter, the airplane is seen descending in a near vertical attitude (see Figure 3 below). The airplane's position and strobe light appeared to be illuminated throughout the video. The preliminary review of the recorded audio from the camera footage revealed that there were sound components at frequencies that correspond to the normal operating speed range of the airplane engines.

Figure 6: Excerpts of Security Camera Footage

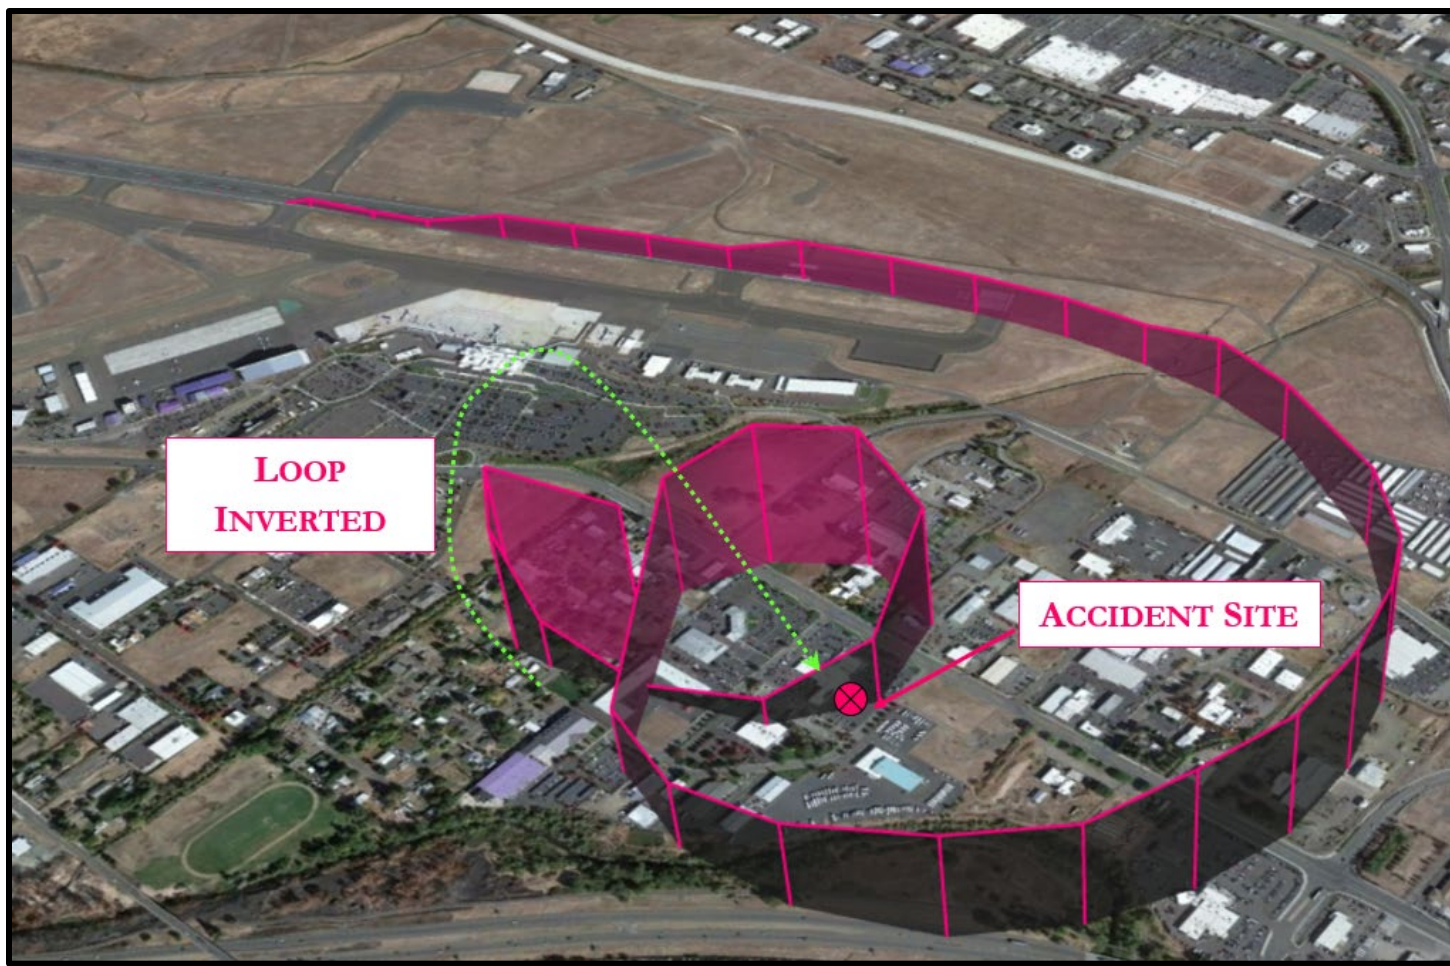
Figure 7: Flight Path with Annotations

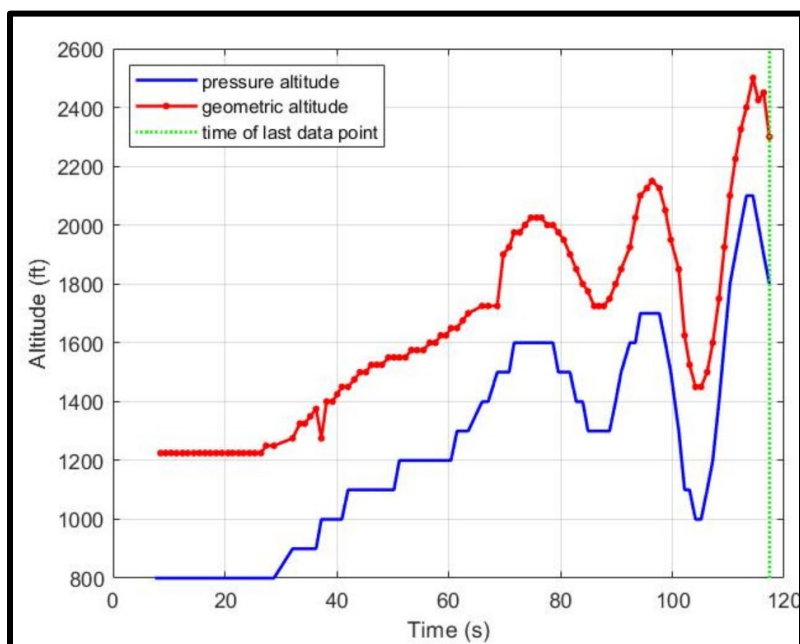
The geometric altitude increases from 1450 feet to 2500 feet between time 105.2 seconds and time 114.4 seconds. This is average climb rate of $(2500-1450)/(114.4-105.2)=114$ feet/second = 6840 feet/minute.

Figure 9: Altitude Chart

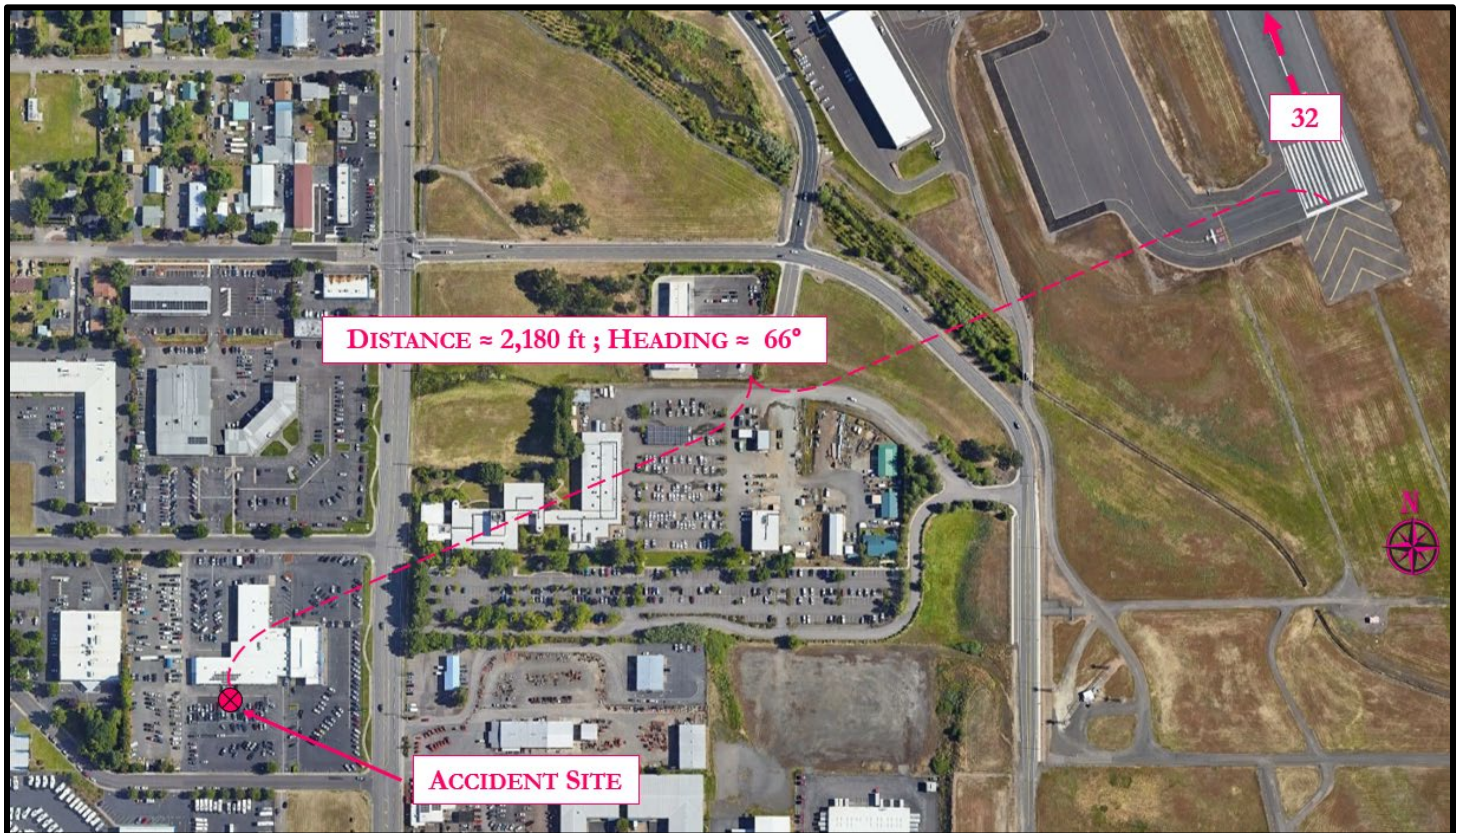
The accident site was located in a car dealership parking area 2,180 ft west-southwest from the departure end of runway 32. In character, the impact area was flat asphalt surrounded by numerous automobiles and adjacent to large garage door bays [the unoccupied Service Center]. The wreckage was found distributed on the dealership roof and throughout the parked automobiles, with the nose coming to rest on a heading of north. Approximately 13 automobiles were damaged and 11 were destroyed.

Figure 10: Accident Site in Relation to the Runway

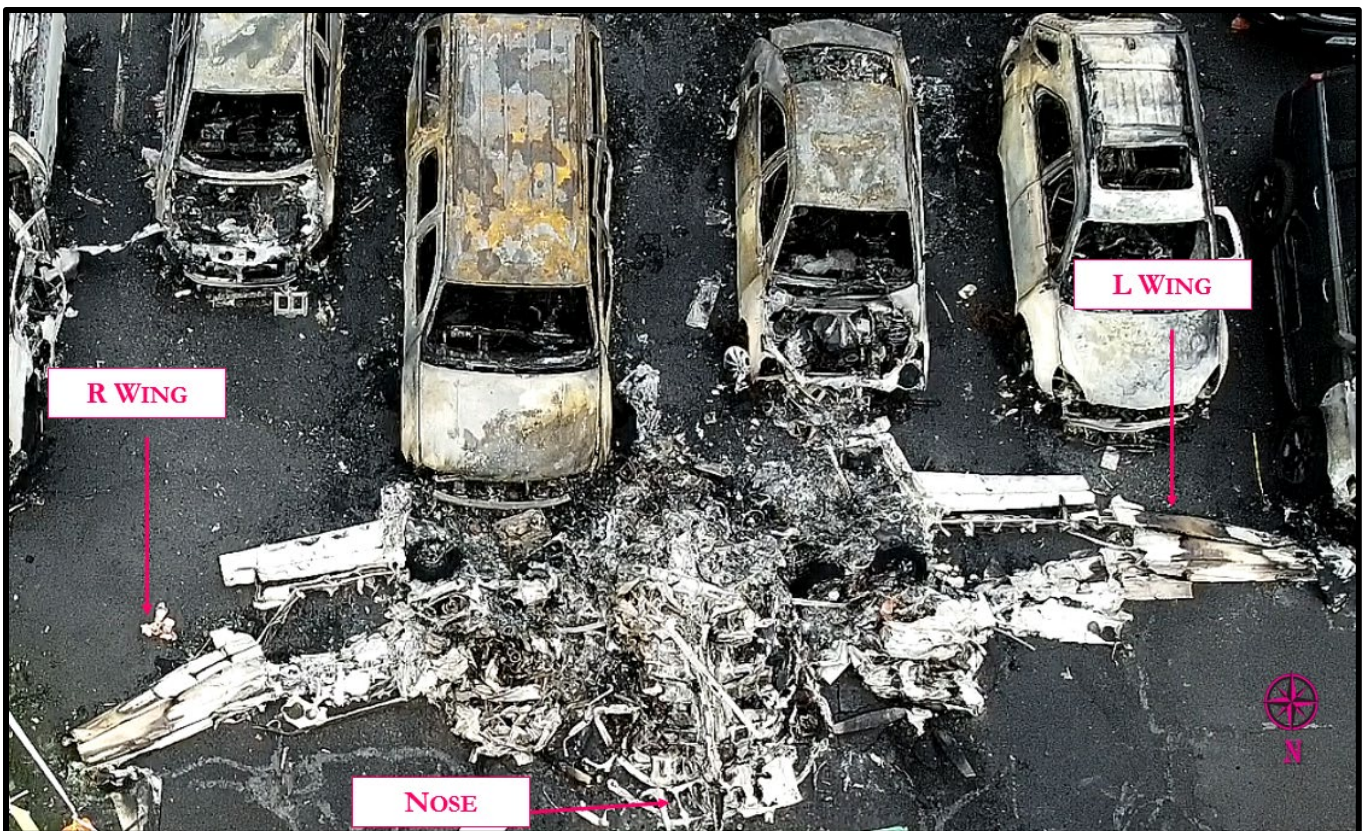
Figure 12: Ariel View of Accident Site (showing fuselage)

The fuselage sustained aft crush damage and was partially consumed by the post-impact fire. The nose section sustained the most fragmentation with the nose landing-gear displaced aft, aligning with the main wing-spar. The instrument panel had sustained major thermal damage with the instruments and radios separated; there was limited meaningful information that could be derived from the gauges due to the damage. The landing gear lever remained attached within the instrument panel and was positioned midway through its range.

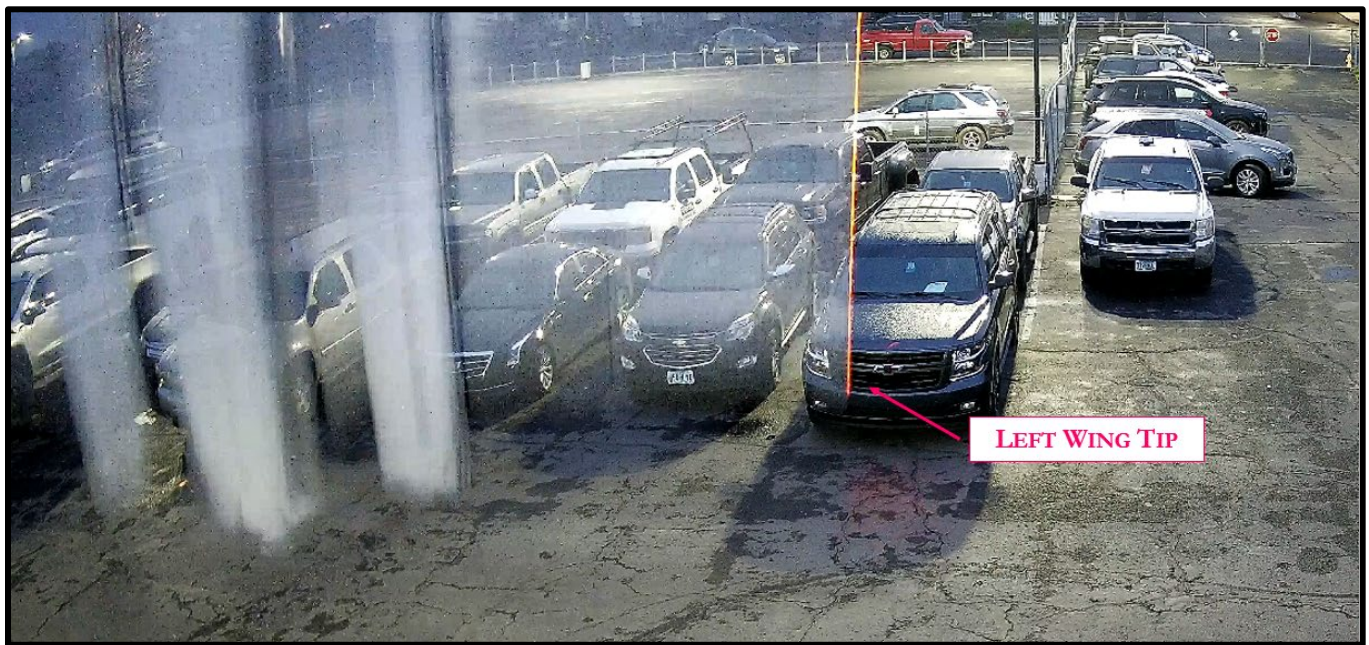
Figure 13: Video Image Showing the moment Before Impact

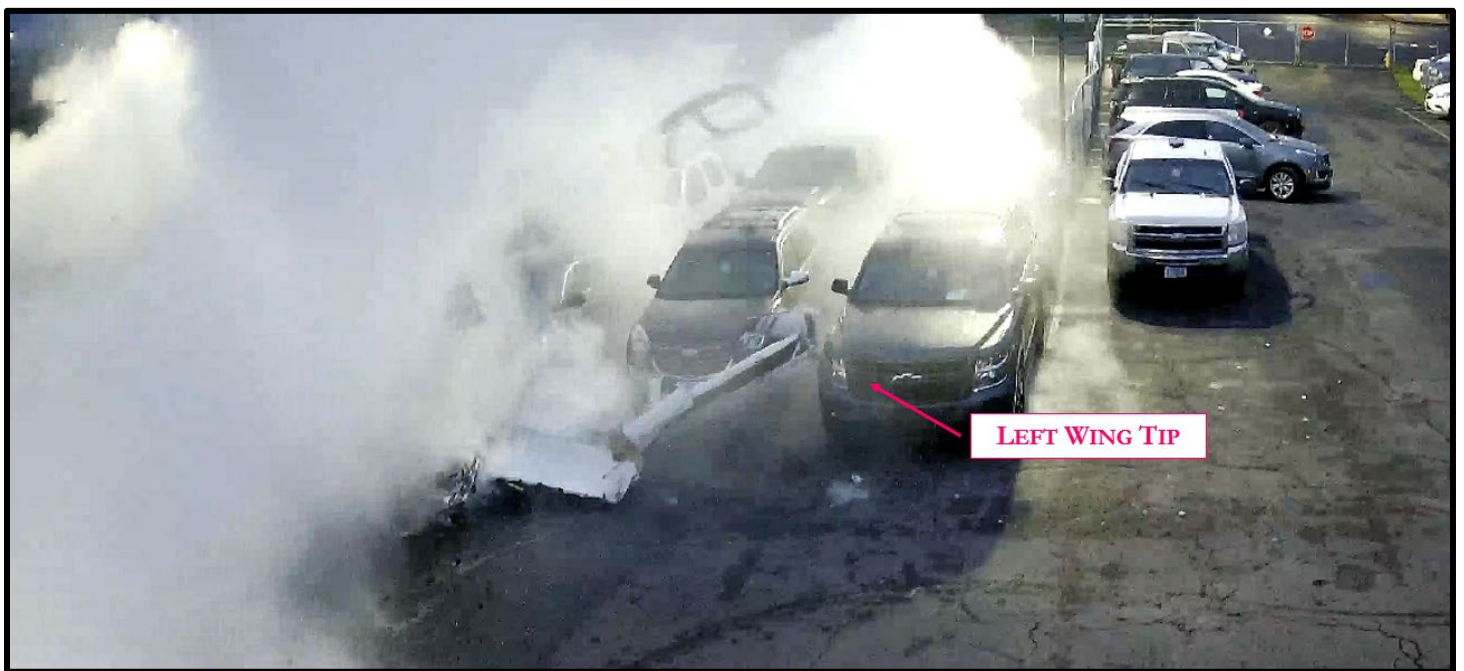
Figure 14: Video Image Showing the Moment After Impact

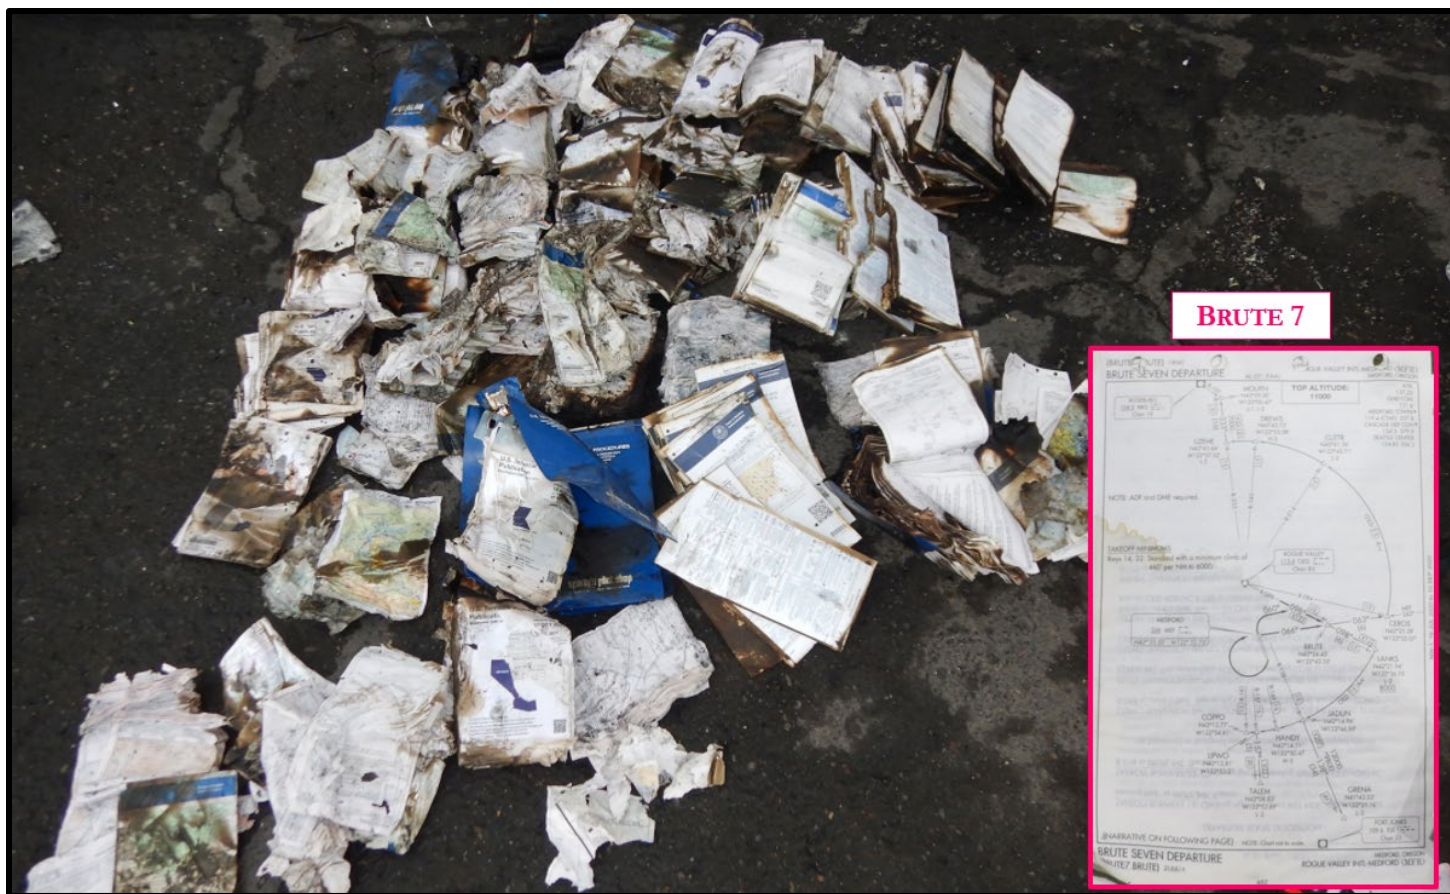
In the wreckage there were numerous paper charts, including the current departure procedures.

Figure 26: Paper Aeronautical Maps and Charts Found in the Wreckage

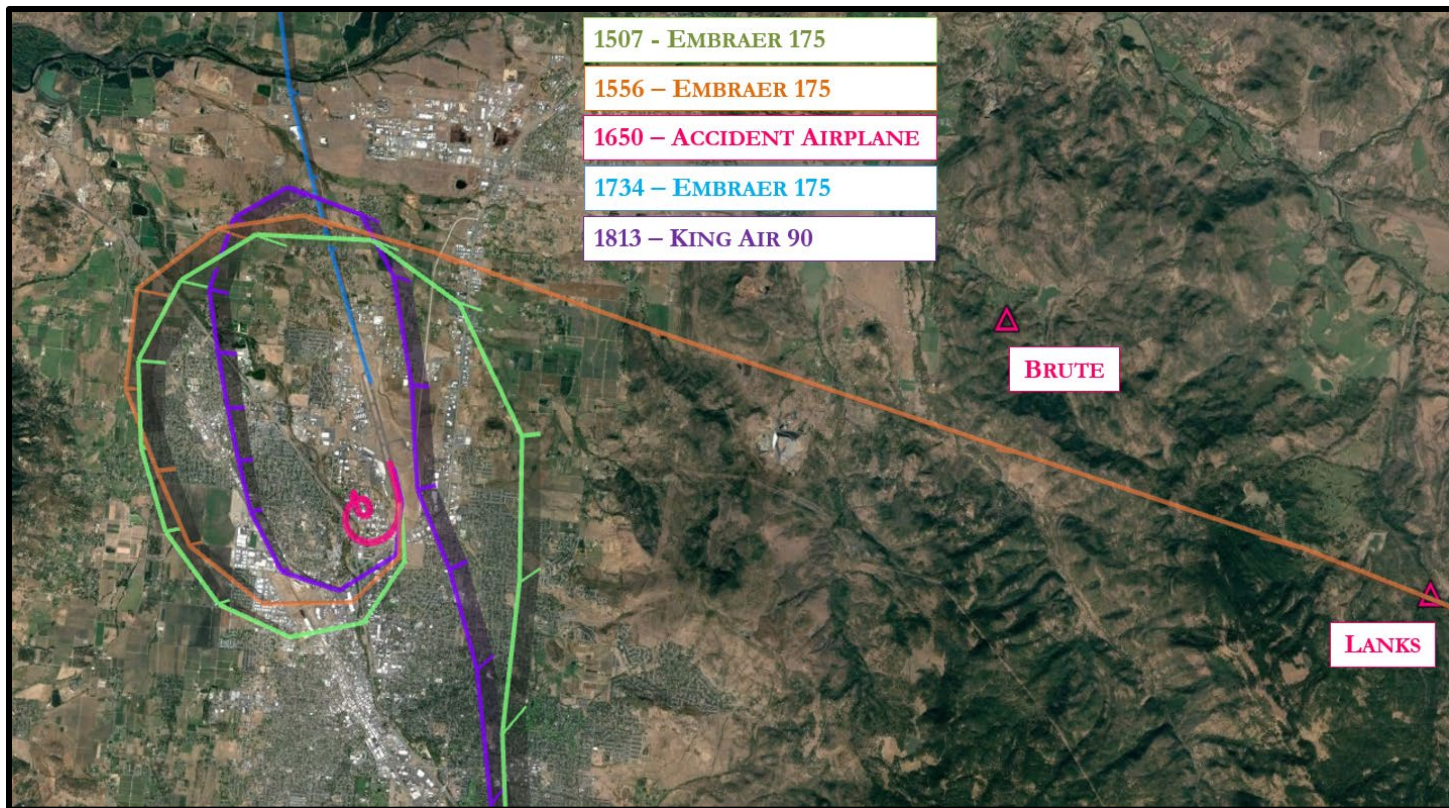
Investigators compiled a comparison of ADS-B data from two airplanes that departed before the accident airplane (at 1507 and 1556) and two that departed after (1734 and 1813). A comparison of flight tracks from the three airplanes that departed runway 14 revealed that all began the right turn after the accident flight.

Figure 31: Comparison of Flight Tracks from Departures Before and After the Accident Flight

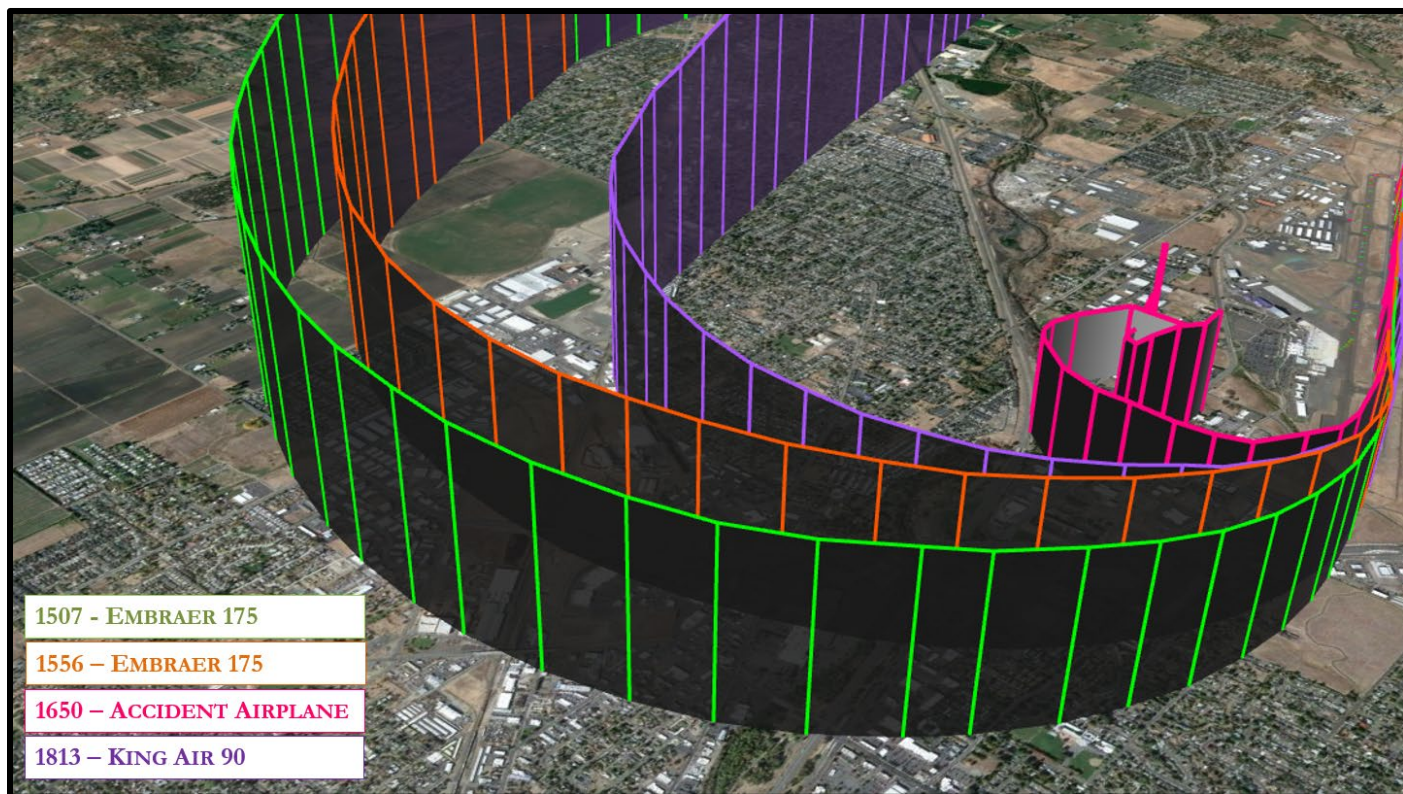
Figure 32: Comparison of Flight Tracks from Departures Before and After the Accident Flight

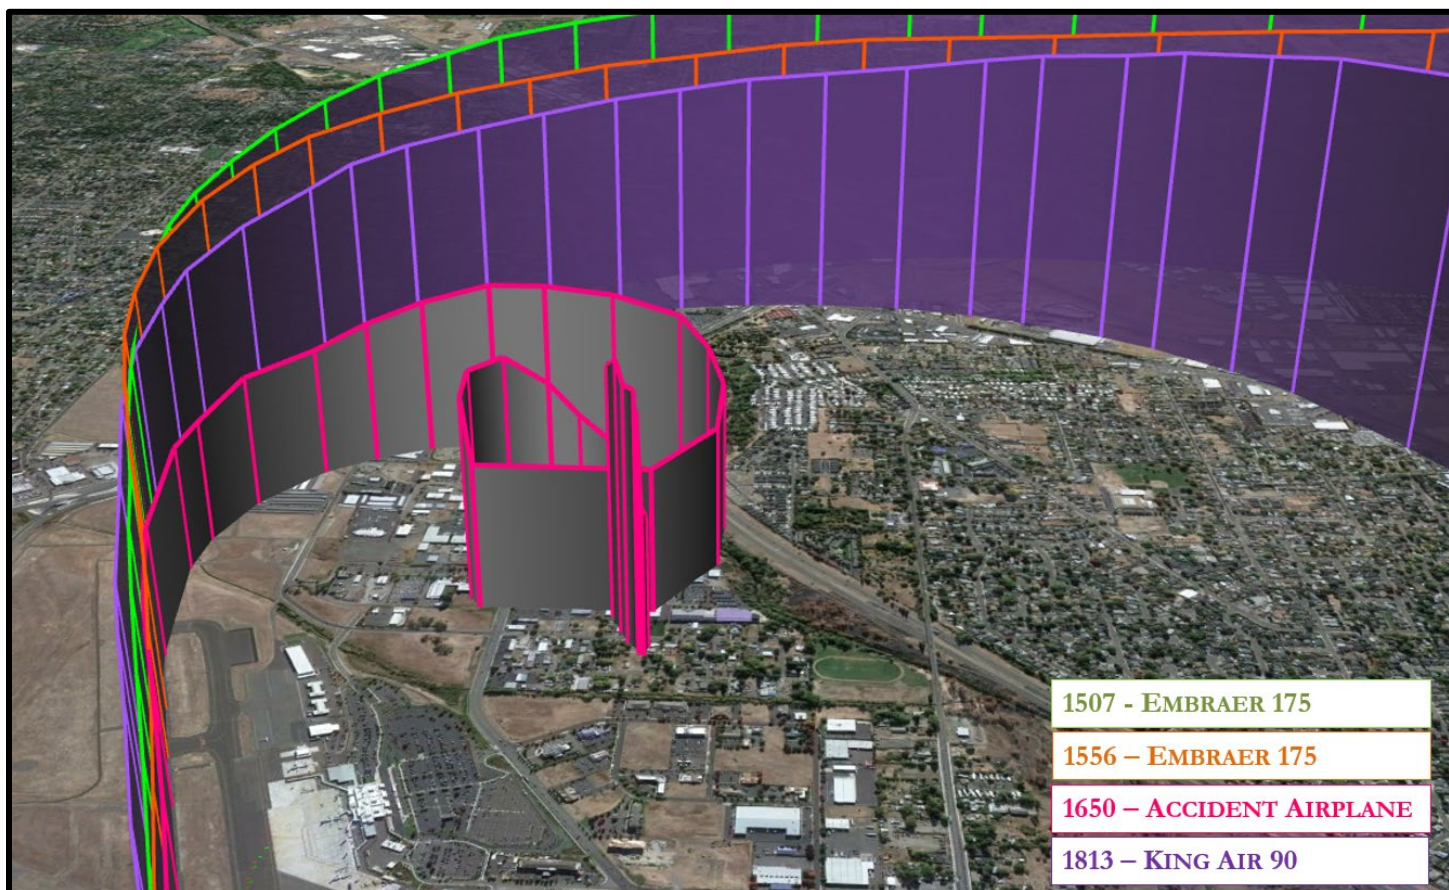
Figure 33: Comparison of Flight Tracks From Departures Before and After the Accident Flight
