ZOE KELIHER
Sr. Air Safety Investigator
Office of Aviation Safety – Western Pacific Region

Subject: WPR23FA034

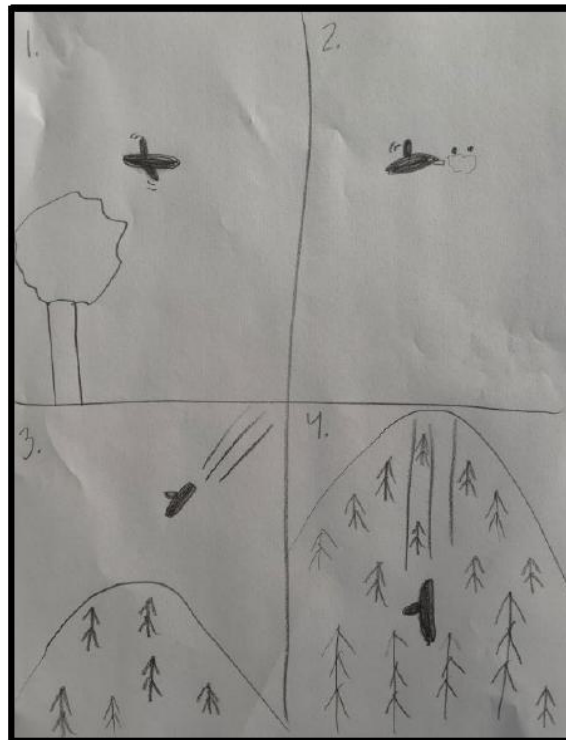
██████████ a nine-year old in fourth grade, stated she was at recess when she witnessed the accident. She said that while in-line to go in from recess at about 10:40am she observed the airplane flying normally. The airplane started shaking from side-to-side and then she saw two black dots coming off. The airplane then started to pitch down. The airplane then continued straight down behind the trees. She noted that she didn't observe any fire or smoke; there were only normal sounds/noises.
