**NATIONAL TRANSPORTATION SAFETY BOARD  
OFFICE OF AVIATION SAFETY  
WASHINGTON, D.C. 20594**

**POWERPLANTS GROUP CHAIRMAN'S FACTUAL REPORT**

NTSB ID: DCA2020MA059

Location: Calabasas, California  
Date: January 26, 2020  
Time: 0947 Pacific Standard Time (PST)  
Aircraft: Sikorsky S76B, N72EX, operated by Island Express Helicopters

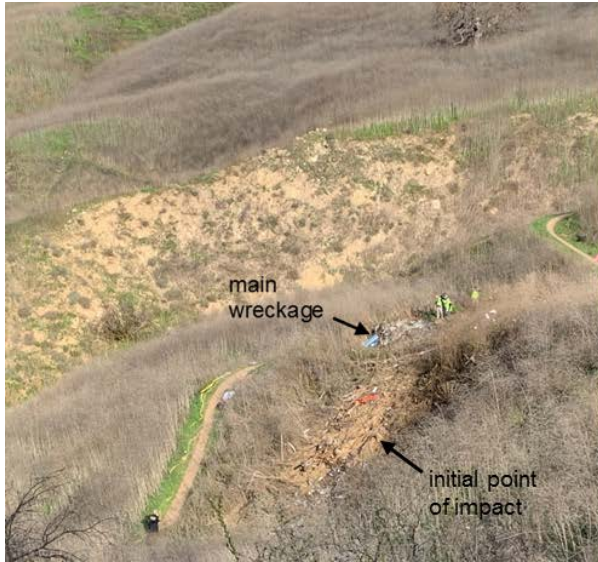
Figure 2. Wreckage path

The engines were found approximately 153 feet from the initial point of impact, in the main wreckage area. See Figure 2. The main wreckage was substantially destroyed by fire. See Figure 3.

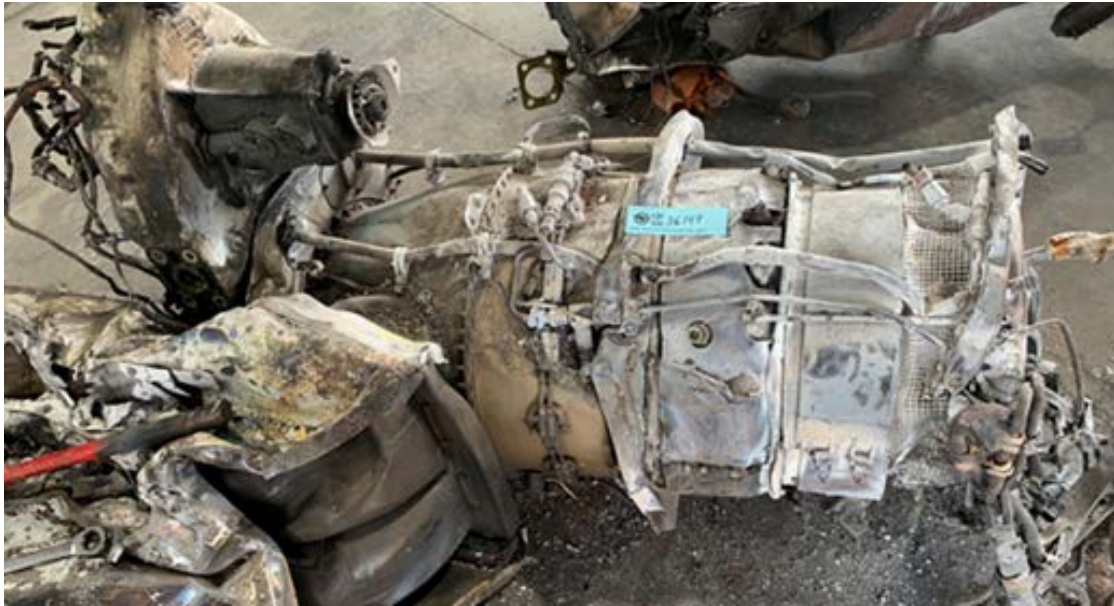
Figure 8. Engine S/N PCE 36149, as recovered

The engines were documented as received. See Figures 8 – 10.

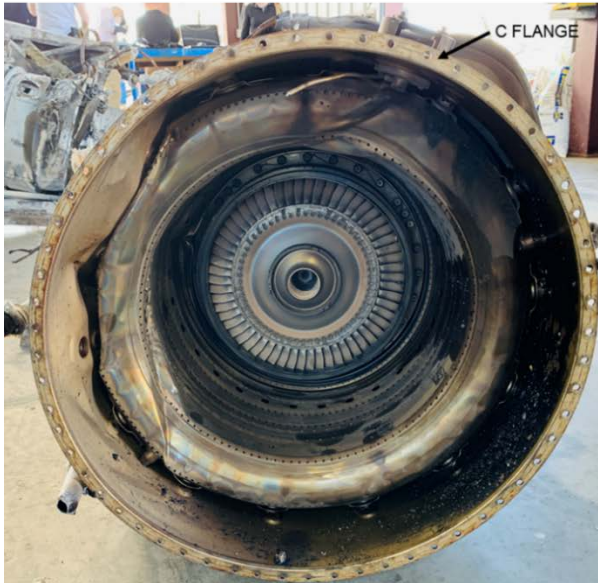
The C flange was separated to expose the compressor turbine and the power turbine stator housing assembly. See Figures 16 and 17.

Figure 16. Compressor turbine and combustor exposed by C flange separation

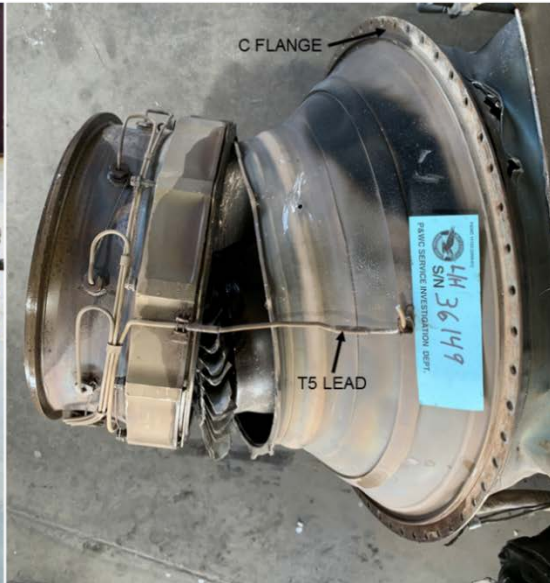
Figure 17. Power turbine stator housing after separation from the gas generator section

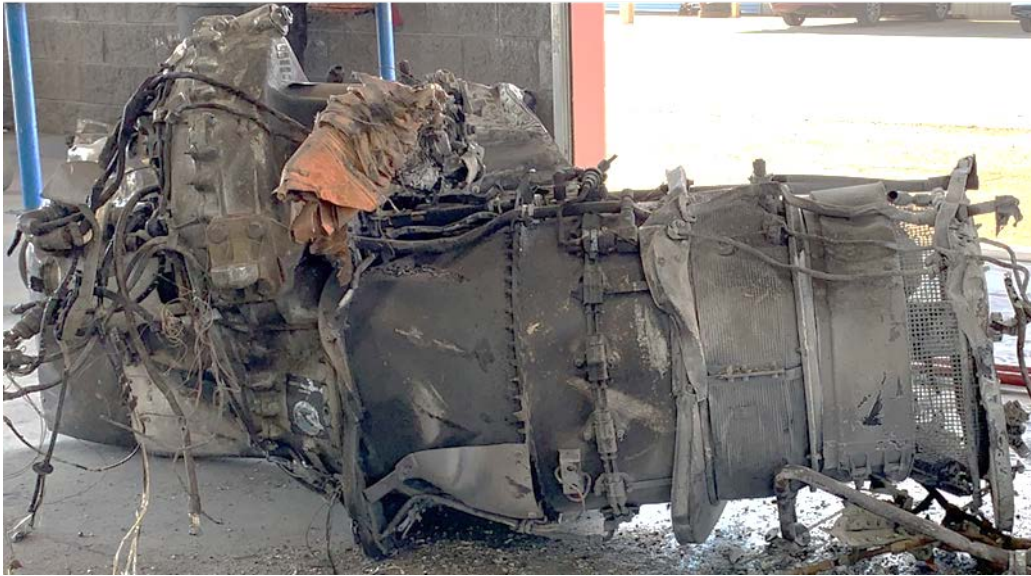
Figure 39. Engine S/N PCE 36144, left side view

The as-received condition of the engines was documented. See Figures 39 – 42.
