## **NATIONAL TRANSPORTATION SAFETY BOARD**

### **Factual Report**

# **OPERATIONAL FACTORS**

**WPR19MA177**

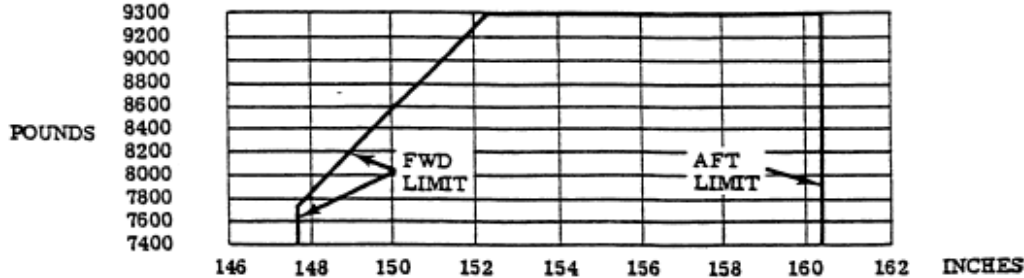
Aft Limit: 160.4 inches aft of datum at all weights.

Forward Limit: At 9300 lbs., 152.2 inches aft of datum; at 7750 lbs. or less, 147.6 inches aft of datum.

Figure 7: Beech King Air A90 weight and center of gravity limitations.<sup>73</sup>

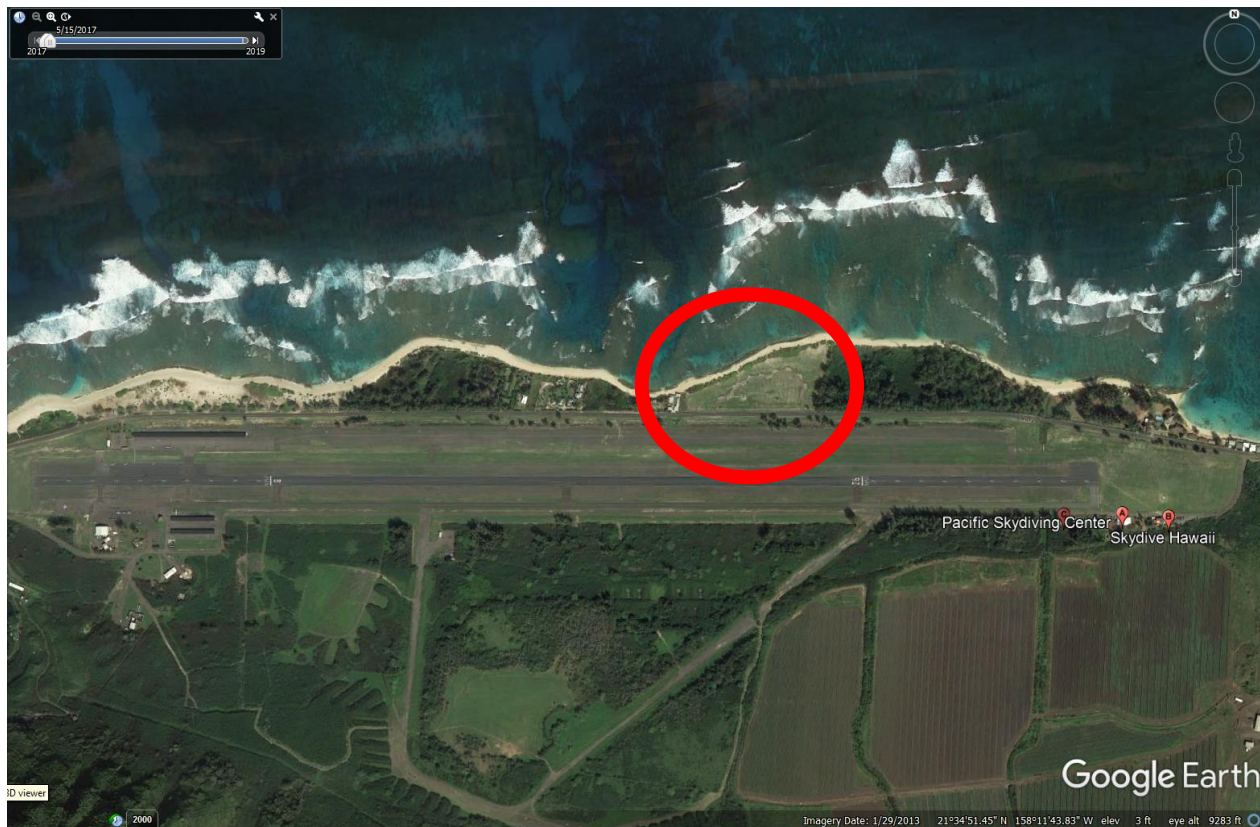
**Figure 12: Google Earth image of Dillingham Airfield. The red circle indicates the beach area pilots were directed to fly over on runway 08 departures to avoid the noise sensitive areas.**

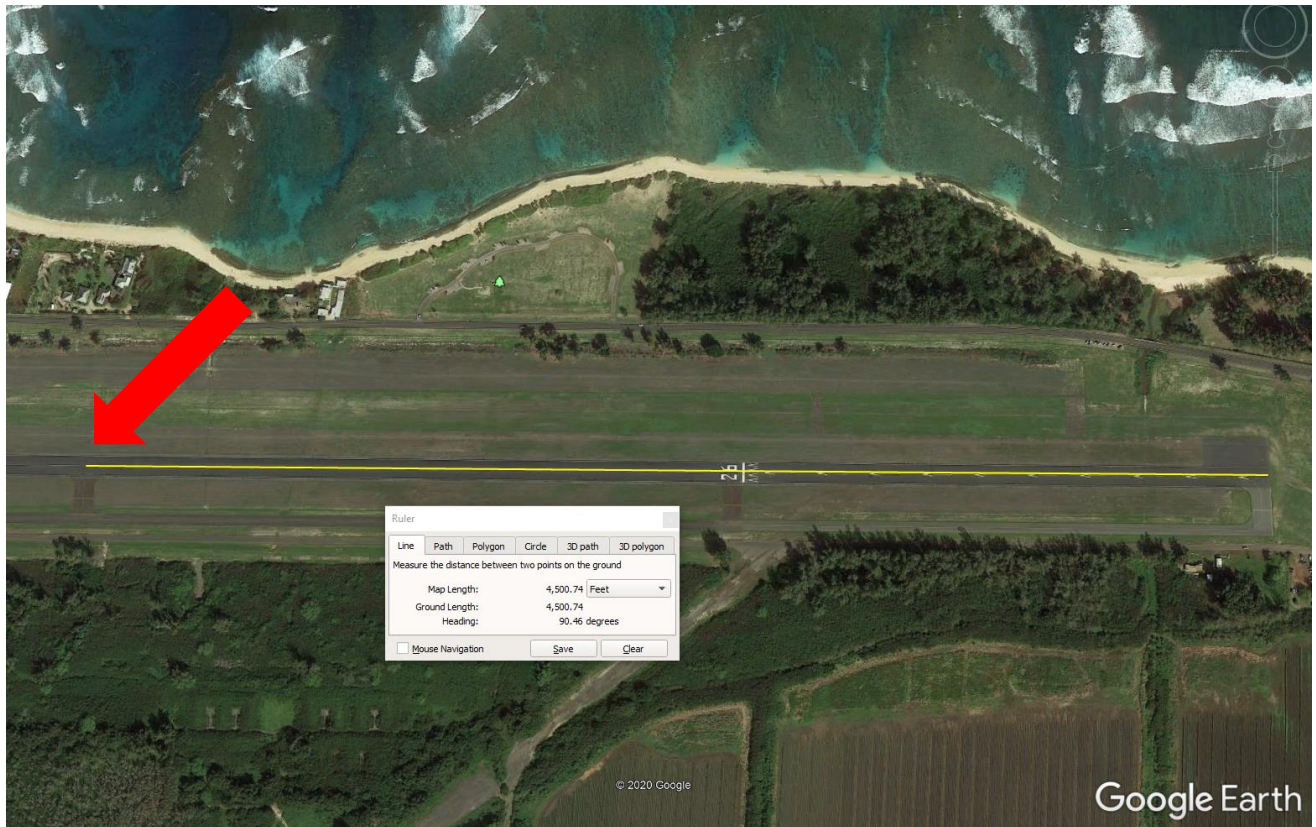
According to the Aeronautical Information Manual (AIM) dated August 15, 2019, page PCG I-5, an intersection departure was a departure from any runway intersection except the end of the runway. A departure from the intersection taxiway on runway 08 (located about midpoint on the runway) at HDH would have provided about 4,500 feet runway remaining for departure (including the displaced threshold east of runway 08) (see Figure 13).<sup>87</sup>

**Figure 13: Google Earth image showing measurement from the mid-runway intersection on HDH runway 08 to the end of the runway. The red arrow indicates the location of the runway 08 intersection.**

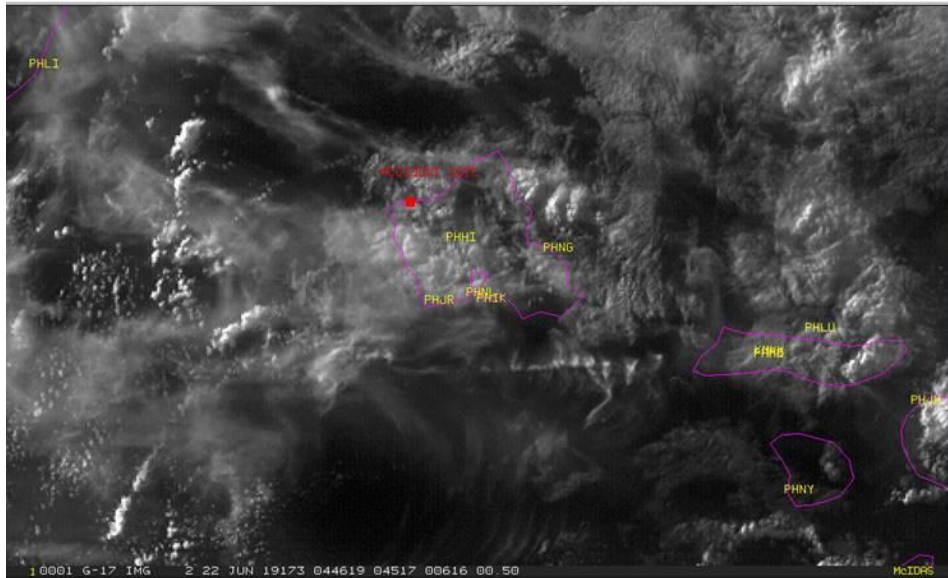
The GOES-17 visible image at 1846 HST (0446Z) is included below which shows multiple cloud layers over HDH. No cumulonimbus clouds were observed in the vicinity of the airport during the period.

Figure 14: GOES-17 visible image at 1846 HST.

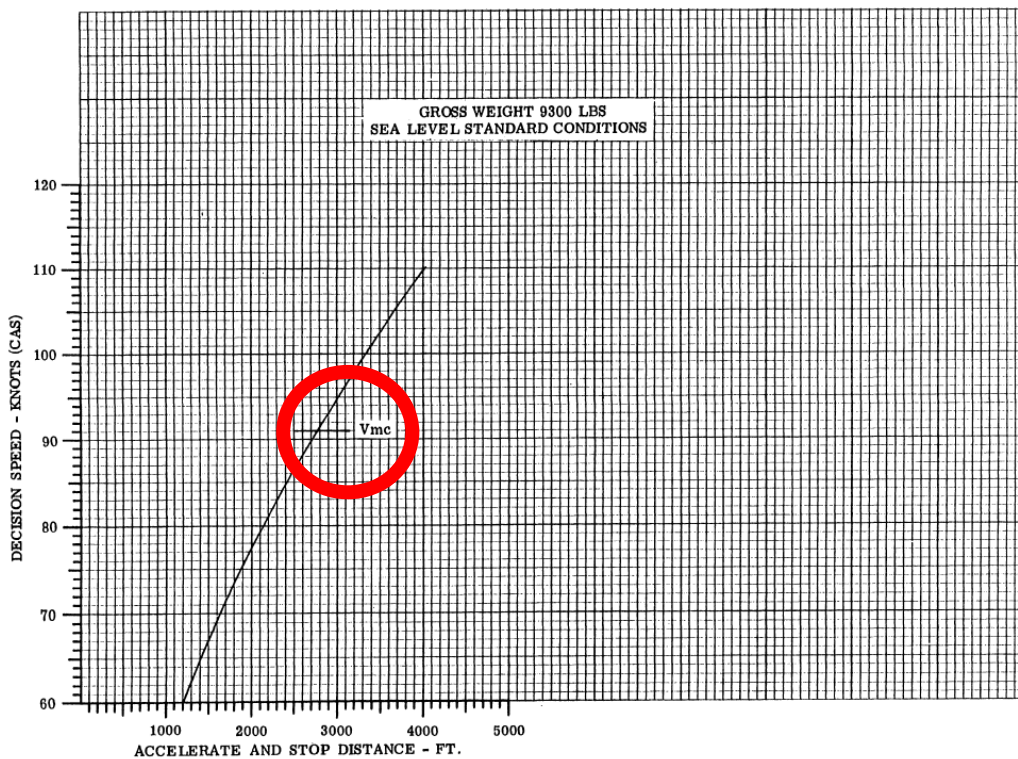
According to the Beech Model 65-A90 Pilot Operating Manual, the  $V_{MC}$  for the King Air was 91 knots.

Figure 20: Beech A90 Accelerate – Stop Distance performance chart showing 91 knots  $V_{MC}$  (indicated by red circle).<sup>123</sup>

According to the FAA Airplane Flying Handbook (FAA-H-8083-3A, dated 2004),  $V_{MC}$  was typically marked with a red radial line on most airspeed indicators. There was no red radial on the accident airplane's airspeed indicator
