NTSB/HIR-22/06

# Collision Between Service Vehicle and School Bus

Decatur, Tennessee

October 27, 2020

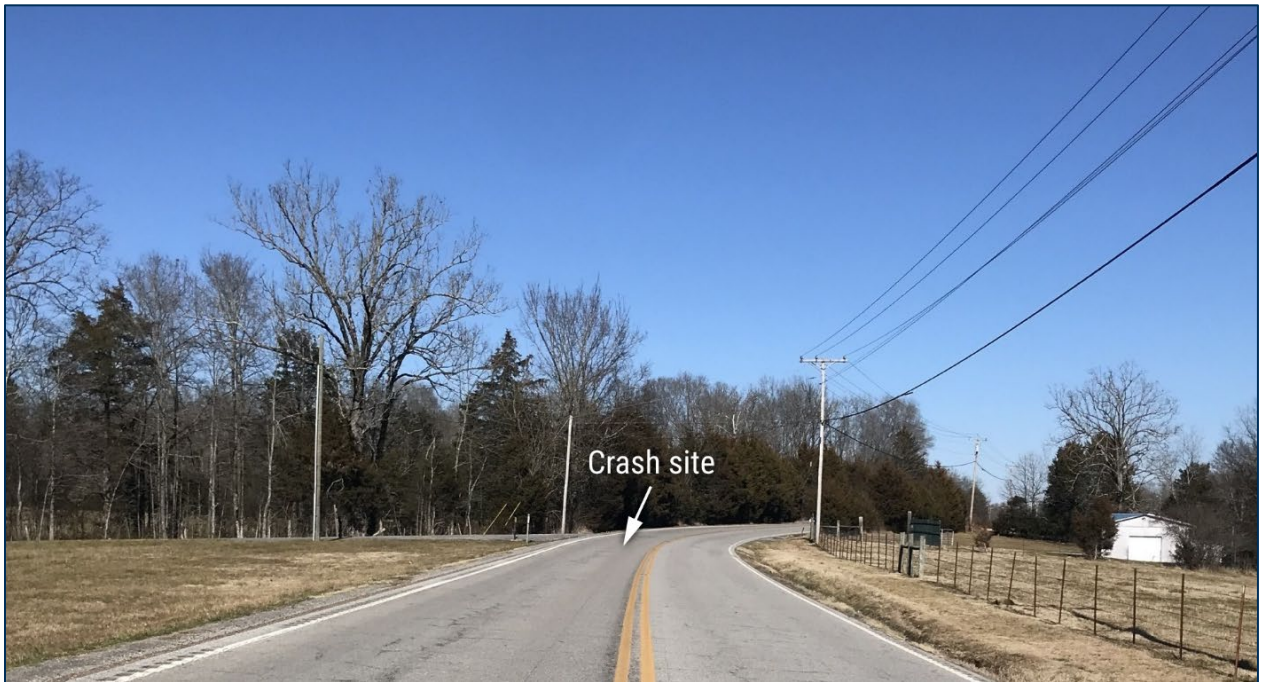
**Figure 1.** Northbound view of SR-58. (Source: Tennessee Department of Transportation)

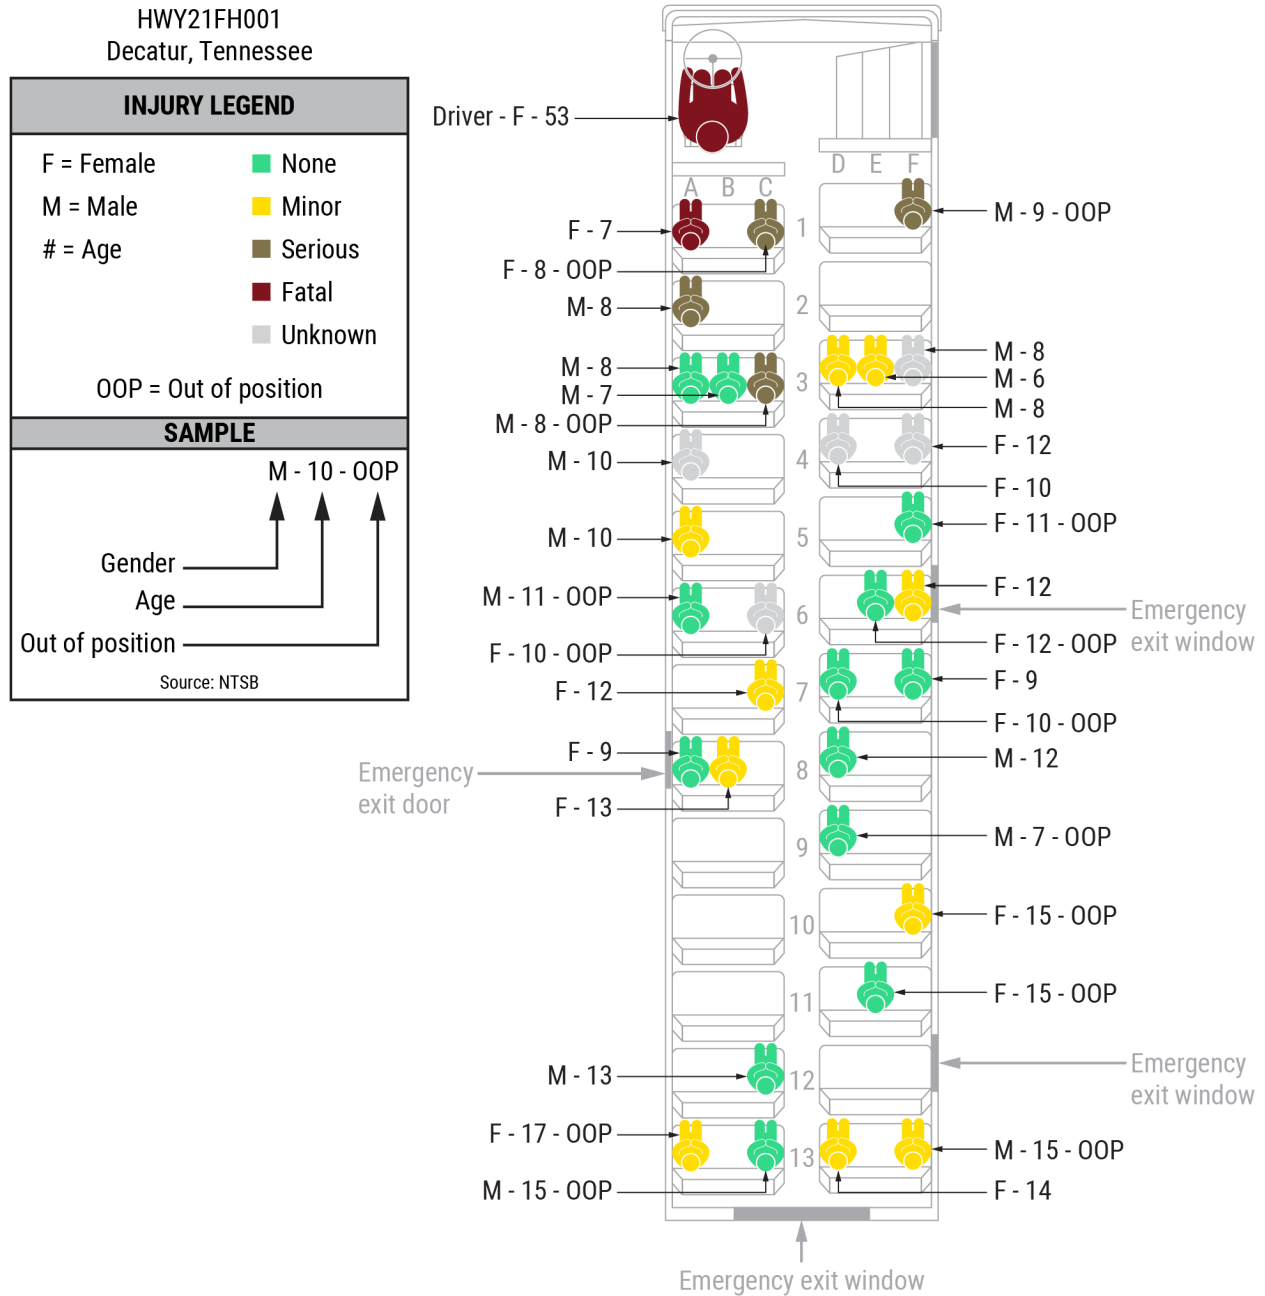
**Figure 5.** Bus diagram showing occupant seating position, sex, age, and injury level.

<sup>9</sup> The NTSB identified several school bus passengers who were out of position in their seats. That is, they were not seated forward-facing in the bus seat. Instead, they were kneeling on the seat, facing backwards, and/or turned toward the aisle.

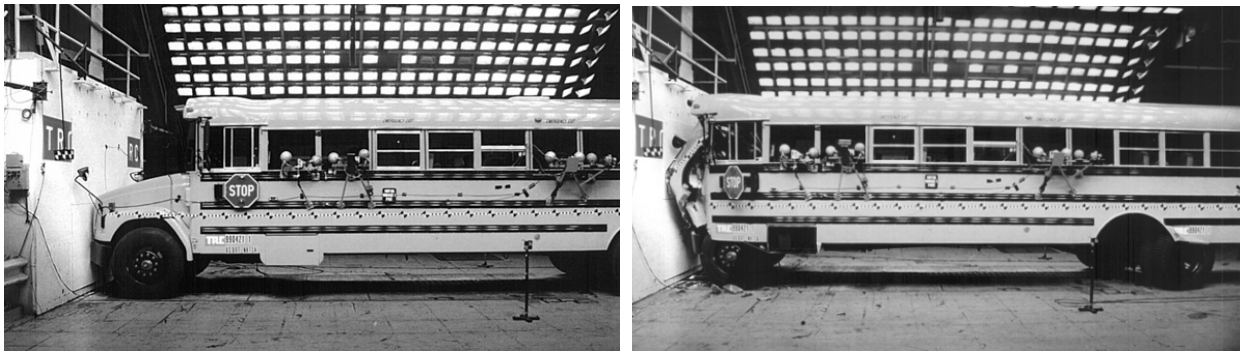
The frontal crashworthiness of school buses has been studied over the years to determine the effectiveness of compartmentalization in preventing passenger injuries (NHTSA 2002, IMMI 2015). In the NHTSA study, a Type C school bus (the most common style) was crashed into a rigid barrier at 30 mph (48.3 km/h), which is similar to crash tests done for passenger vehicles (NHTSA 2002).<sup>58</sup> The large mass of a school bus makes a rigid barrier impact very severe at 30 mph. The Type C school bus sustained significant frontal damage in the crash test (see figure 14).

**Figure 14.** Pre and postcrash photographs of NHTSA's frontal crash test for school buses. (Source: NHTSA 2002)
