McLean, 8 July 2021

It was the third takeoff of the day. My non-pilot (but fellow aerospace engineer) friend and I had flown from Manassas, Virginia (KHEF) to Smyrna, Tennessee (KMQY) to pick up another friend to take her to the Outer Banks. Weather forecasted was severe clear with unusually low winds at altitude. Both the flight to Smyrna and the one from Smyrna to Manteo, NC were absolutely uneventful, with our new passenger in the copilot's seat and her 8-month old but 40 pound Golden Retriever puppy peacefully asleep in my friend's lap in the back.

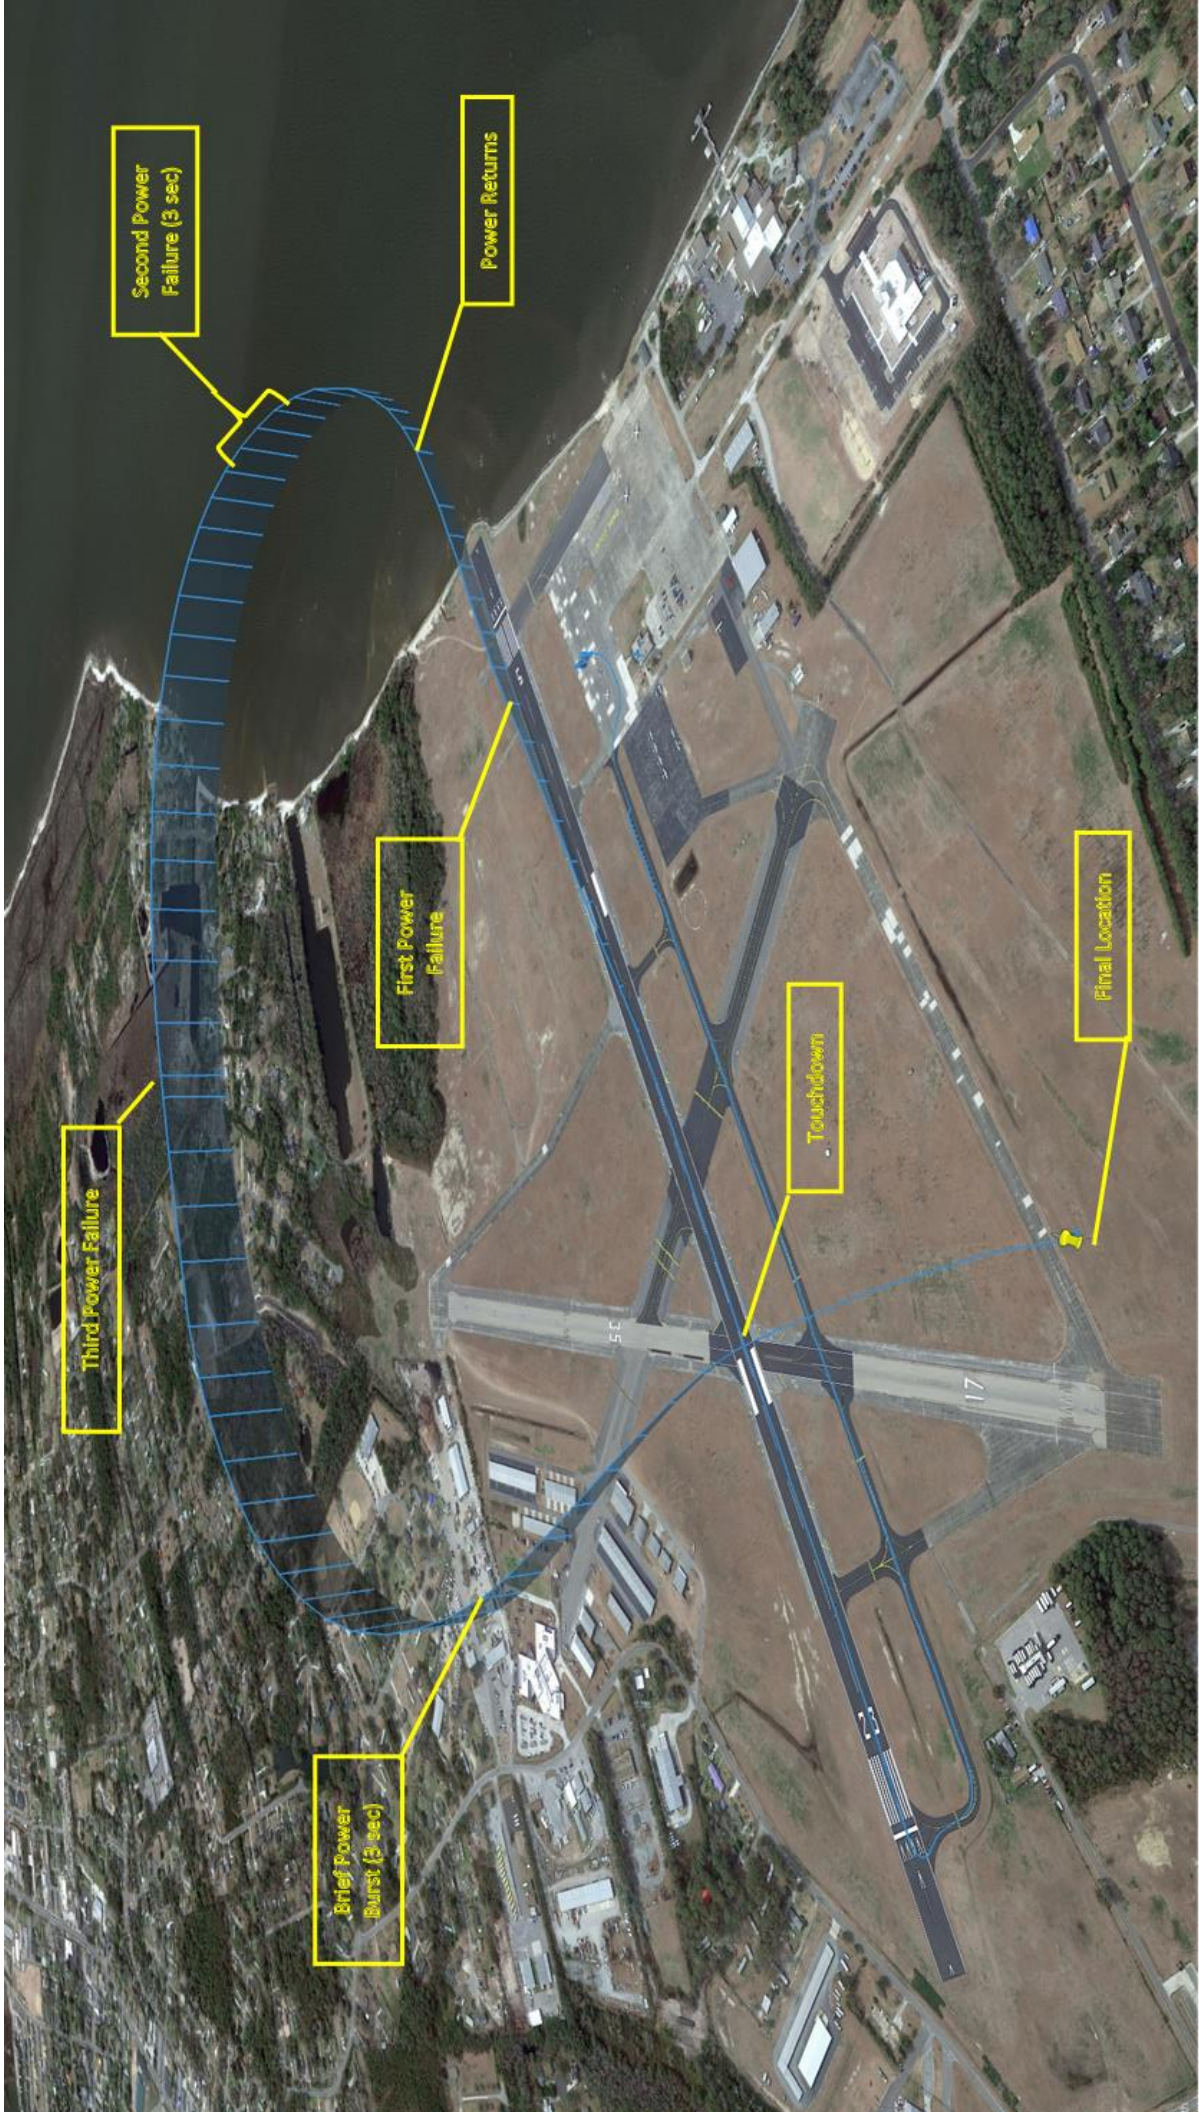
Being a retired but irrepressible engineer, I downloaded the data into one of my computers, wrote a quick Python script to parse the kml (that's Google Earth to you) file, and calculated something called "propulsive power" which is the rate of change in total (kinetic plus potential) energy of the aircraft, not the same as engine power, but it does go up and down like engine power. The ensuing graph shows the various power failures, their duration and their severity. From liftoff to touchdown, the entire saga lasted 72 seconds. The propeller was providing SOME power for 44 of those seconds, and was a big boat anchor for $8+3+17=28$ seconds, or almost 40% of the time.

Second Power Failure (3 sec)

Power Returns

First Power Failure

Third Power Failure
