National Transportation Safety Board

CEN23FA071

Group Chair's Factual Report

Location: Galliano, Louisiana
Date: December 29, 2022
Time: 0834 central standard time
Helicopter: Bell 407, registration N595RL

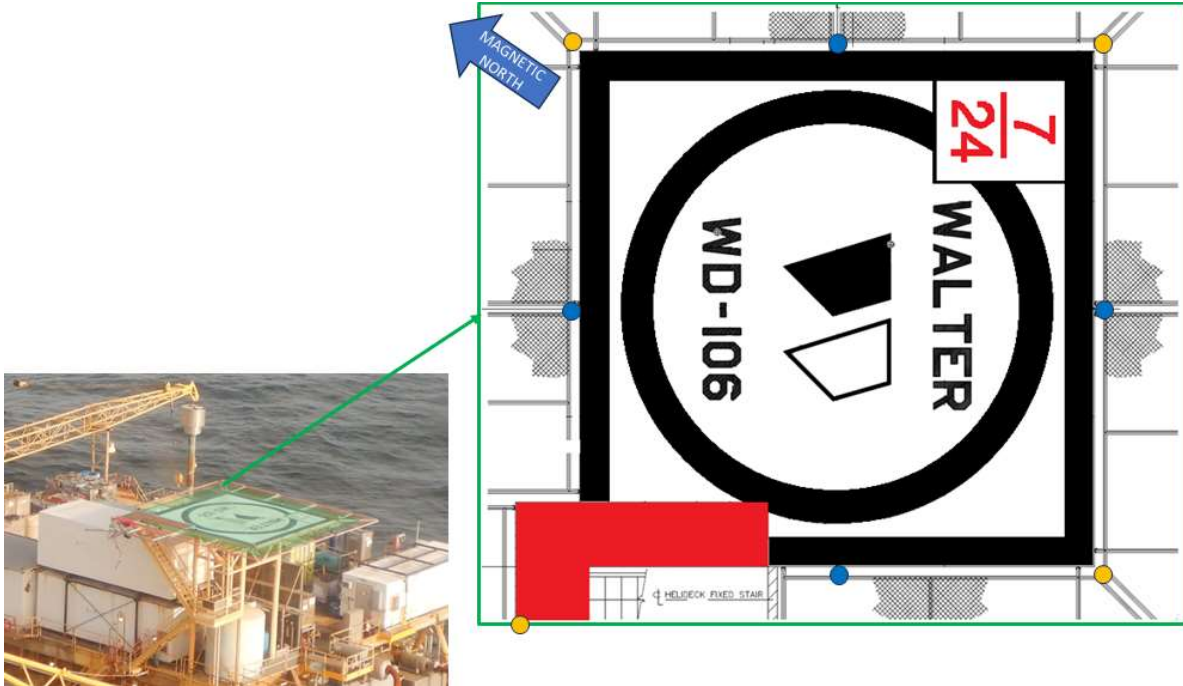
The helipad was generally square in shape, painted white with the border perimeter, target circle, and logo painted in black (**Figure 7**). A chain-link fence perimeter surrounded the helipad. A red-painted landing with stairs was located on the western edge of the helipad. The helipad surface, excluding the fence perimeter, was about 24 feet by 24 feet. At the perimeter of the helipad, orange-colored lights were installed at the four corners of the helipad and blue-colored lights were installed about midpoint between each corner.

Figure 7. A diagram of the helipad with the location of the four orange-colored lights and the four blue-colored lights. (Right image courtesy of Walter Oil and edited by the NTSB)

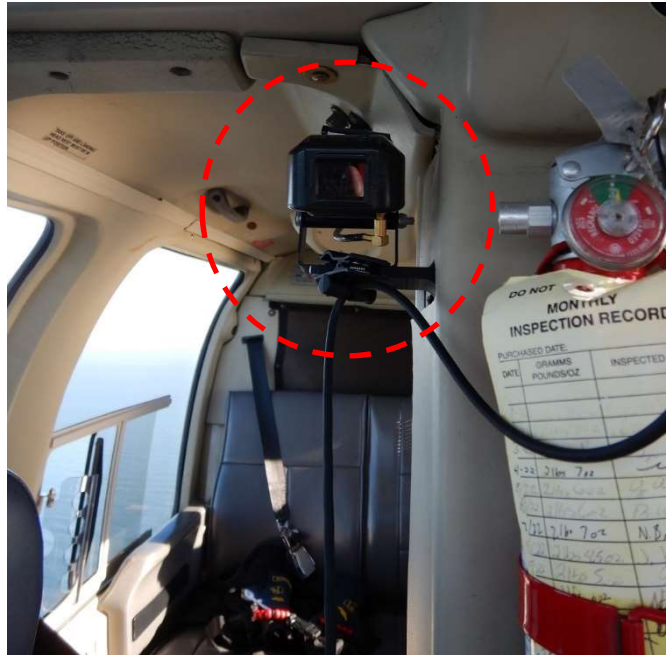
The operator had previously installed an Appareo Vision 1000 cockpit image recorder on the accident helicopter.³ The Vision 1000 was normally installed on the right side of the broom closet structure such that the recorder was behind the [right-seated] pilot's left shoulder (**Figure 14**). On the accident helicopter wreckage, the structure to which the Vision 1000 mounted was partially fractured. The Vision 1000 mount was present, but the image recorder itself was not present on the mount and was not found in the recovered wreckage (**Figure 15**).

Figure 14. An Appareo Vision 1000 installation on an exemplar Bell 407. The viewpoint of this image is forward-looking-aft.

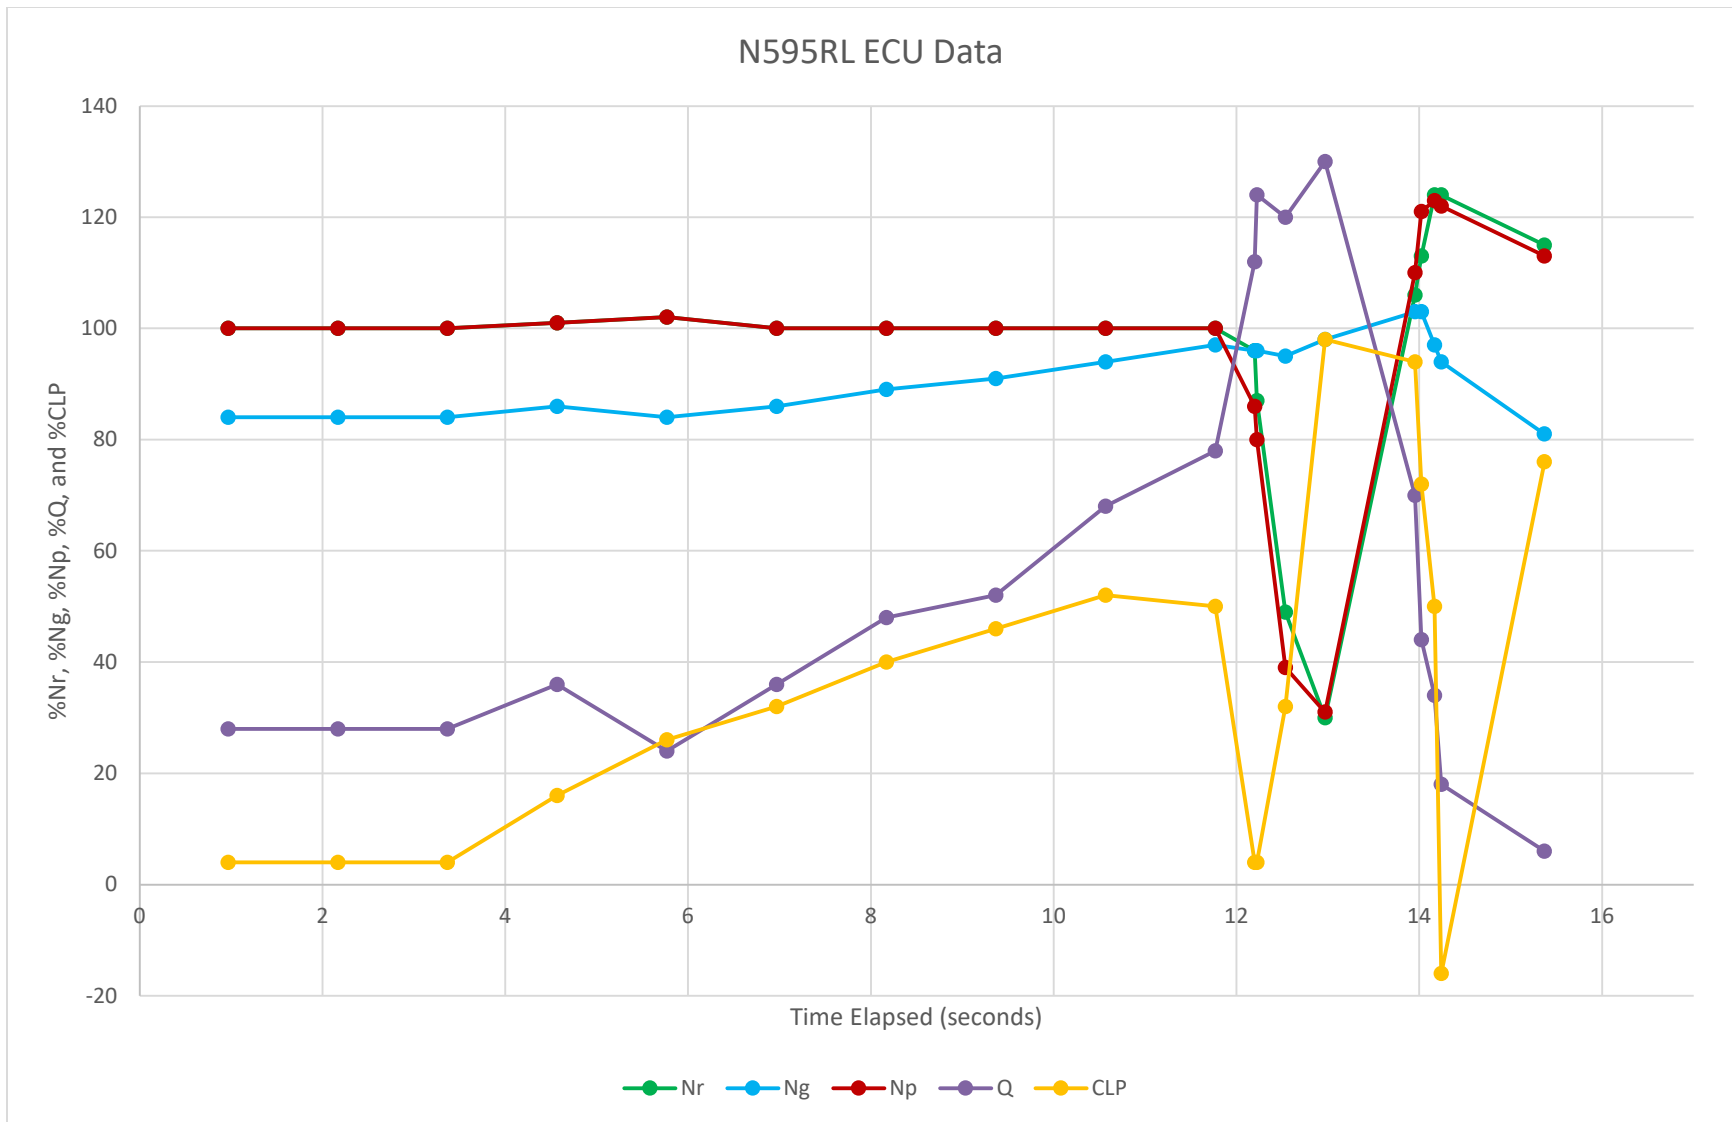
Snapshot	IR Data	Time Stamp ¹²	Nr	Ng	Np	Torque	CLP	MGT
Record #	Record #	2136:XX:XX.XXX	%	%	%	%	%	°F
	1	53:55.968	100	84	100	28	4	960
	2	53:57.168	100	84	100	28	4	980
	3	53:58.368	100	84	100	28	4	960
	4	53:59.568	101	86	101	36	16	1020
	5	54:00.768	102	84	102	24	26	940
	6	54:01.968	100	86	100	36	32	1000
	7	54:03.168	100	89	100	48	40	1060
	8	54:04.368	100	91	100	52	46	1080
	9	54:05.568	100	94	100	68	52	1160
	10	54:06.768	100	97	100	78	50	1240
1		54:07.200	96	96	86	112	4	1220
2		54:07.224	87	96	80	124	4	1220
3		54:07.536	49	95	39	120	32	1180
	11	54:07.968	30	98	31	130	98	1280
4		54:08.952	106	103	110	70	94	1560
5		54:09.024	113	103	121	44	72	1580
	12	54:09.168	124	97	123	34	50	1440
6		54:09.240	124	94	122	18	-16	1380
	13	54:10.368	115	81	113	6	76	1120

Figure A-1. A graph of select parameters from the recovered ECU data.
