National Transportation Safety Board

HWY23MH015

VEHICLE FACTORS

Group Chair's Factual Report

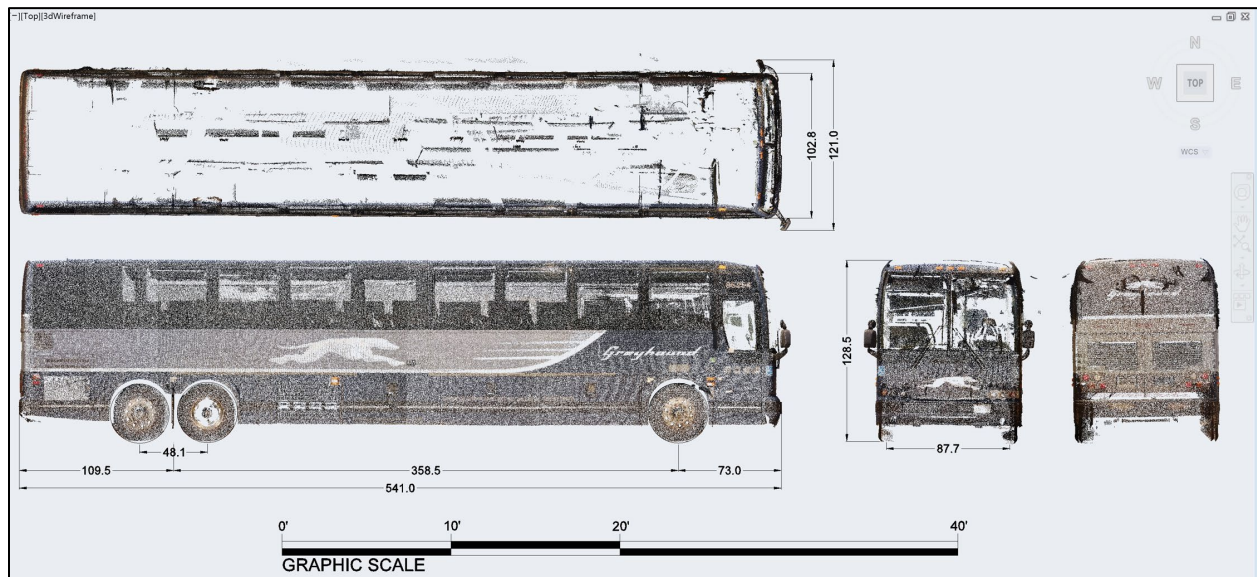
Figure 9: Motorcoach - Exemplar Dimensions¹⁰

Figure 9 shows the measurements taken from an undamaged exemplar motorcoach utilizing 3D terrestrial laser scans taken during the on-scene inspection.

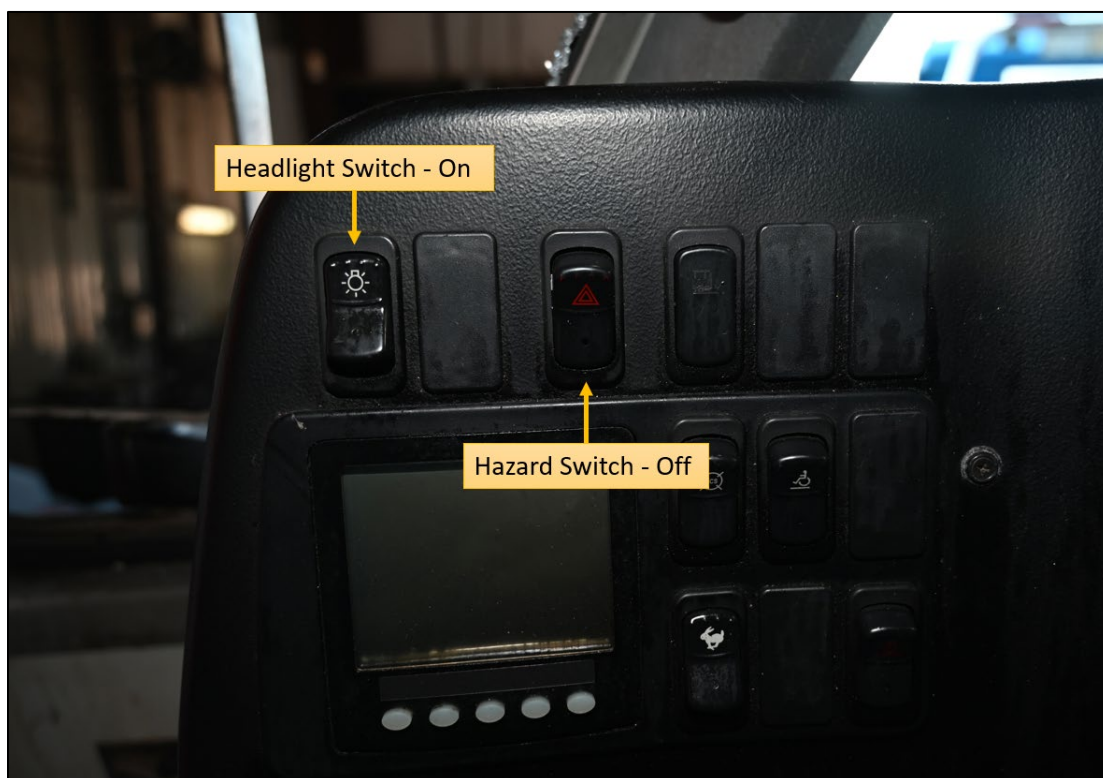
Figure 10: Motorcoach - Driver Controls - Headlight and Hazard Light Switches

All driver controls remained intact and appeared in functional condition. The motorcoach was electronically governed at 68 mph.¹¹ Below in Figure 10, Figure 11, and Figure 12, an overview of the available driver controls can be observed. The instrument cluster to the motorcoach was functional when power was supplied. Prior to supplying power, all gauges were recessed to their neutral zero position. The headlight switch was found in the "on" position at the time of the vehicle examination. The cruise control switch was in the "off" position. The driver's accelerator and brake control pedals were intact and in place.
