National Transportation Safety Board

CEN23FA071

VIDEO FILE AND ONBOARD IMAGE, AUDIO, AND DATA RECORDER

Group Chairman's Factual Report

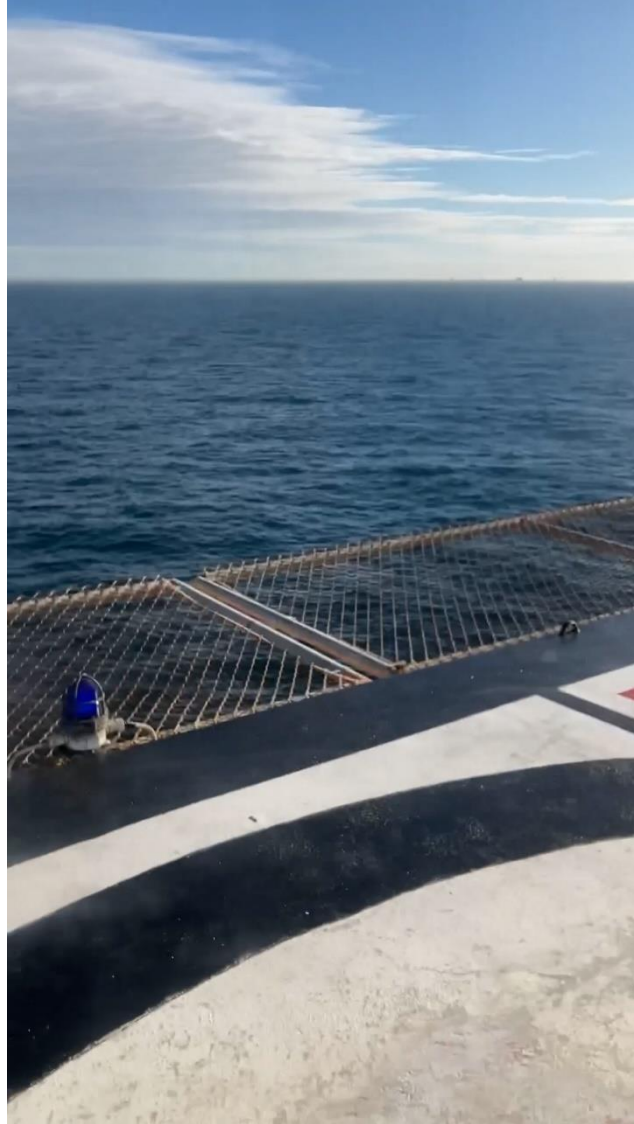
The passenger was sitting in the forward-facing seat on the left side of the passenger compartment of the Bell 407. The camera was pointing outward from the window of the seat. Figure 1 is a screenshot showing the point of view of the camera. The times used in this summary are expressed as video elapsed time. The timing format is given in SS:FF, where SS stands for the number of elapsed seconds, and FF stands for the number of elapsed frames.

Figure 1. Screenshot showing the point of view of the PED camera.

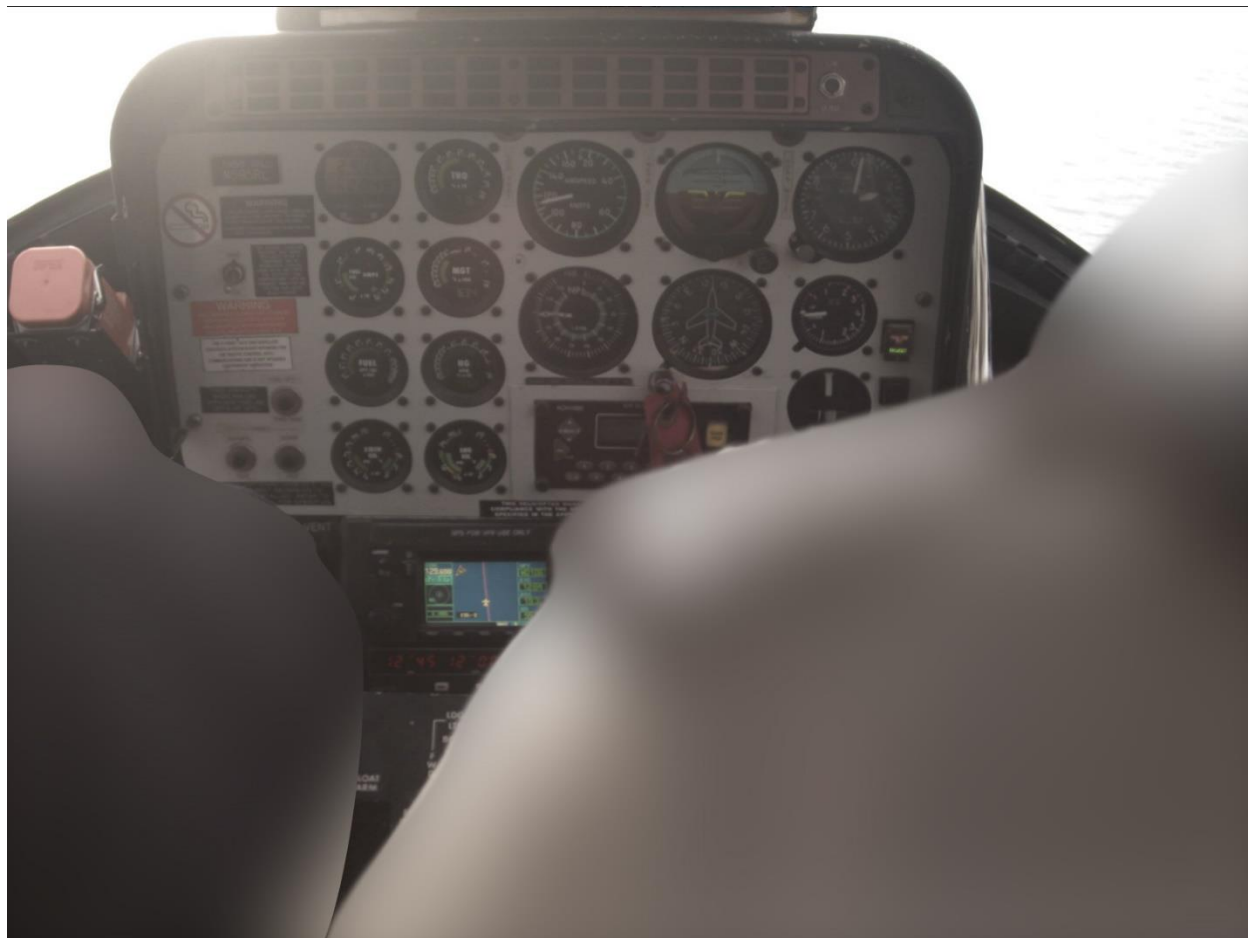
The video started with the Bell 407 at the GAO airport, getting ready for takeoff at 13:39:41.75. Figure 4 shows the point of view of the camera during the flight. Due to the low resolution of the image and glare caused by the sunlight, the readings on the instruments on the instrument panel were unclear at times. When digital numbers on the instruments were unable to be determined by the group, they were represented with "X" in this report. For example, if the second digit of the three-digit number on the measured gas temperature (MGT) instrument is undetermined, the number would be noted as 3X1.

Figure 4. An image frame showing the point of view of the Appareo Vision 1000 camera.

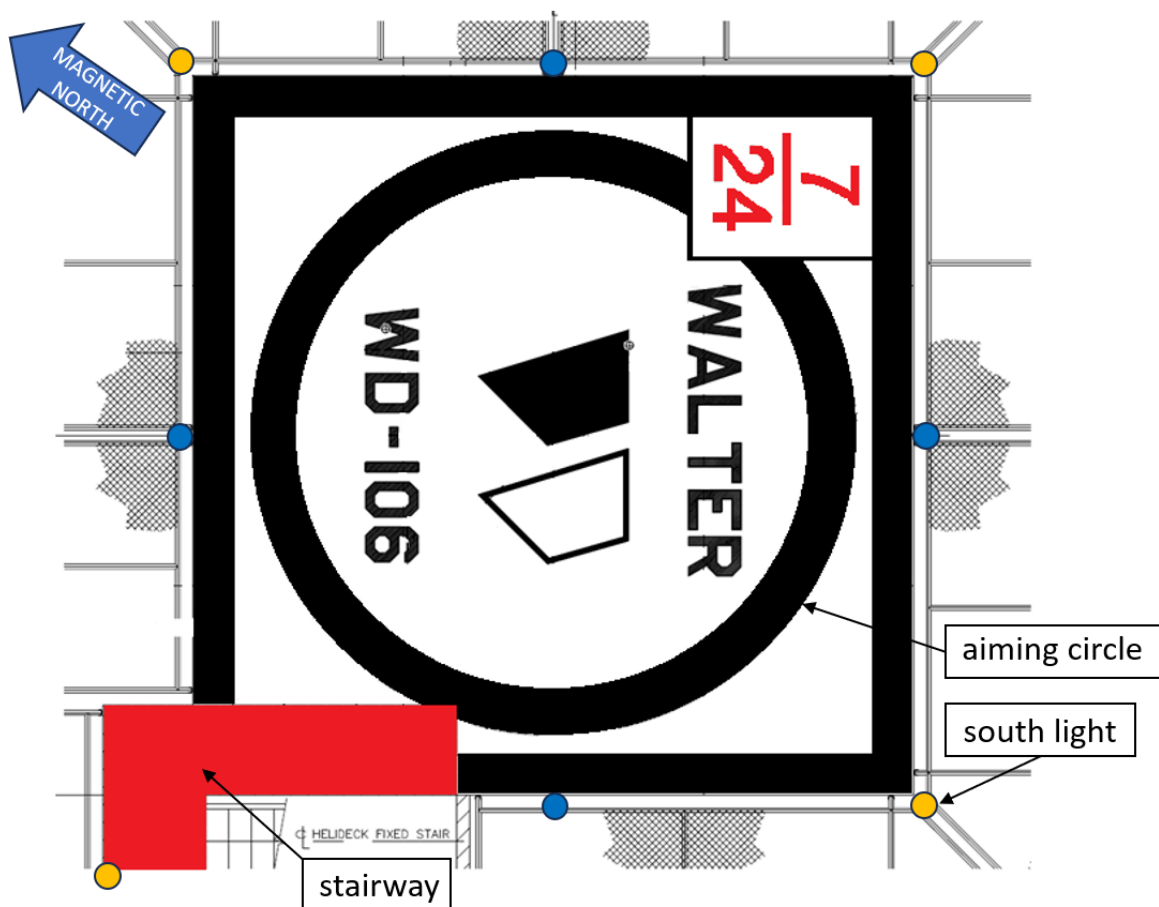
At 14:29:47.75, the outer border of the helipad was visible in the upper right corner near the south light based on Magnetic North. Figure 5 shows a diagram of the helipad. The direction of the Magnetic North and the south light are annotated on the diagram.

Figure 5. Diagram of the helipad with the south light, aiming circle, and Magnetic North annotated.

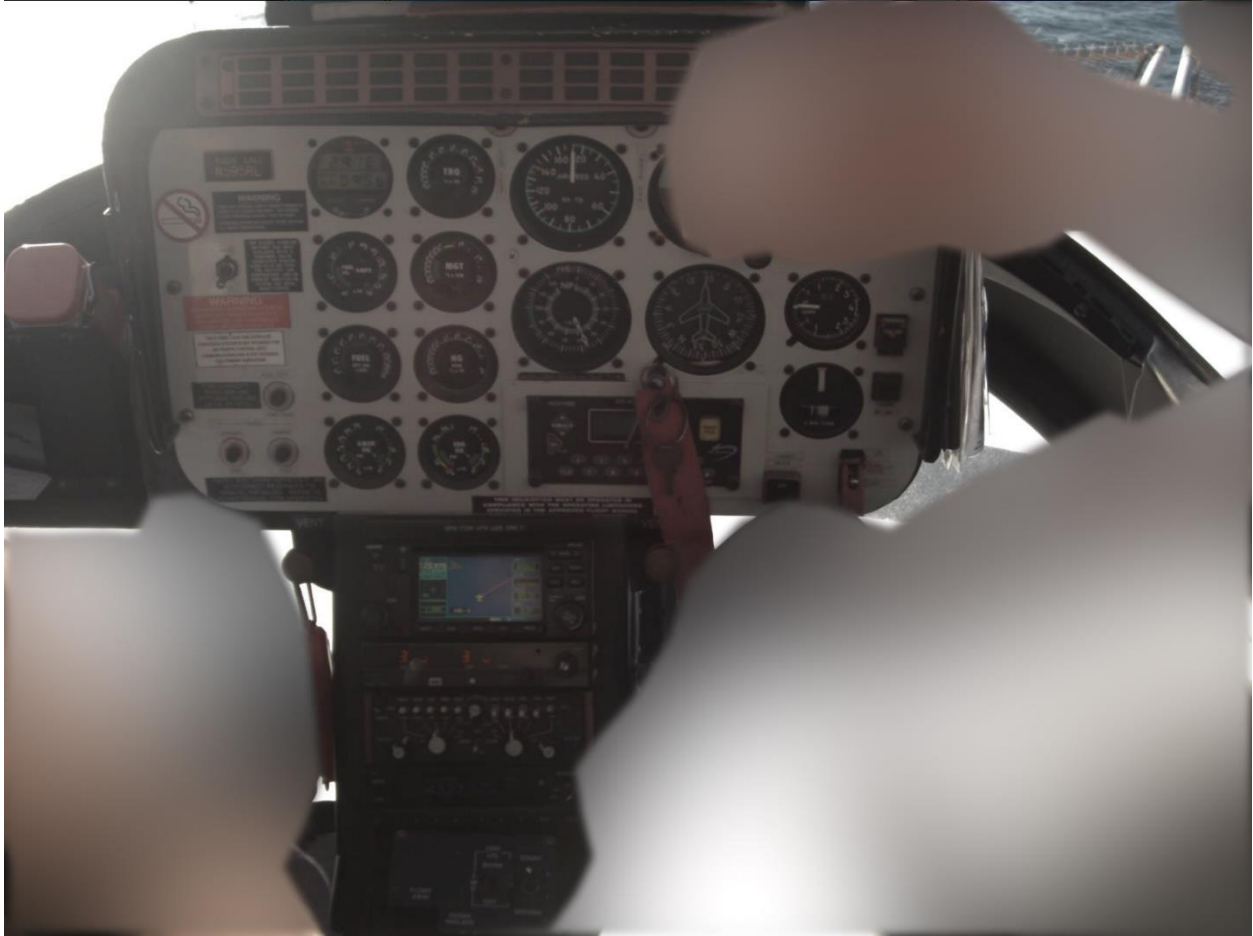
At 14:31:32.75, a part of the aiming circle was visible in the pilot's chin bubble. The tie-down was visible just past the pilot's shoulder harness. Figure 6 is the image frame at this time. Figure 7 and Figure 8 are additional image frames around the same time prior to the takeoff having a part of the aiming circle and the south light visible.

Figure 7. Image frame with a part of the aiming circle visible. Parts of the image were redacted.

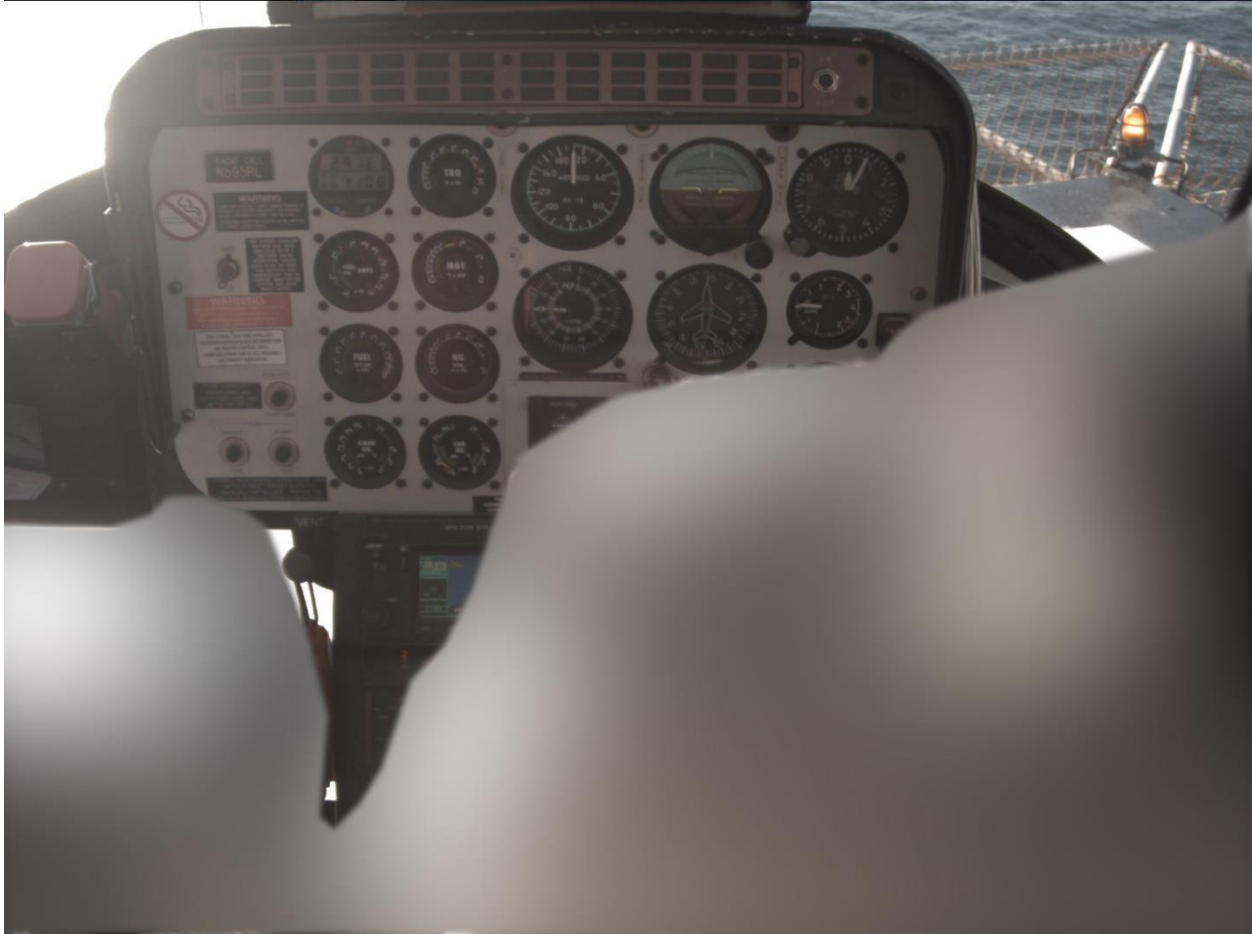
Figure 8. Image frame with the south light visible. Parts of the image were redacted.

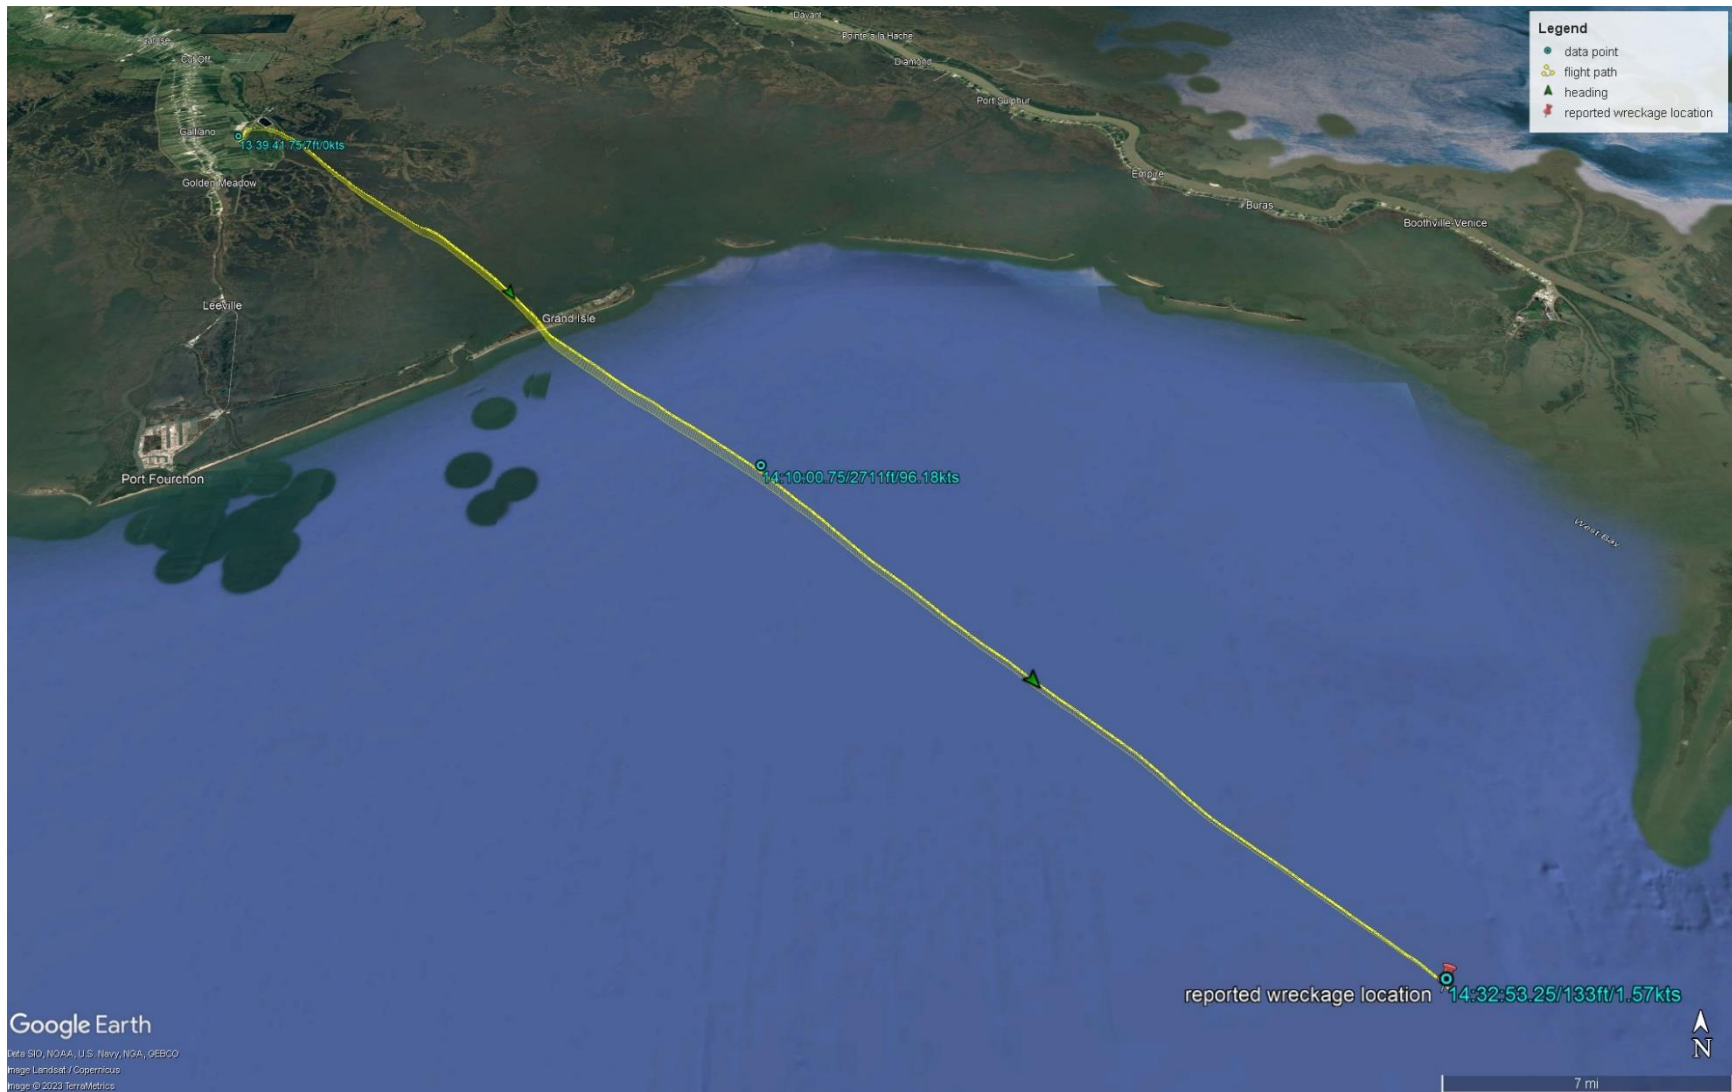
Figure 13 is a Google Earth overlay of the accident flight track. The reported wreckage location is shown with a red pin. Note that the weather and lighting conditions in Google Earth are not necessarily the weather and lighting conditions present at the time of the recording.

Figure 13. Google Earth overlay of the entire accident flight track.
