National Transportation Safety Board

CEN23FA071

OPERATIONS GROUP CHAIRMAN REPORT

Location: Galliano, Louisiana
Date: December 29, 2022
Time: 0832 CST
1432 UTC
Helicopter: Bell 407 / N595RL

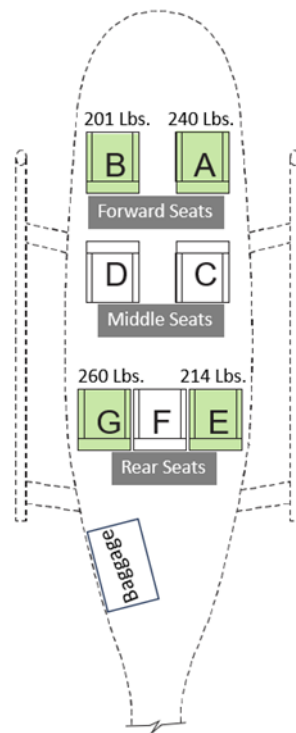
Figure 3. Tables showing the seating locations for the accident flight. The illustration shows the seats used and weights of the pilot and passengers. Total baggage weight was estimated at 60 lbs.

Seat	Name	Weight
A: Right front	Pilot	240 lbs
B: Left front	Passenger 1	201 lbs
C: Right middle	N/A	N/A
D: Left middle	N/A	N/A
E: Right rear	Passenger 2	214 lbs
F: Middle rear	N/A	N/A
G: Left rear	Passenger 3	260 lbs
Baggage	N/A	60 lbs est

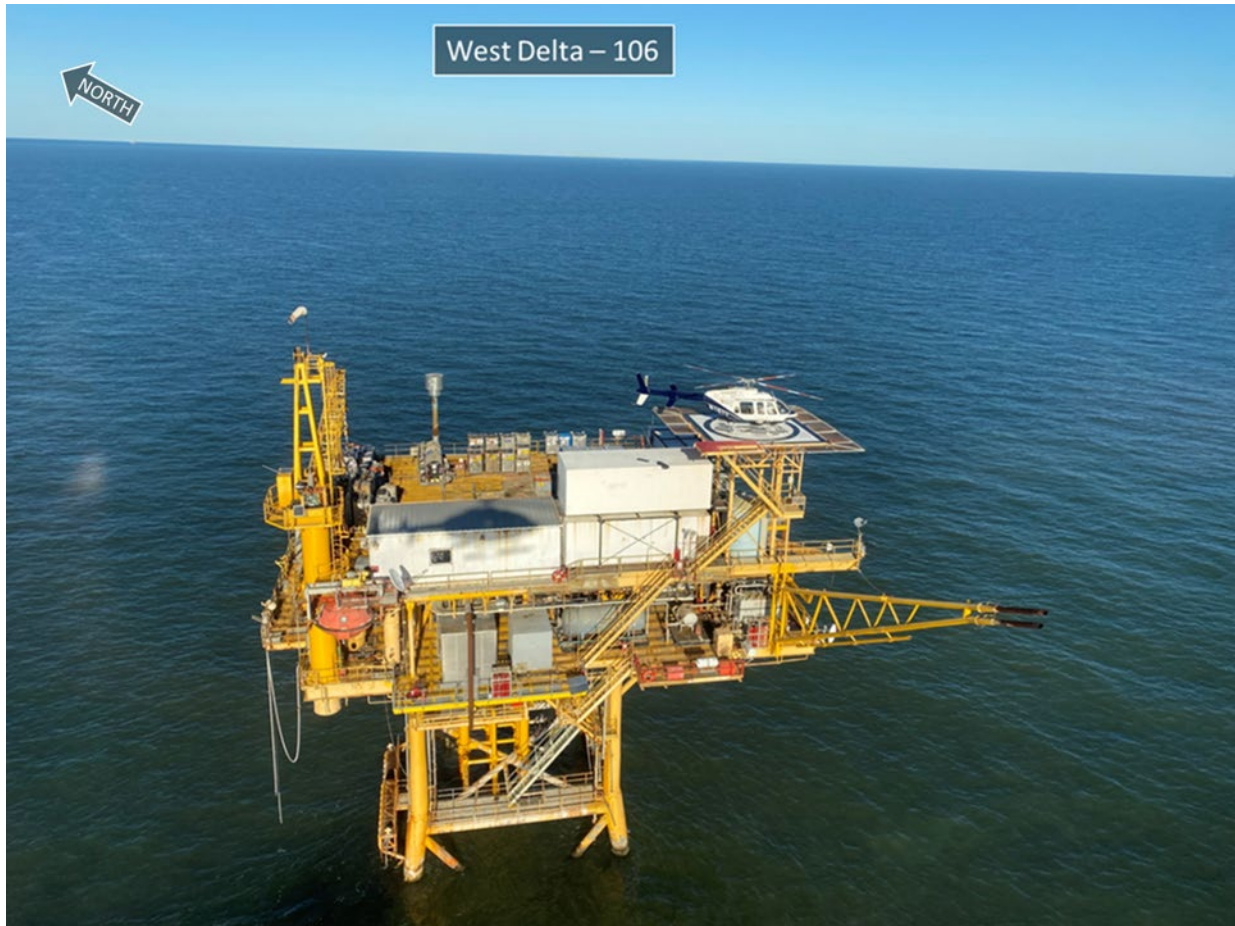
Figure 4. WD-106 platform with an exemplar Bell 407 helicopter on the helideck.

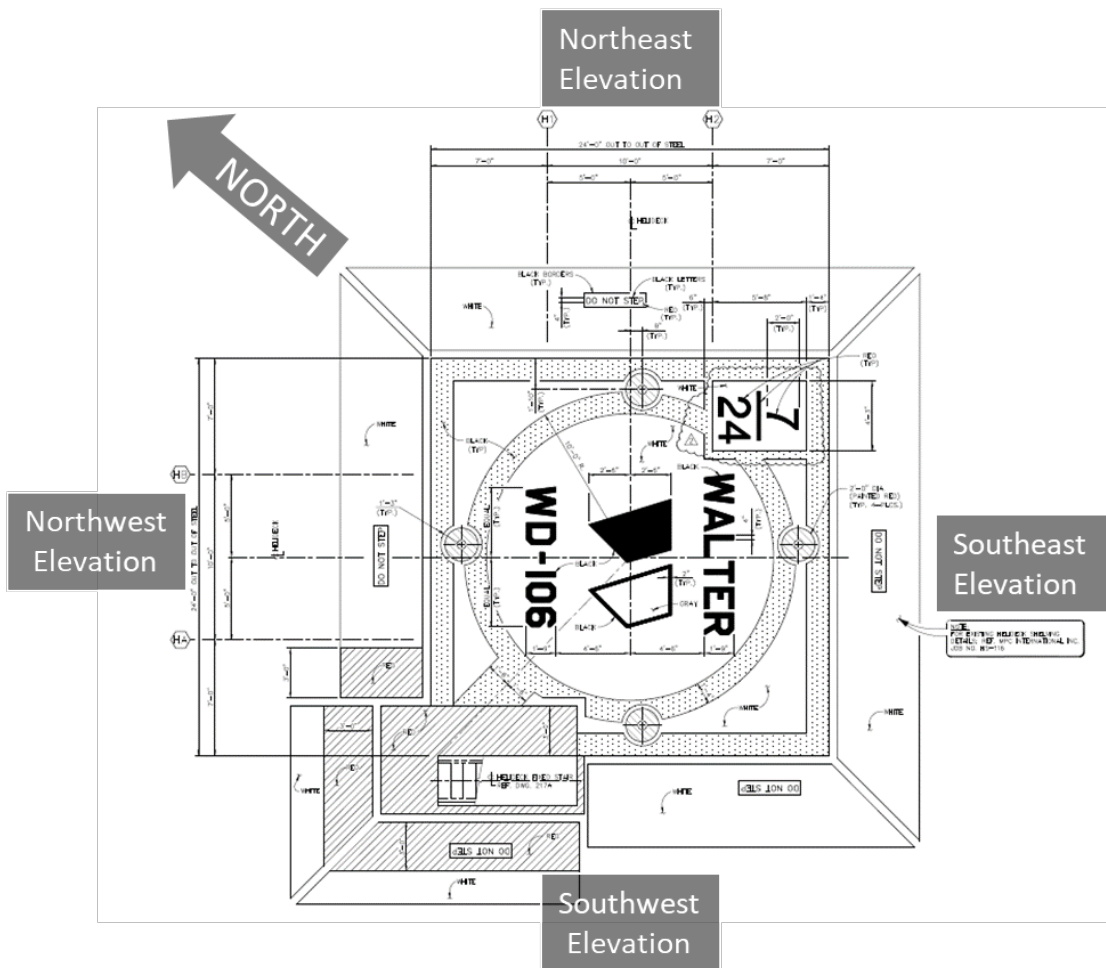
WD-106 was owned by Walter Oil and Gas, Houston, Texas, and operated by employees of Island Operating Company, Lafayette, Louisiana. According to Walter Oil and Gas, the platform was constructed in accordance with American Petroleum Institute (API) 2L 3rd edition standards. WD-106 was equipped with a 24 ft by 24 ft helideck, located on the south corner. An engineering drawing is shown in Figure 6.

Figure 6. Engineering drawing of the WD-106 helideck showing magnetic north and the four elevations. Illustration courtesy of Walter Oil and Gas.

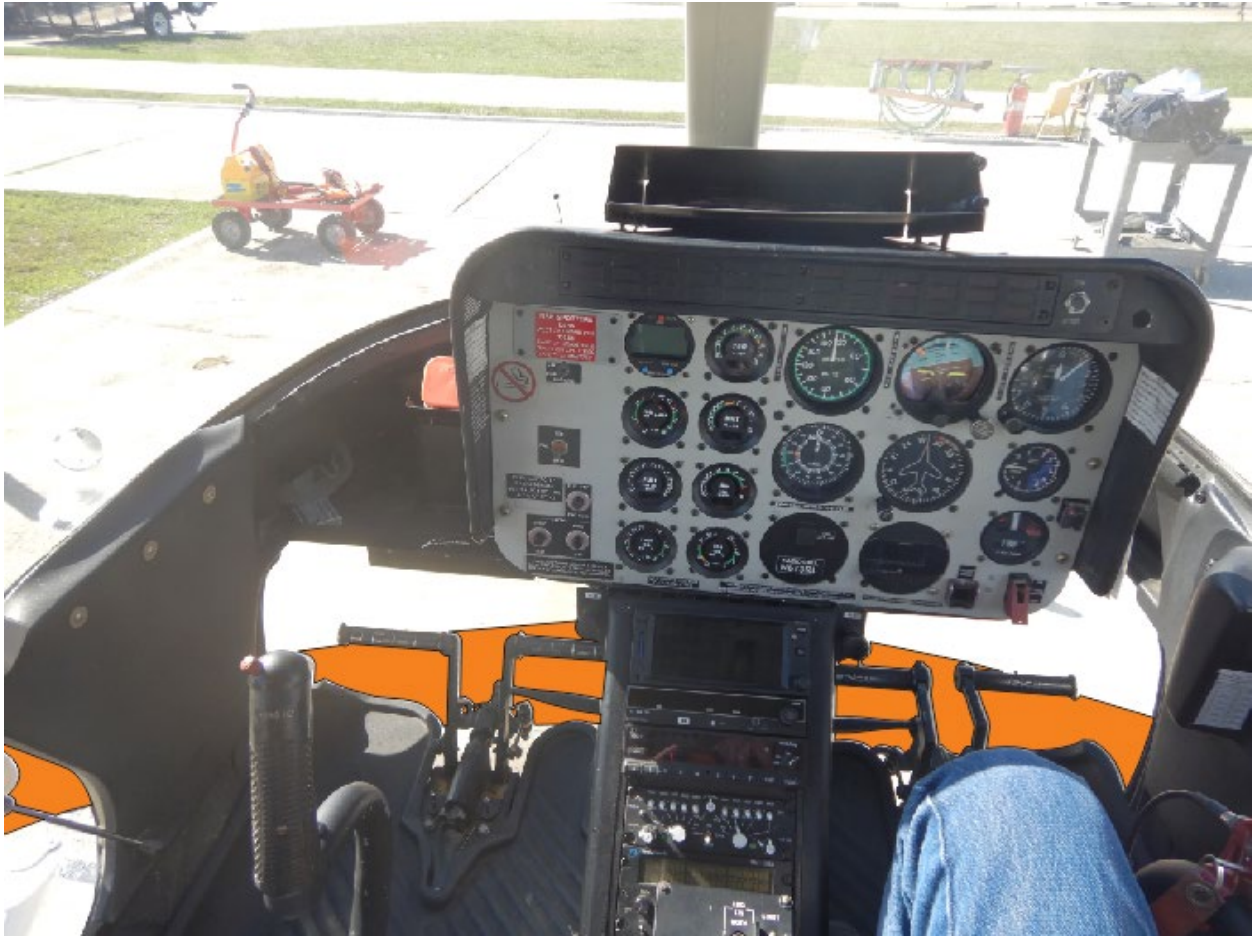
Figure 14. Photo captured with the camera positioned near the installed Appareo video recorder. The helicopter is positioned in the center of a 10 ft diameter aiming circle. The aiming circle is highlighted in orange to emphasize its location in the image only.

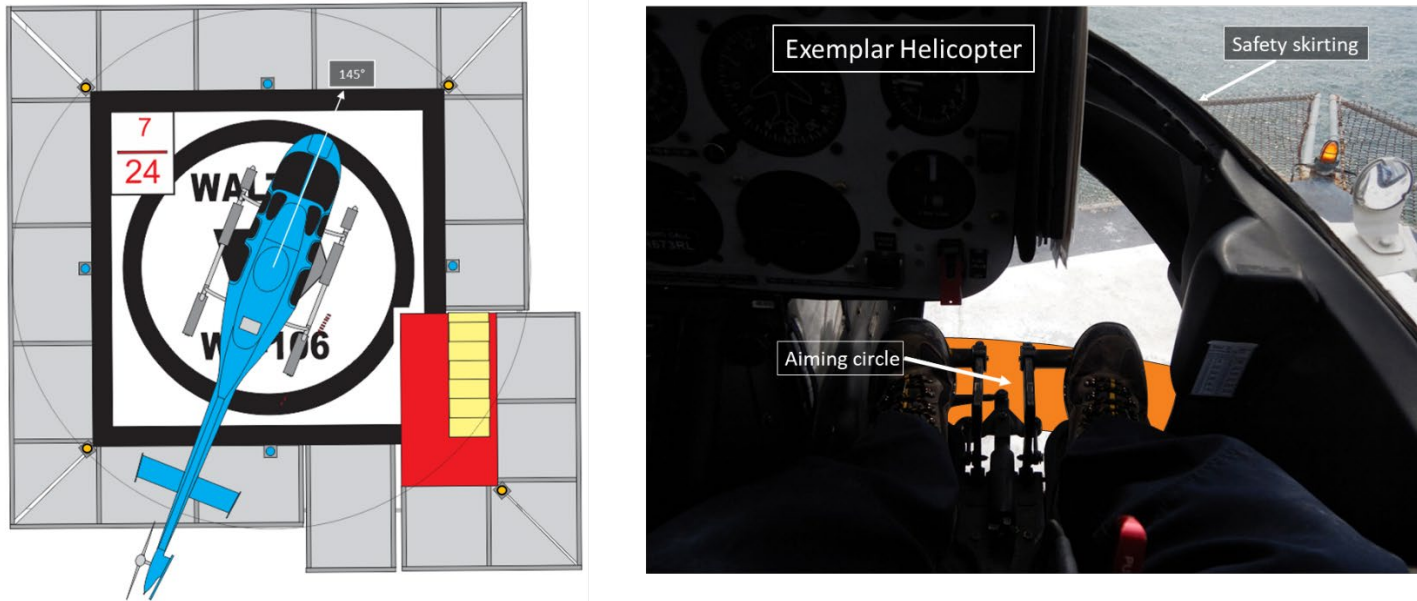
WD-106. The helicopter was parked in the center of the 10 ft diameter aiming circle, on a heading of 145° magnetic or about the 1 o'clock position. With the camera placed alongside the Appareo recorder, a photo was captured to show the view of the aiming circle from the right-side pilot's chin bubble, as shown in Figure 15. The captured image showed the aiming circle under the anti-torque pedals.

Figure 15. Image captured while the exemplar helicopter was in the center of the aiming circle and the right-side chin bubble showing the location of the aiming circle (highlighted in orange) under the anti-torque pedals. The illustration shows the helicopter's position and orientation.

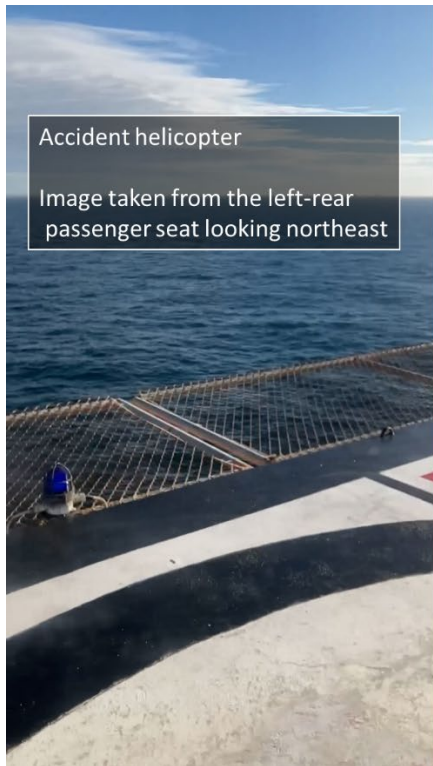
While the exemplar helicopter was positioned in the center of the aiming circle, a photo was captured from the left-side, forward-facing, aft seat. The camera was oriented toward the northeast elevation, as shown on the right side of Figure 16. The left side of Figure 16 was an image captured by the accident passenger seated in the left-side forward-facing aft seat.

Figure 16. Left image that was captured by the accident passenger in the left-rear passenger seat. Right image captured by the NTSB passenger seated in the left-rear passenger seat.

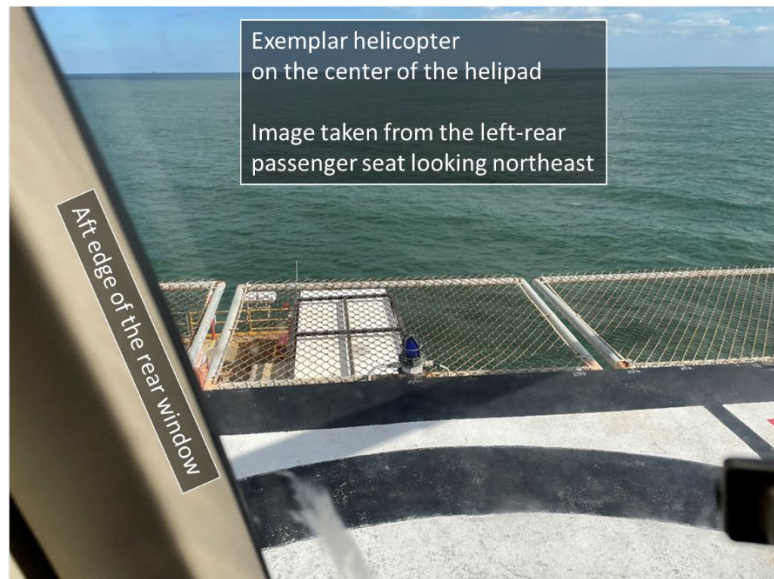
The exemplar helicopter was then repositioned straight aft to match the calibrated exemplar recorder FOV to the accident recorder’s FOV, as shown in Figure 17.

Figure 17. Side by side comparison of the accident Appareo’s FOV (left) and the exemplar Appareo’s FOV (right). Aiming circles are highlighted in orange.
