# National Transportation Safety Board

HWY24FH004

## **FACTUAL REPORT OF INVESTIGATION**

Group Chair's Factual Report

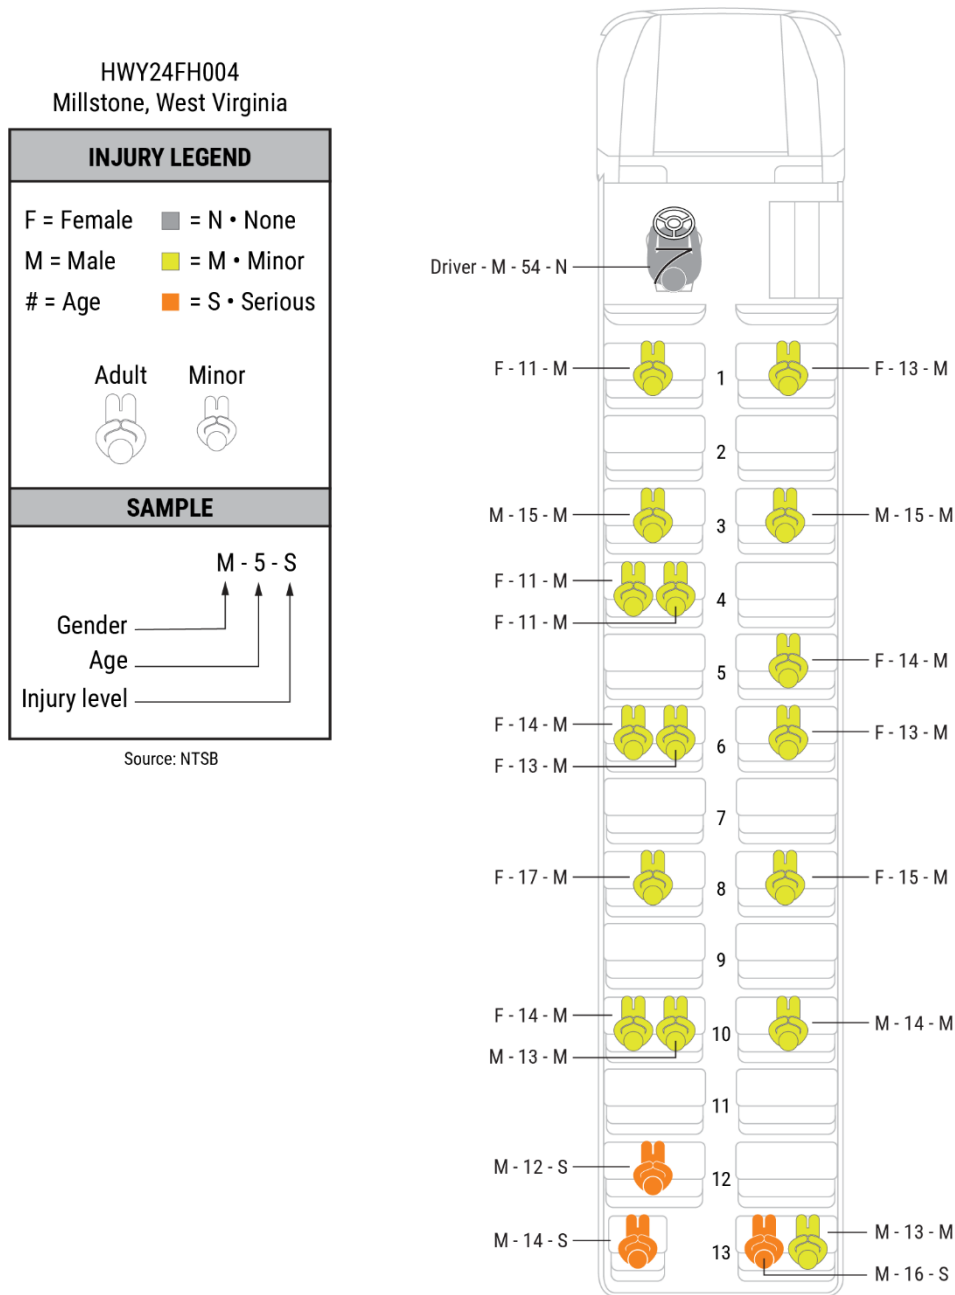
At the time of the crash, the bus was occupied by 19 student passengers and one adult driver. Occupant seating locations were provided by the West Virginia State Police following unrecorded passenger interviews (Figure 5). The Video and Occupant Safety Group Chair's Factual Report provides more information about occupant seating and injuries.

**Figure 4.** Seating Positions with age, gender, and injury level (Source: WVSP).

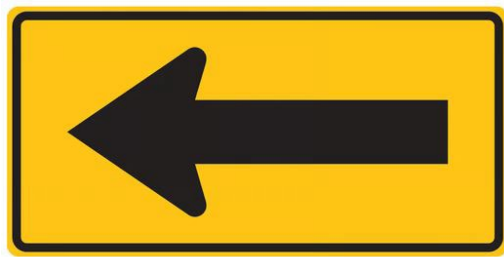
A one-direction large arrow (W1-6),<sup>14</sup> pointing to the left, is posted prior to the curve the bus was traversing (Figure 6).

**Figure 5.** One-direction large arrow sign (W1-6).
