## TEST DEPARTMENT LABORATORY REPORT

**Subject:** Derailment: Bordulac, North Dakota      **Keywords:** ES, RAIL, CM, EC, 092  
Broken Rail Analysis

**Report Date:** December 31, 2024      **Project No.:** 2024-092

**Sample Description:** One 43" section of 115lb rail manufactured by Colorado Fuel & Iron. Based off available stampings the age is unknown.

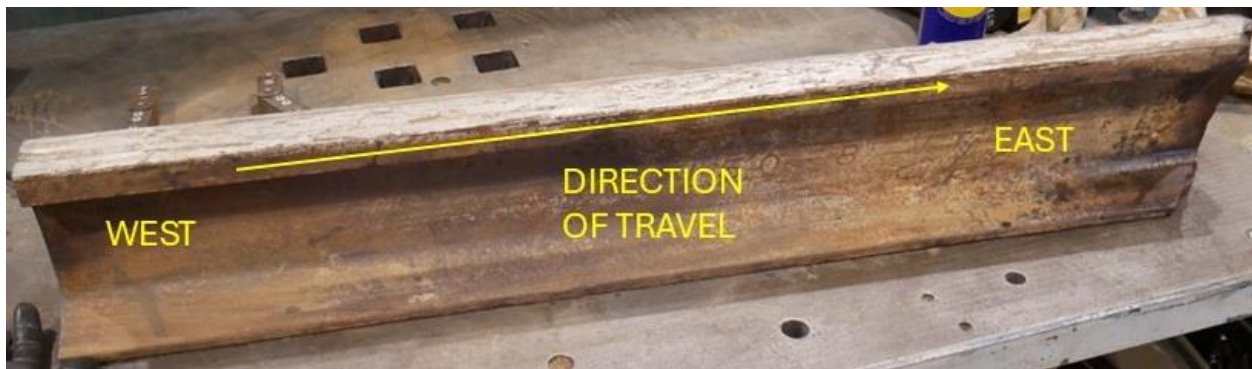
- Visual inspection of the rail showed that it was subject to minor batter, including what appears to be wheel ride along the head. There was no indication that this section of rail was the point of derailment for the incident.
- Inspection of the fracture face's morphology showed that the rail failed due to a sudden brittle fracture. There was no indication of crack propagation or fatigue.

Image 1: The 43" section of rail after being cleaned. The field side is visible.

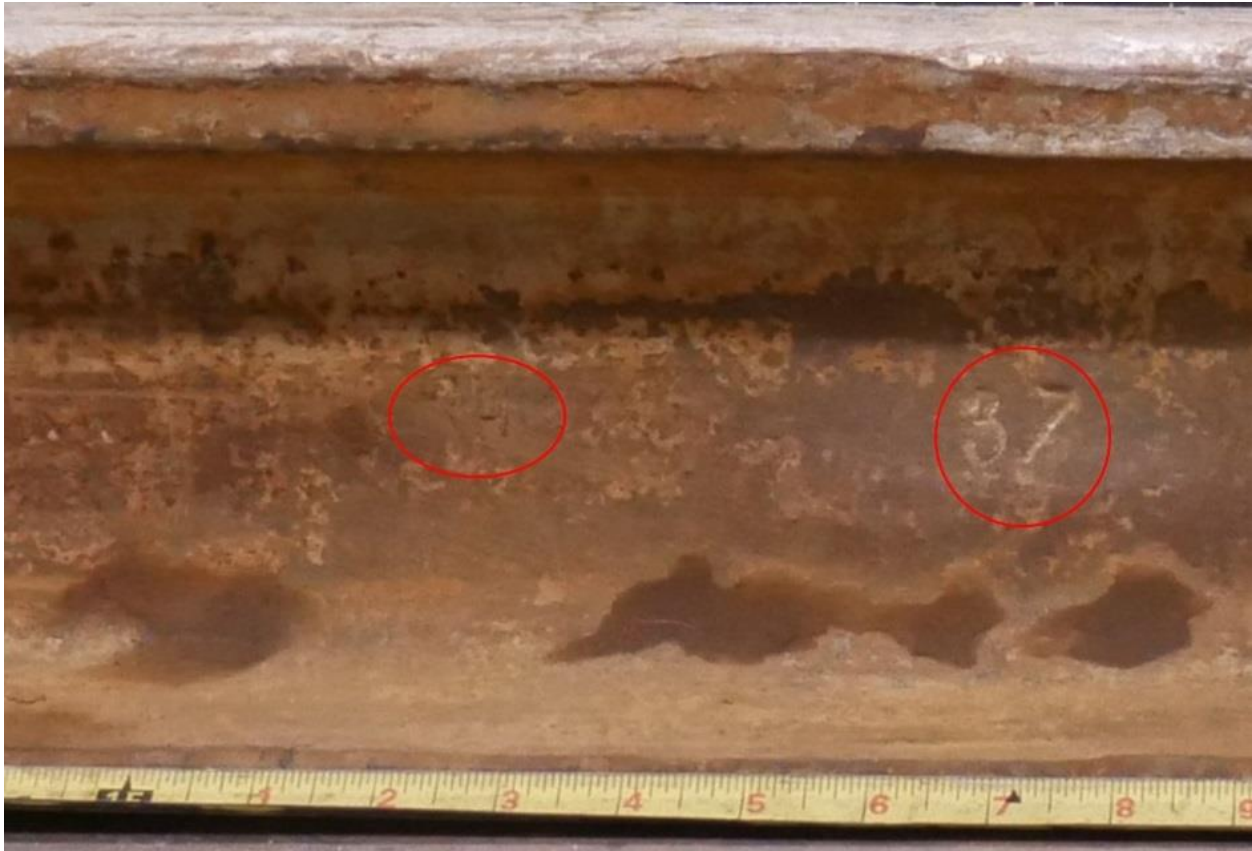
It should be noted that due to incomplete markings; the vintage of the rail is unknown. Testing compared the rail to current AREMA and internal specifications.

Image 3: Gauge side rail stamp saying “IH” and “37” on opposite side of rail.

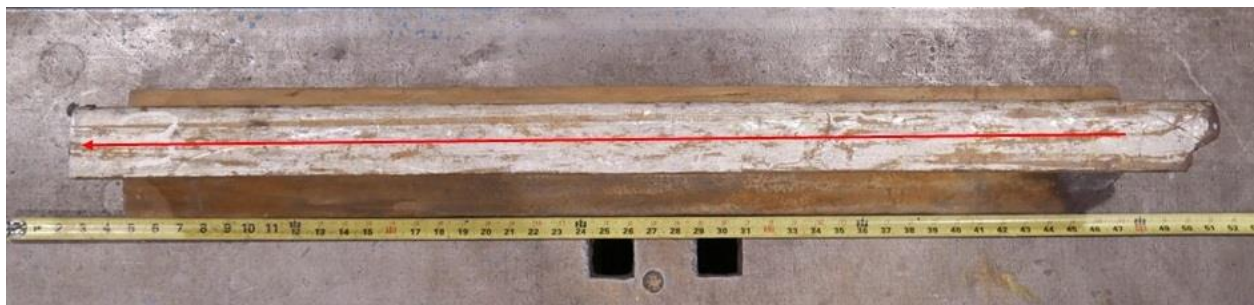
- Ultrasonic inspection of the rail did not yield any indications of internal defects.

The rail was subject to ultrasonic testing across its entire length, beginning at the site of the fracture and terminating at the end of the rail. The probe examined the portion of the head immediately above the web and searched for indications through the height of the rail, all the way to its base. No indications of any defects were detected.

Image 7: The start point and direction of travel of the UT probe.

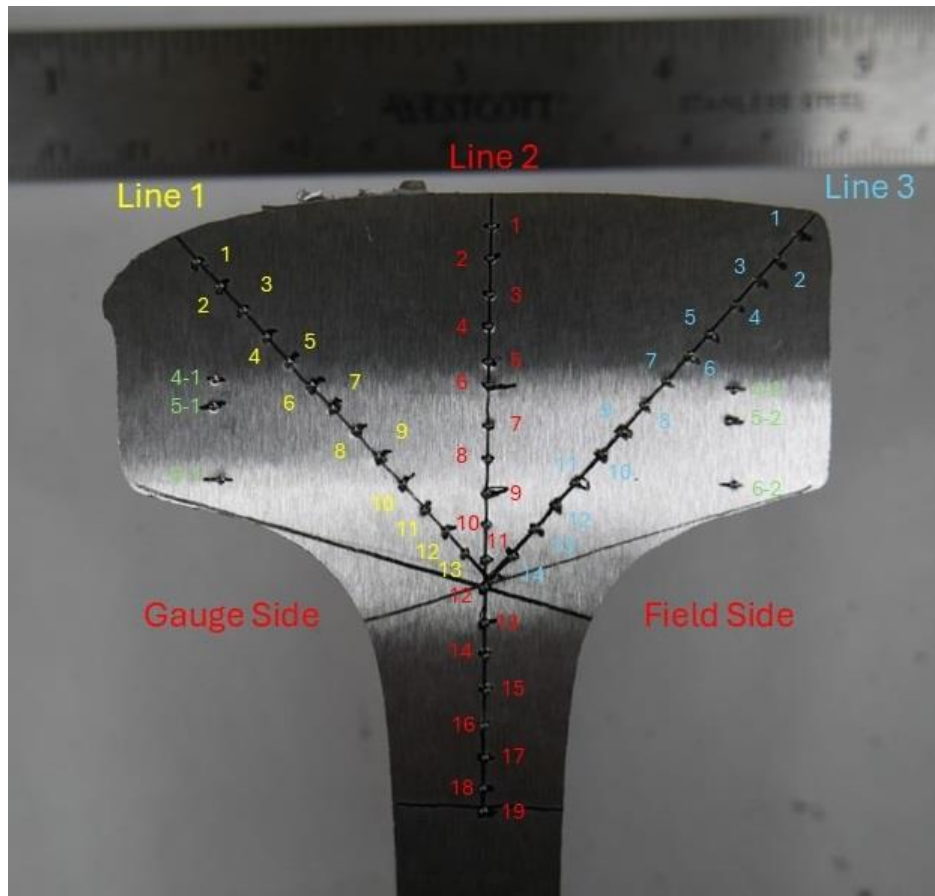
- Hardness gradients within the rail head were found to be typical. Two of three hardness measurements near the running surface fell below the head hardness minimum requirement for intermediate strength rail (350 BHN) but were above the requirement for standard steel rail (310 BHN).

Figure 2, illustrates the hardness gradient within the rail head along lines 1, 2, and 3. Point 1 on line 1 hardness was found to be 356 BHN, above the minimum requirement for intermediate strength rail head hardness (350 BHN). However, similar hardness measurements for point 1 on lines 2 and 3 fell below this minimum but were above the minimum for standard rail (310 BHN).

Image 9: Location of hardness measurements in the rail head. Along lines 1,2, and 3 each point is spaced out by 0.125" Furthermore, points 6-1 and 6-2 were added as they were not part of the original specification for the head. This was done as a contingency in case points 4-1/4-2 and 5-1/5-2 were too close together.

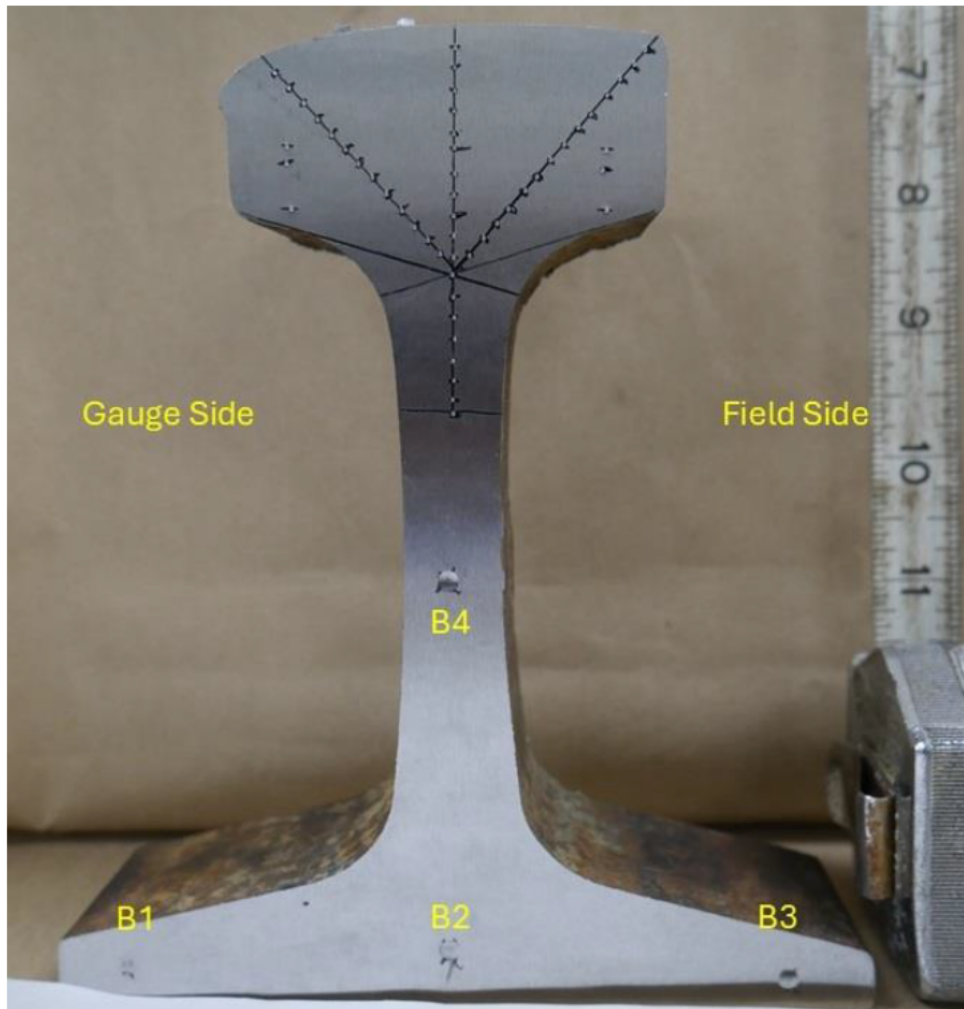
Meanwhile, the measurements taken from the rest of the web and the base were done using a Brinell hardness tester. See Image 10 for the pattern followed.

Image 10: The location of the four Brinell hardness tests conducted in addition to the Rockwell C test.

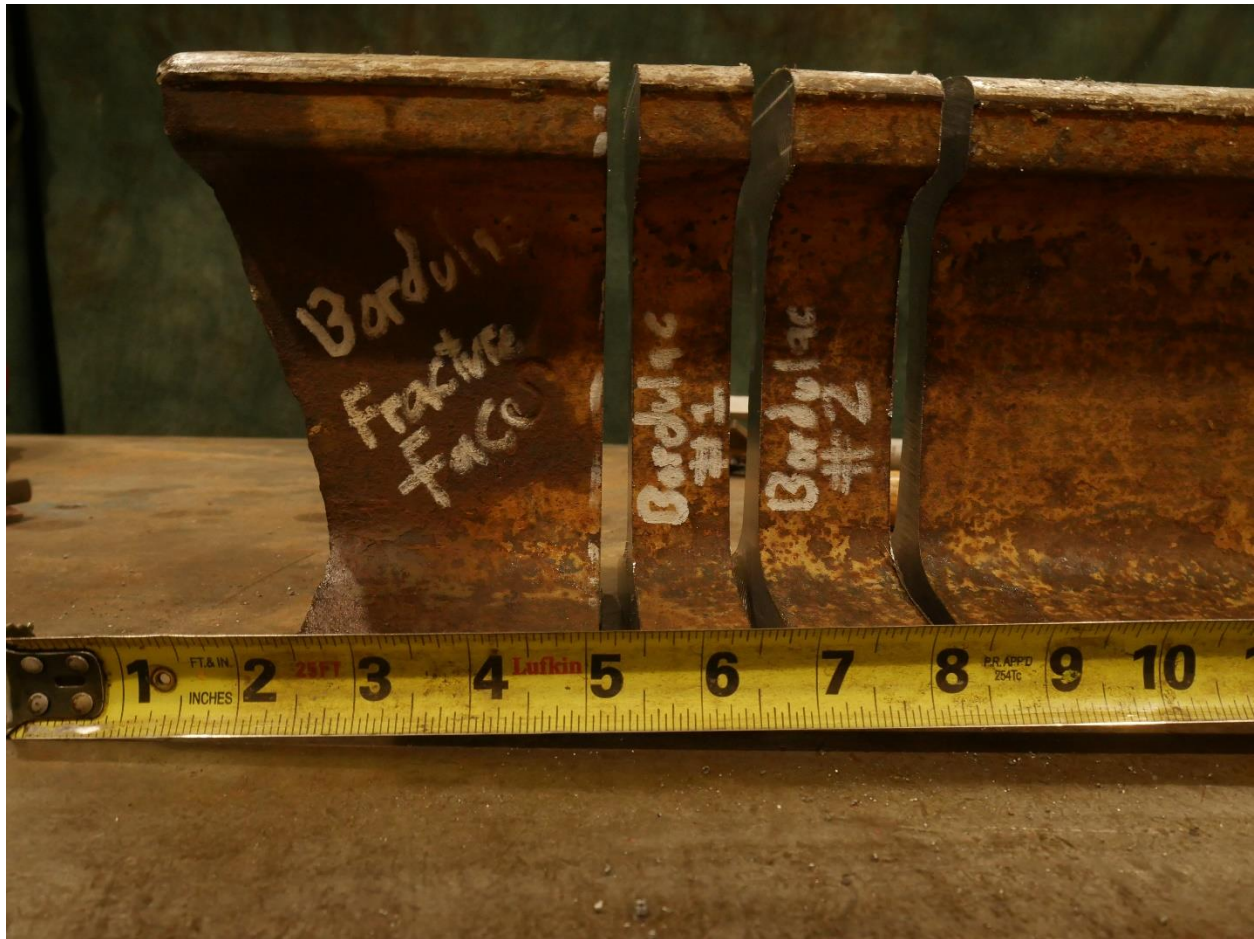
Once the non-destructive testing was completed, the rail was cut into four sections in order to get the two samples necessary for the destructive testing. The first section, with a length of 3.5", was the fracture face. It was cut from the rest of the rail in order to preserve it. The second section (1" long) was sample 1, which was macroetched. The third section (1.5" long) was sample 2, which was used for both hardness testing and chemical analysis. Finally, the fourth section was the remainder of the rail; it was not used for any destructive testing.

Image 12: The four sections of rail, the fracture face, sample 1, sample 2, and the remainder.
