Highway Accident Report

Multivehicle Collision
Interstate 44 Eastbound, Gray Summit, Missouri
August 5, 2010

**National
Transportation
Safety Board**

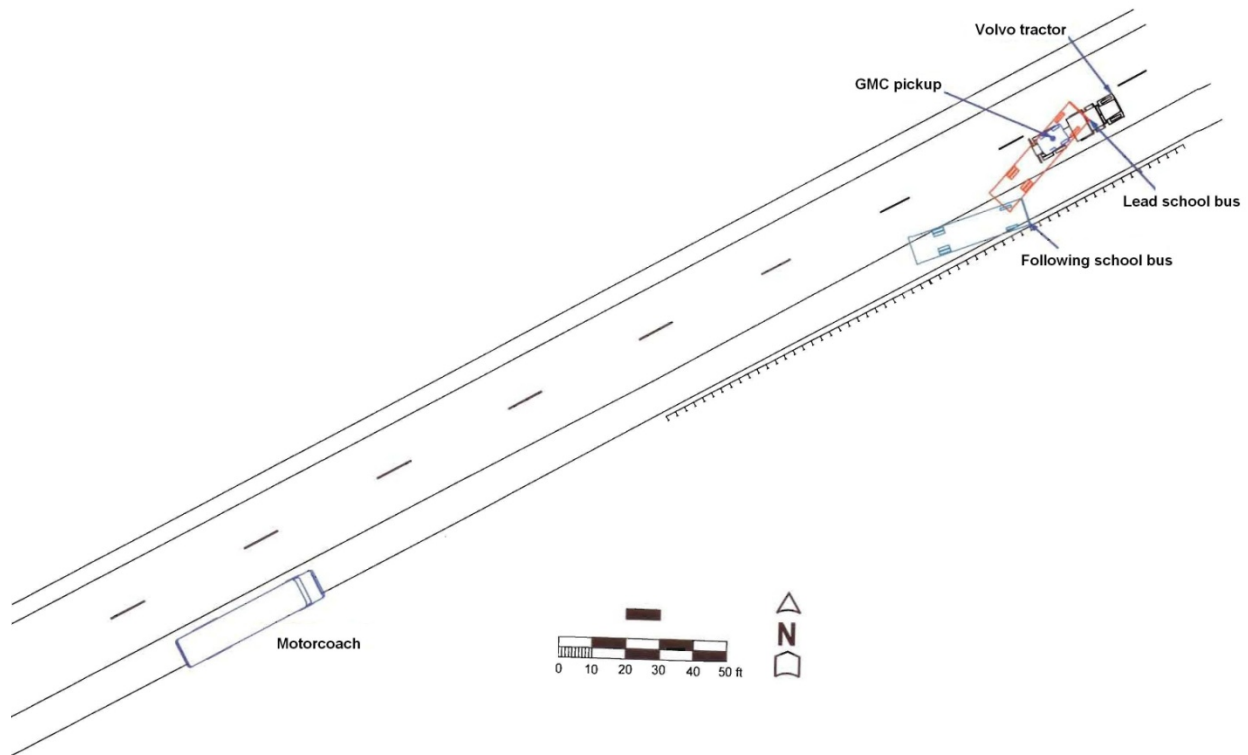
1 the following bus struck the right rear of the lead bus. The following bus remained engaged with
2 the lead bus. (See figures 2–5.)

1 **Figure 2.** Diagram of accident vehicles at rest. Final rest position of GMC pickup was beneath
2 lead school bus. Motorcoach shown to the west was not involved in accident but is referenced
3 throughout the report.

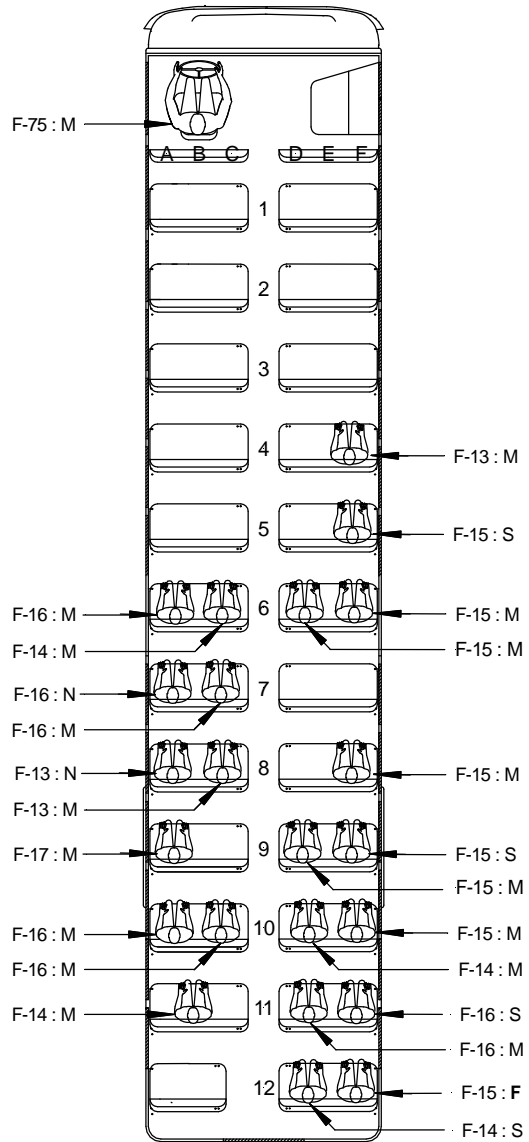
2 Table 1 summarizes the injuries resulting from the accident. Figures 6 and 7 show the
 3 seating charts for the lead and following school buses, respectively. The passengers in the lead
 4 bus were female students, 13–17 years old. The passengers in the following bus included
 5 1 chaperone and 30 male students, 6–18 years old. None of the occupants in either bus were
 6 ejected during the accident sequence.

1 **Figure 6.** Seating chart for lead school bus.

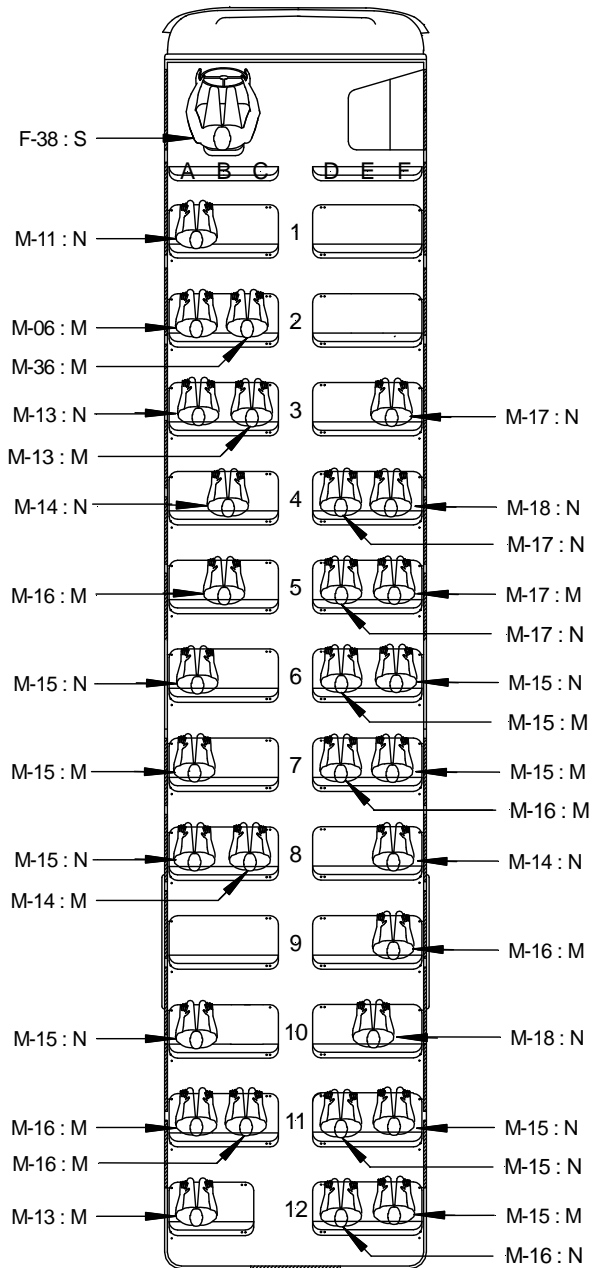
- 1 **Figure 7.** Seating chart for following school bus.
- 2 *Alt text: Seating chart for the following school bus, indicating the driver with serious injury, 15*
- 3 *passengers with minor injuries, and 16 passengers with no injuries.*
- 4
