Collision with Terrain  
Promech Air, Inc.  
de Havilland DHC-3, N270PA  
Ketchikan, Alaska  
June 25, 2015

NTSB/AAR-17/02  
PB2017-102178

# Aircraft Accident Report

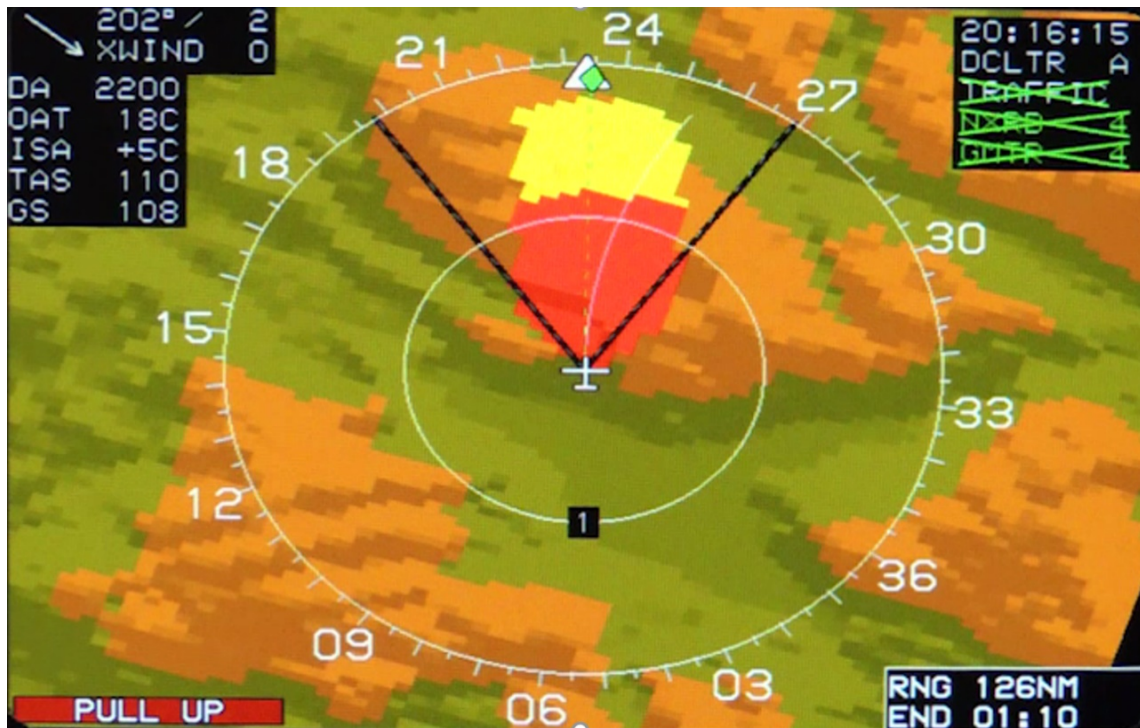
The Chelton EFIS in the accident airplane included a terrain awareness and warning system (TAWS), software version 6.0B, that provided color-coded cautions and warnings of terrain on the moving map on the MFD and a forward-looking "virtual" model of the outside world (a replica of a day VFR view out the front window in proper scale and perspective according to the aircraft's position, altitude, and heading) on the PFD. The system's integrated caution/warning/advisory system (CWA) also provided auditory and flag alerting functions. The CWA alerts for the TAWS features included an auditory annunciation (such as "pull up") accompanied by a red flag and text (such as "PULL UP") on the display. (See figure 6.)

**Figure 6.** An example of how the Chelton EFIS software version 6.0B depicts TAWS cautions (yellow) and warnings (red) on the MFD.

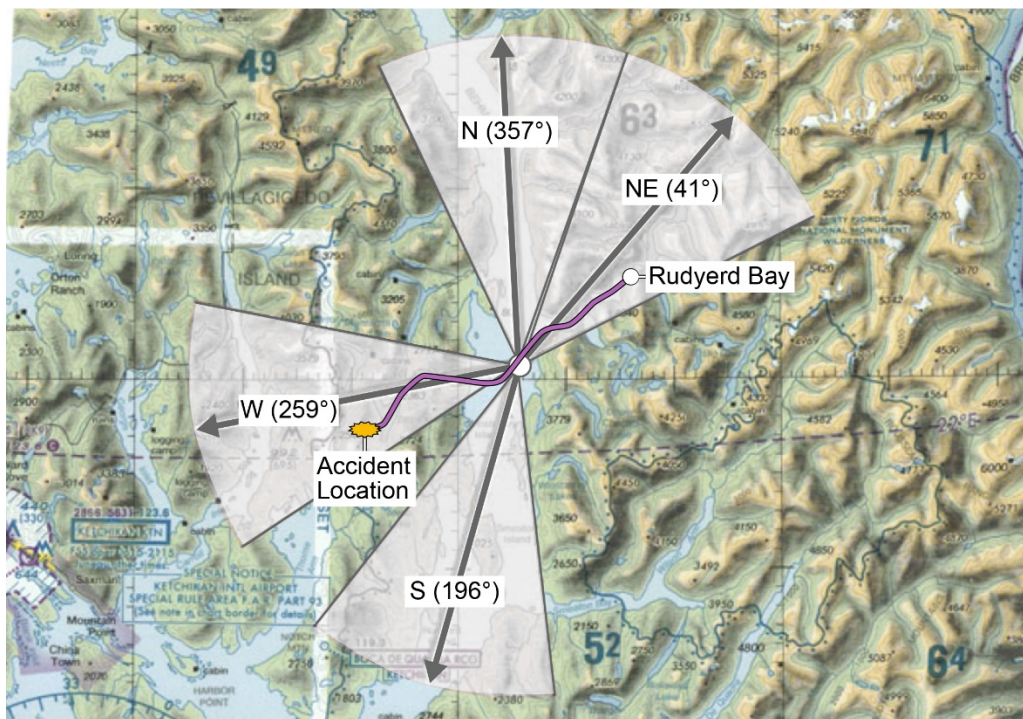
**Figure 8.** Map showing Misty Fjords camera range of views with the accident flightpath shown in purple.

The west-facing camera captured the accident area. Figure 8 depicts the camera range of views over a sectional chart with the accident flightpath marked in purple.

Note: The direction and bearing labels are approximate and presented in reference to true north.

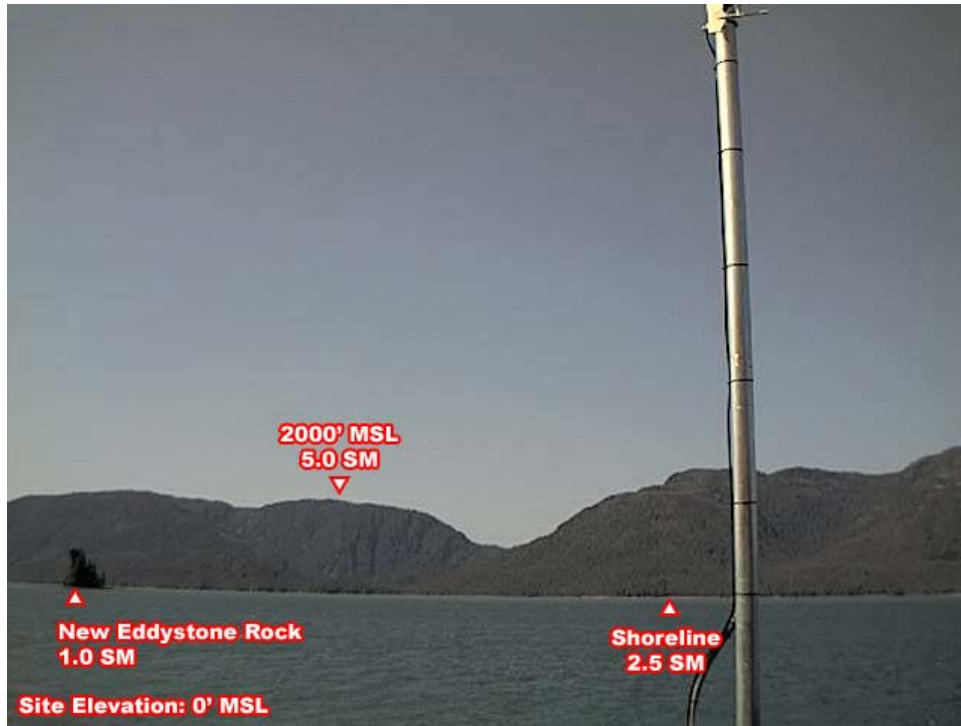
**Figure 9.** Image from west-facing (259°) Misty Fjords camera on a clear day.

Note: Distances to select landmarks are provided for reference, and the accident site is about 5 miles beyond the labeled 2,000-ft ridge. This image, as labeled, appears on the FAA web page for this camera, available from <http://avcams.faa.gov/sitelist.php>.

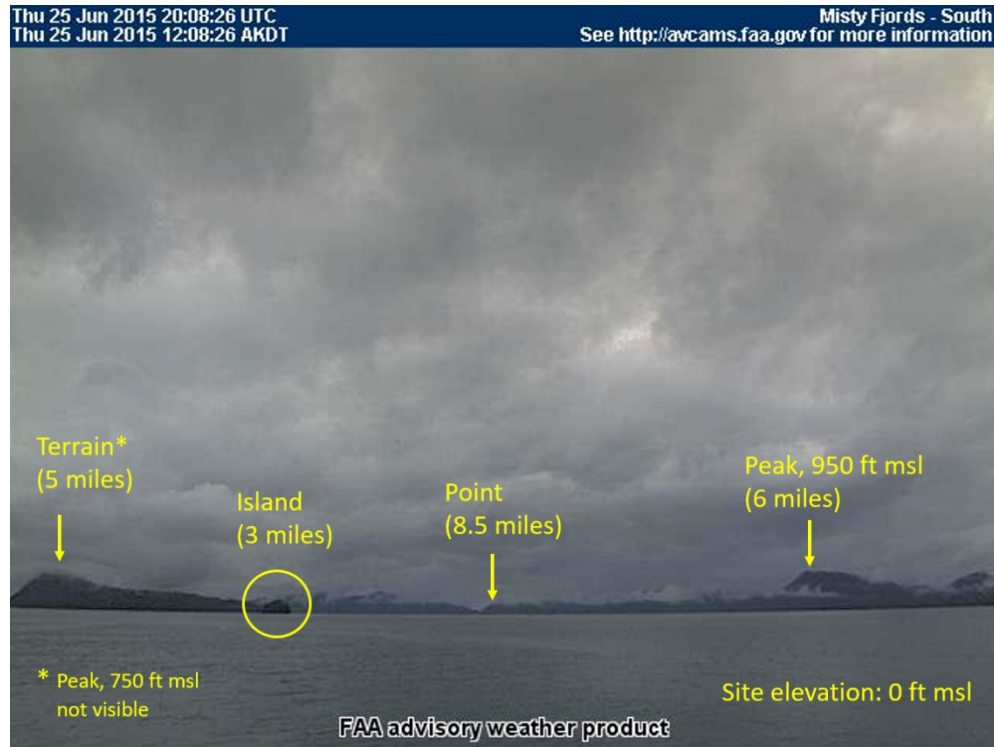
An FAA weather camera in Ketchikan facing toward the accident location also depicted the higher terrain obscured by clouds with visibility restricted less than 1 mile during the period. Figure 12 is an image captured by the south-facing Misty Fjords camera at 1208. This camera view showed that conditions in Behm Canal, which is part of the long route over the water, included good visibility.

**Figure 12.** Image from south-facing (196°) Misty Fjords camera at 1208, showing conditions on the long route over the water.

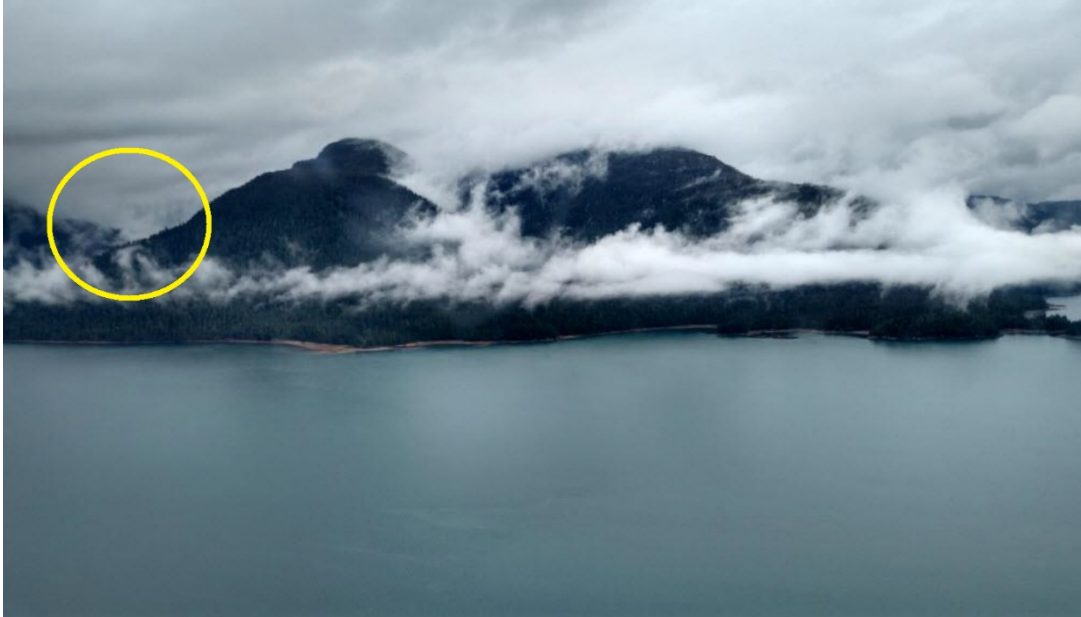
**Figure 13.** Photograph of entrance to Ella Narrows (circled) taken by a passenger on board the first Promech flight in the accident tour group to depart Rudyerd Bay.

The pilot of this first Promech flight stated that, when his flight reached Ella Lake, a cloud ceiling was above the lake about 1,600 to 1,700 ft msl, with a slightly lower ceiling (about 1,400 to 1,600 ft msl) over the south end of the lake. He reported that there were no “jagged edges” or “hanger” clouds below the ceiling. He recalled encountering misty rain and flying near the clouds but said his visibility was never obscured and recalled that he could see Thorne Arm (located about 5 nm from the south end of Ella Lake) while the flight was over the lake.

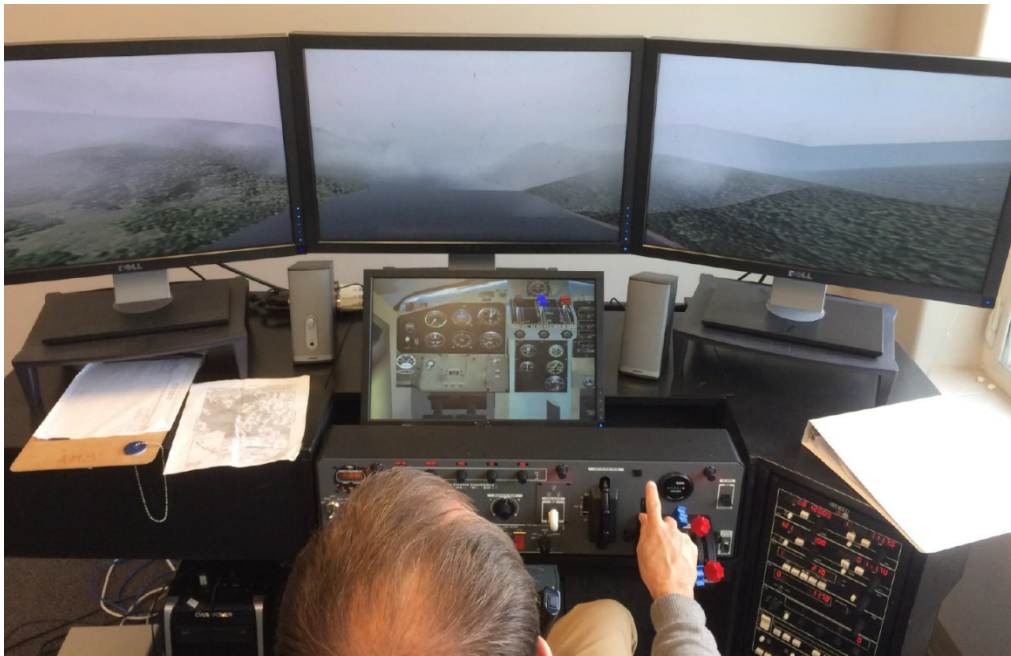
The cue-based training module that the accident pilot completed in the BATD included a scenario that required him to escape an inadvertent encounter with IMC by reversing course. NTSB investigators observed a demonstration of the training module, which involved an overwater flight with progressively decreasing cloud ceiling and visibility. Investigators noted that both the ceiling height and forward visibility were uniform and transitioned abruptly when adjusted by the instructor. Also, the terrain features and ground texture were not photorealistic.

**Figure 15.** Medallion Foundation BATD and CFIT-avoidance training scenario.
