A. Accident Information

Accident Number	DCA16FP003
Type of System	Natural Gas Distribution Pipeline
Accident Type	Building Explosion and Fire at 8701 Arliss Street, Silver Spring, MD (Flower Branch Apartment Building)
GPS Coordinates of Accident	Long. 38.59.54.36 N and Lat. 77.00.03.98 W
Date	August 10, 2016
Time	About 11:53 p.m. ¹
Pipeline Owner / Operator	Washington Gas
Material Released	Natural Gas
Pipeline pressure at time of release	About 20 Psig on main and 7-inches of water column downstream of service regulators and outlet of the building meter sets.
MAOP	25 Psig
Pipeline Material	Steel
Pipeline Outer Diameter	2-inch main, 2-, 1-, 3/4-inch services and 1-inch house piping. ²
Pipeline Year of Installation	1955
Buried Main and Service Pipeline Coating Type	Black Wrapped Coated Steel.

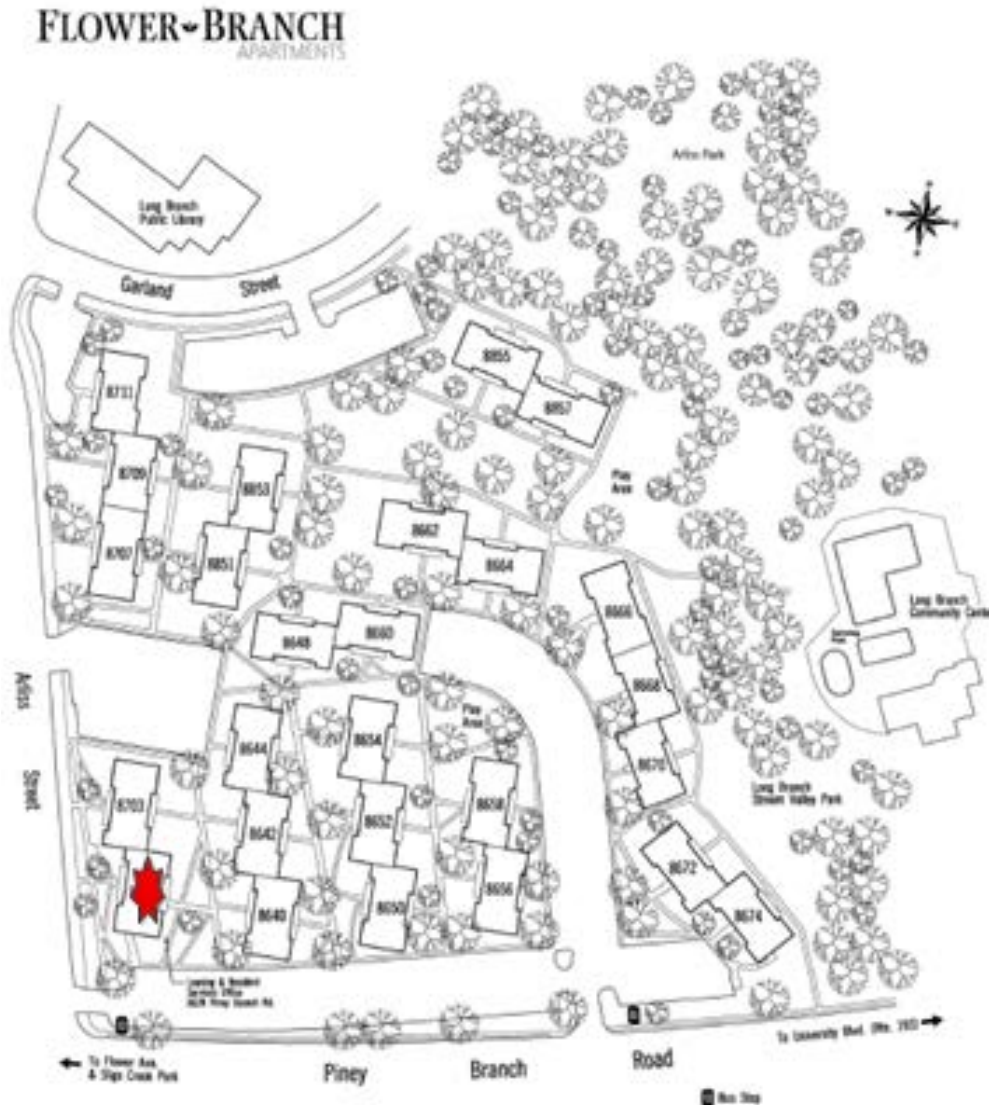
Figure 12: Layout of Flower Branch Apartments. 8701 Arliss Street is located in the southwest corner.

As shown in figure 12, the accident building, 8701 Arliss Street, and the apartment complex is bordered on the south by Piney Branch Road. Piney Branch Road is intersected on the east by University Boulevard and to the west by Flower Avenue. Arliss Street runs along the west side of the apartment complex.

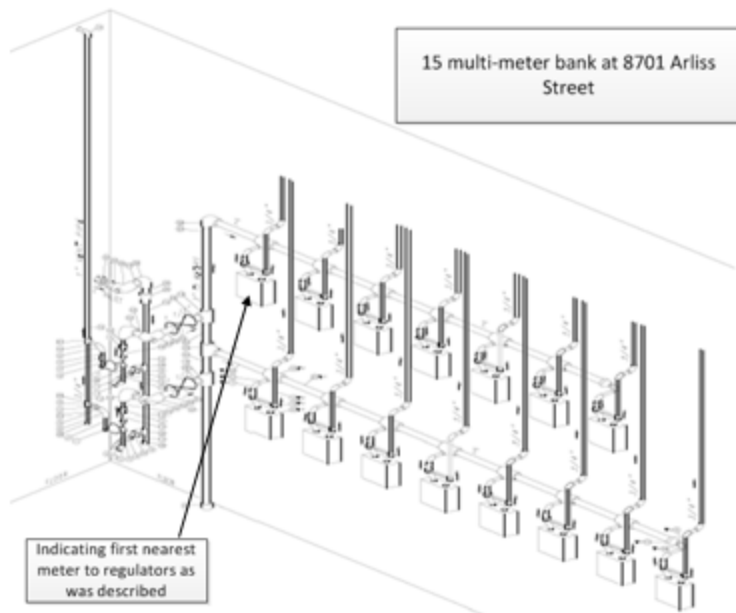
Figure 13: Schematic of 15 multi-meter bank at 8701 Arliss Street. Source: WG

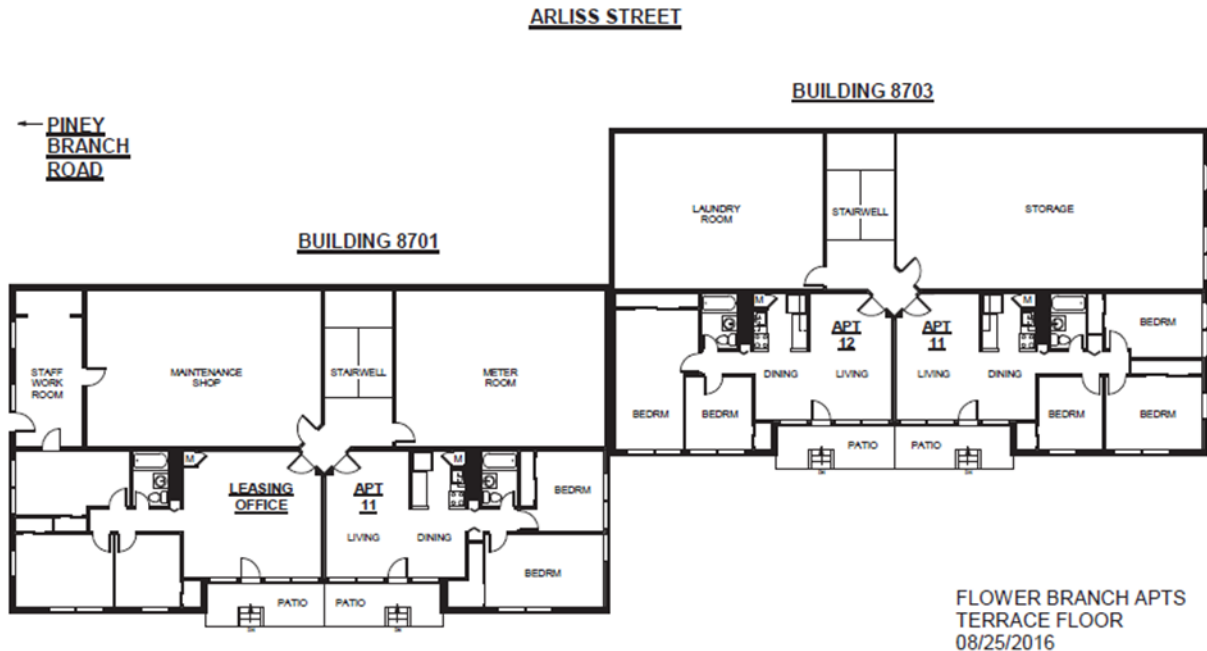
Figure 14: Adjoining buildings, 8701 and 8703, basement floor plans showing the incident building meter room and adjacent rooms on the left.

8701 Arliss Street layout differs in a major way from the other buildings on the Terrace level shown in figure 14. This level had only one apartment compared to two in other buildings due to Kay Management Leasing Office located on this level. In addition, the Terrace level included the maintenance shop that was storage room in other buildings. The space that served as laundry room in all other buildings was used as storage room at 8701 Arliss Street. As a result, this building did not have a common “washers and dryers” equipment location. The entry door to the meter, utility and storage room was locked at all times.⁵⁷

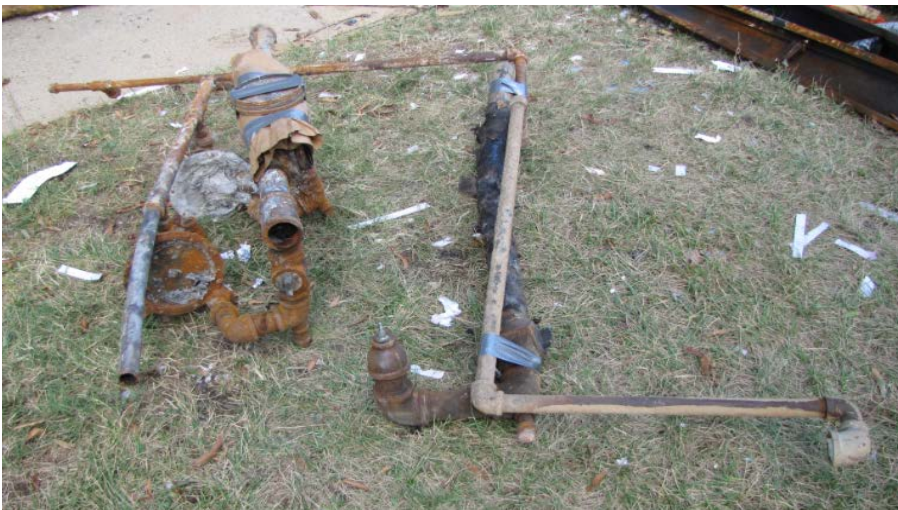
Figure 15: Evidence sent to NTSB Laboratory

Figure 15 shows two sections of 2-inch pipe cut outs from 8701 and 8703 Arliss Street service pipeline of about 12-inches each. These pipe pieces were cut out during the incident investigate,

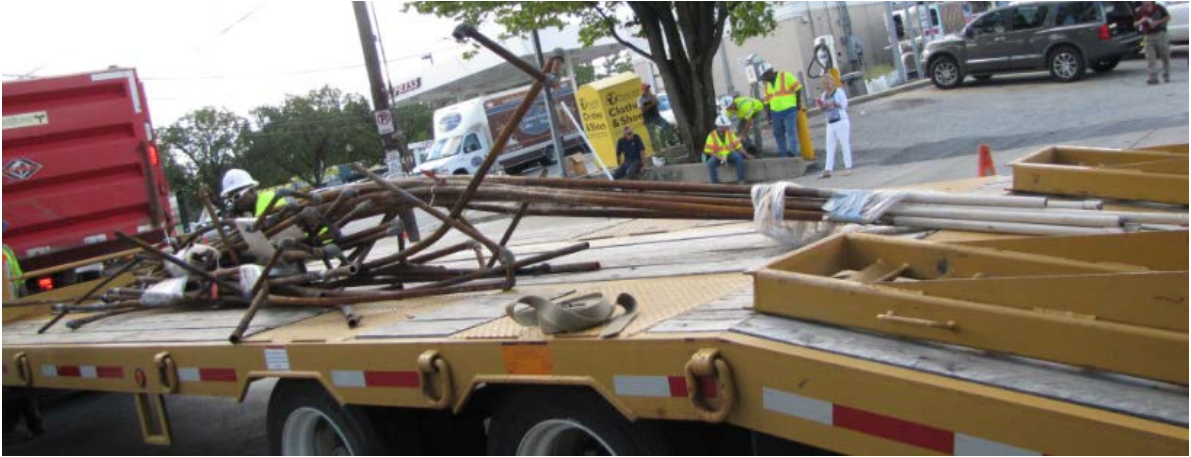
Figure 16 is the 8701 Arliss Street customers meter sets, including some parts of the customers' gas piping retrieved from the incident building and loaded on truck bed. Figure 17 below shows the house piping retrieved from the incident building meters, utility and storage room located in the basement and loaded on a trailer bed for transportation to WG, Springfield, VA.

Figure 17: 8701 Arliss Street Silver Spring, Apartment Customers Gas Piping on Trailer bed.

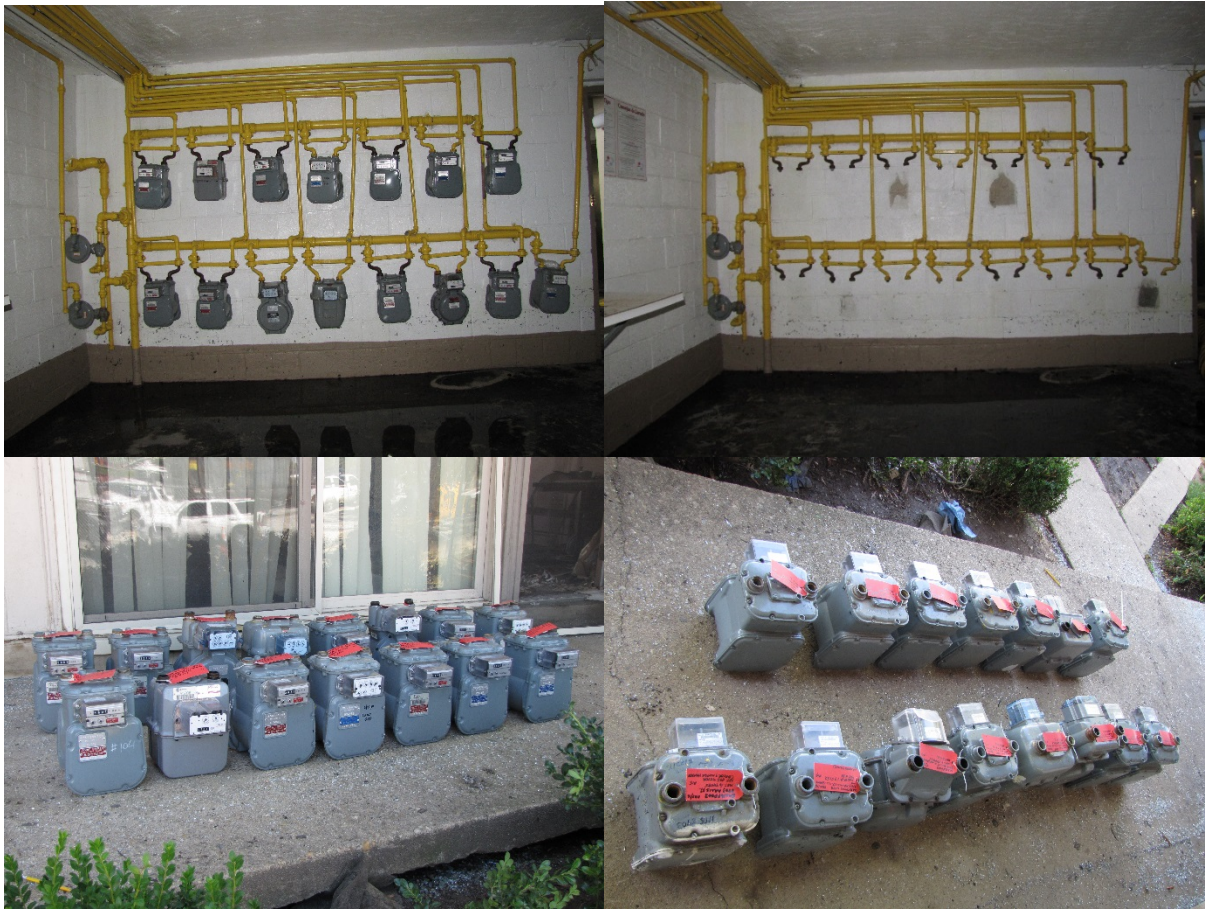
Figure 19: 8703 Arliss Street Silver Spring WG meter set piping, meters prior to and post removal.

The 15 meter sets displayed in figure 19 were removed from 8703 Arliss Street and taken to the WG Springfield, VA office location for NTSB storage.
