NATIONAL TRANSPORTATION SAFETY BOARD
Vehicle Recorder Division
Washington, DC 20594

Onboard Image Recorder

Specialist's Factual Report
By Jane Foster

Location: Oakland, Iowa
Date: December 12, 2017
Aircraft: 2004 IC, Model 3S530,
Operator: Riverside Community School District
NTSB Number: HWY18MH003

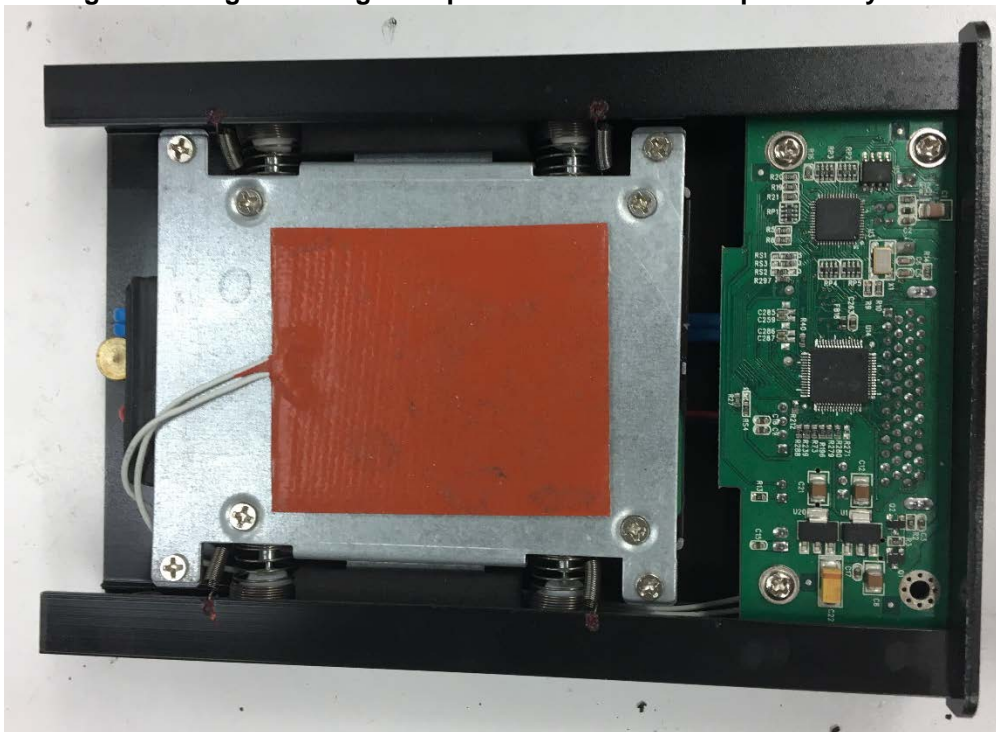
the hard drive was removed. The hard drive was sent to a third party hard drive recovery company for further analysis. Figures 1 through 4 show the extent of the damage and the disassembly of the device. Figure 5 shows an exemplar undamaged version of the hard drive and suspension system.

Figure 5. Image showing exemplar hard drive and suspension system.
