**Washington
Gas**
A WGL Company

WASHINGTON GAS MEETINGS WITH NTSB MEMBERS

NTSB ACCIDENT ID
DCA16FP003

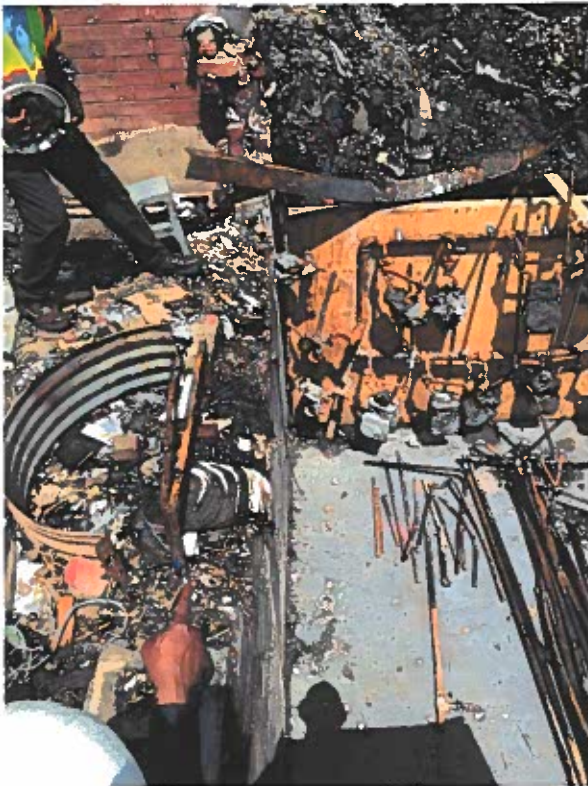
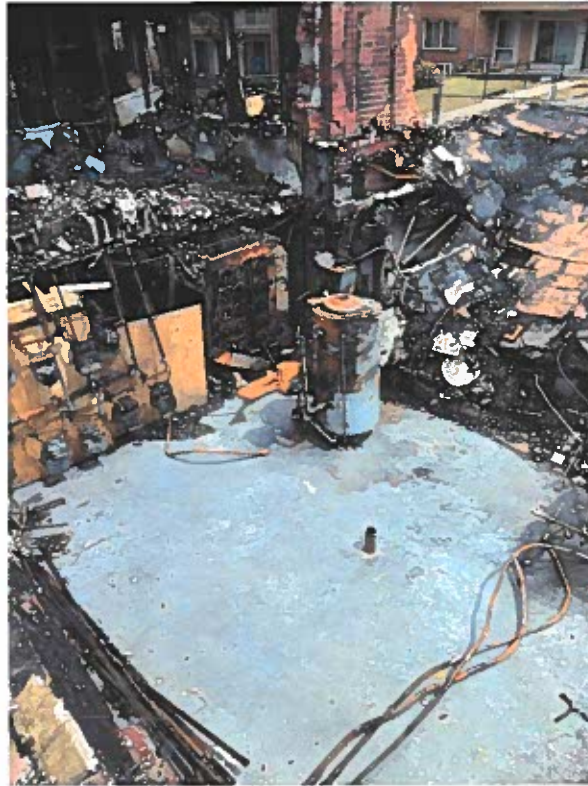
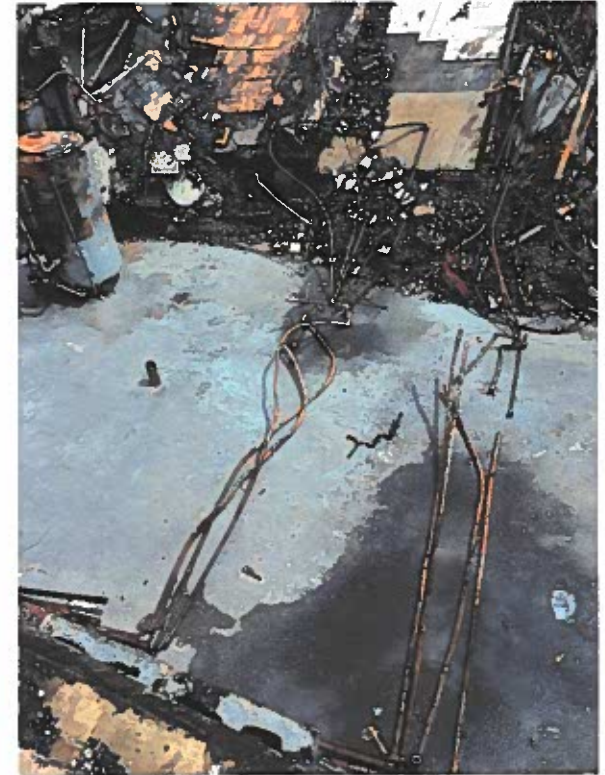
ATF IDENTIFIED MANY POTENTIAL SOURCES OF FUGITIVE GAS

- Regulator failure
- Failure of the meter bank
- Water heater
- Associated piping

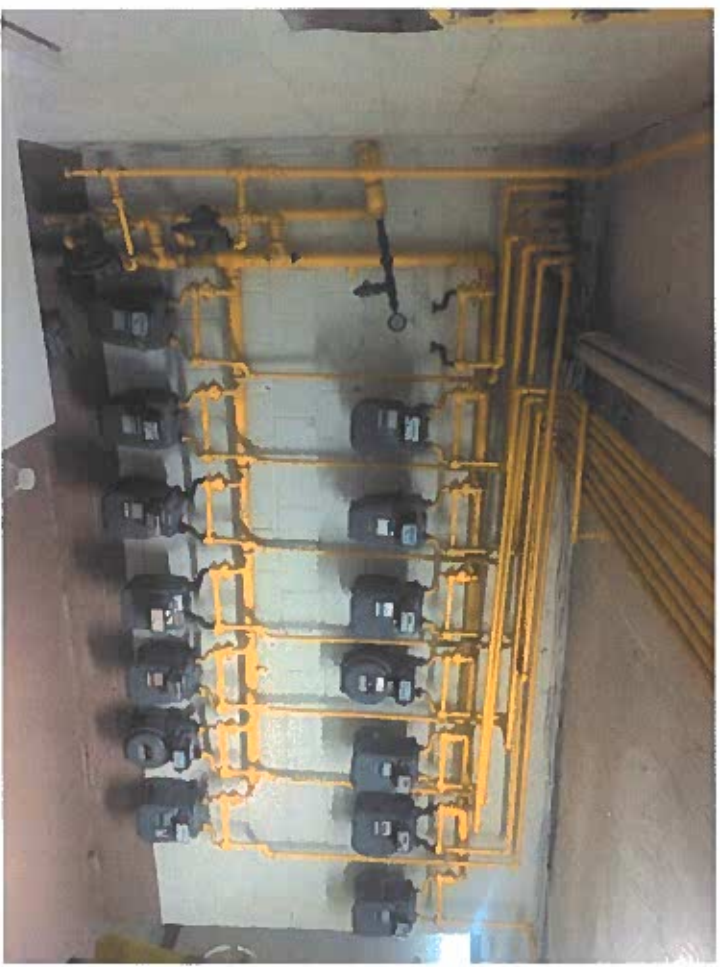
SERVICE REGULATORS

REGULATOR FAILURE IS IMPROBABLE AS A CAUSE

- ATF suggested regulators were a source of high flow gas – Not true
- No evidence of regulator failure
- ATF relies on the open fitting found after explosion
- Fitting condition likely a result of the explosion/collapse

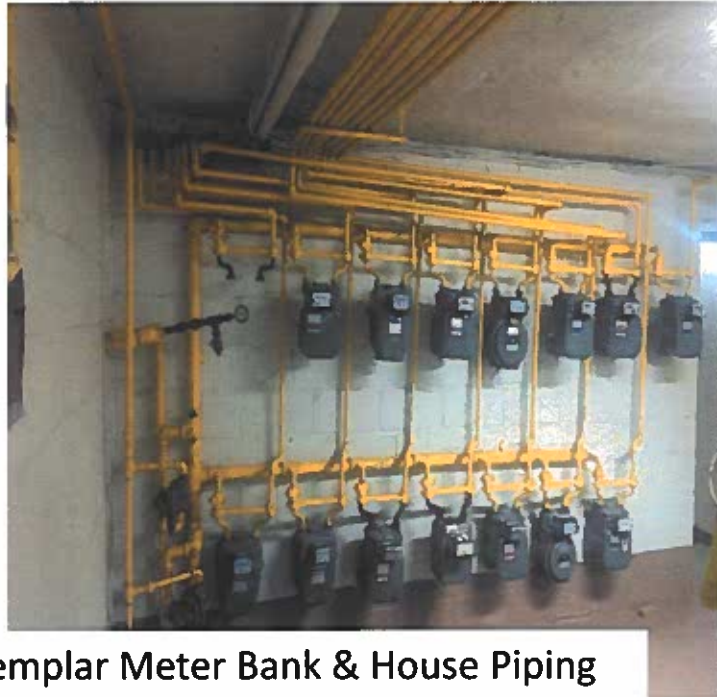
METER SWIVELS

- Meters exposed and vulnerable to damage from heavy objects
- Numerous swivels found broken
- Evidence of heavy materials / equipment stored near meter rack
- Severed swivel would produce a gas flow of 1,613 CFH (<10 minutes to LEL)
