NATIONAL TRANSPORTATION SAFETY BOARD
Office of Aviation Safety
Aviation Engineering Division
Washington, DC 20594
June 21, 2019

STRUCTURES GROUP CHAIRMAN'S FACTUAL REPORT
DCA18MA142

On April 17, 2018, at 1103 eastern daylight time, Southwest Airlines flight 1380, a Boeing 737-700, N772SW, experienced a left engine failure and loss of portions of the engine inlet and fan cowl during climb through flight level (FL) 320. Fragments from the engine inlet and fan cowl struck the wing and fuselage, followed by one cabin window departing the airplane and cabin depressurization. The flight crew conducted an emergency descent and diverted into Philadelphia International Airport (KPHL), Philadelphia, PA. Of the 144 passengers and five crewmembers onboard, one passenger received fatal injuries and eight passengers received minor injuries. The airplane sustained substantial damage. The regularly scheduled domestic passenger flight was operating under 14 Code of Federal Regulations Part 121 from LaGuardia Airport (KLGA), Queens, New York, to Dallas Love Field (KDAL), Dallas, Texas.

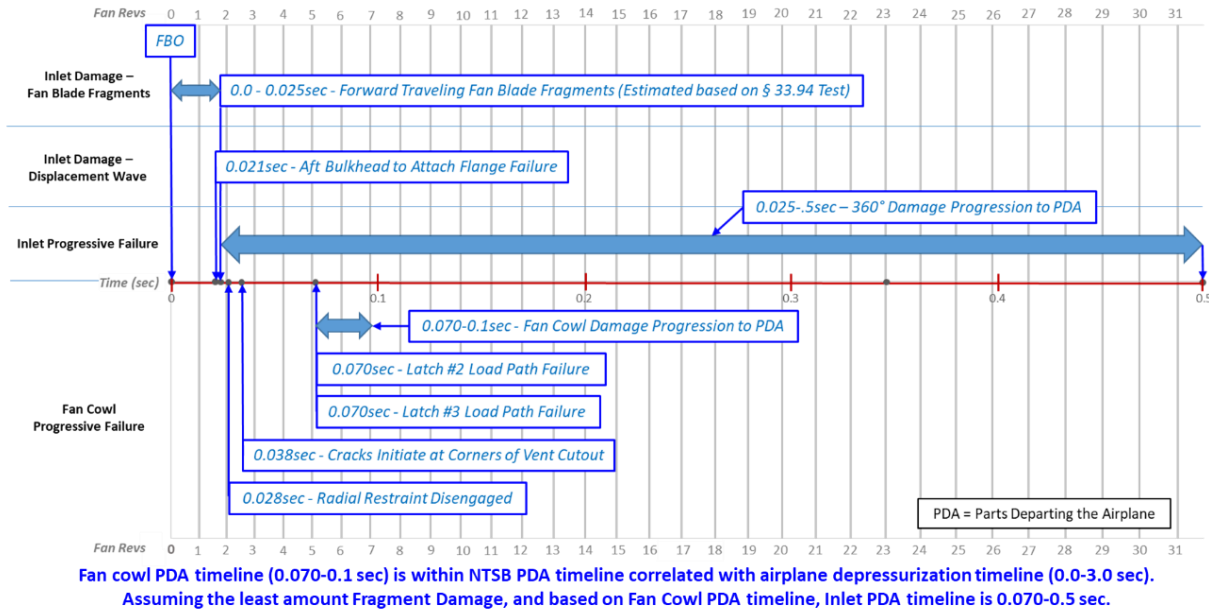
Figure 12 – Fan Cowl and Inlet Failure Sequence Event Timeline

After the accident, Boeing and CFM together developed analytic models to predict the behaviour of the engine and airplane structure during a 737-700/CFM56-7B FBO event and correlated those models with the accident inlet and fan cowl hardware damage documentation, the CFM56-7B engine FBO containment certification test results, and flight data recorder (FDR) and cockpit voice recorder (CVR) data. The models were determined to be sufficiently accurate to determine the extent and timing of the damage sustained by the accident inlet. **FIGURE 12** provides a composite timeline based on the available data.

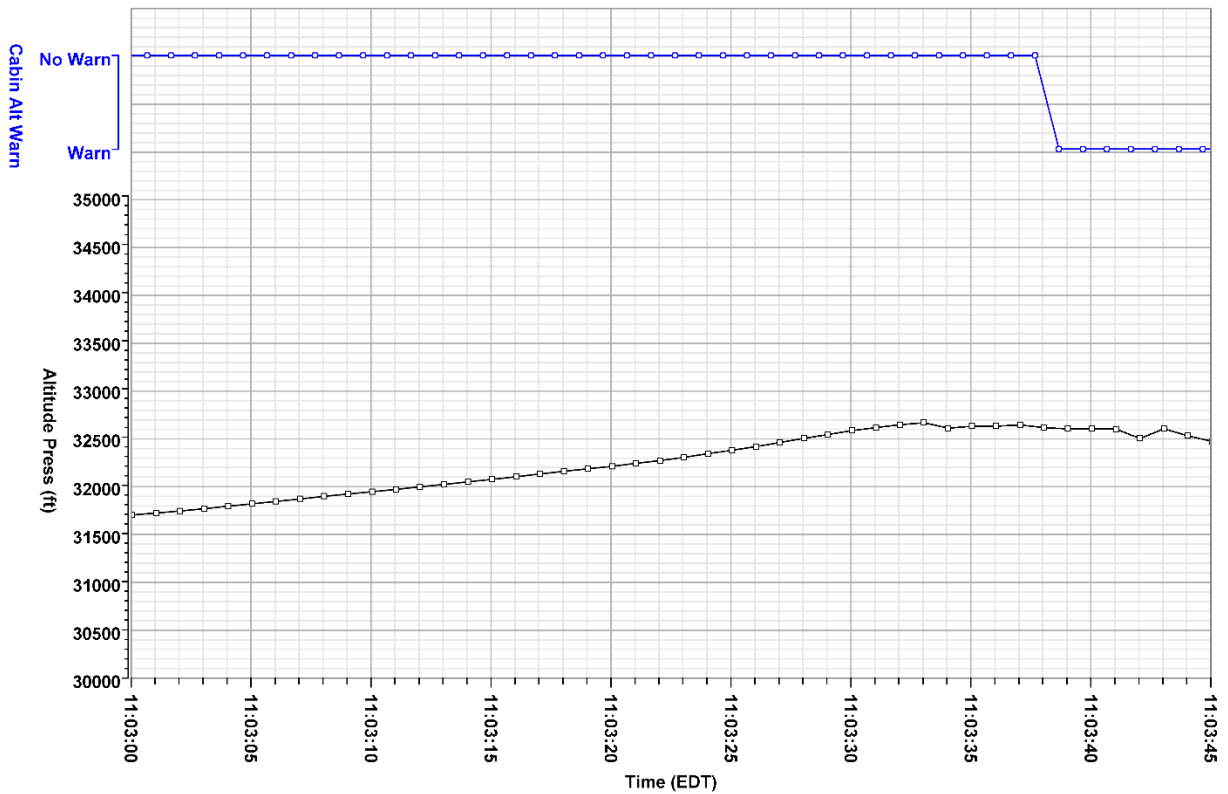
Figure 15 – FDR Data of Cabin Pressure Altitude Warning and Altitude Pressure Versus Time

The cabin altitude at the time of the 10,000 feet cabin altitude status message was recorded by the cabin pressure controller at 10,661 feet. The FDR data showed that the cabin altitude warning parameter, which was sampled once per second, transitioned from NO WARNING to WARNING between 1103:37.6 and 1103:38.6 (FIGURE 15).³ The CVR recorded the sound of the cabin altitude warning horn at 1103:39. Based on the CVR and FDR data for the cabin pressure warning and the FBO event, the fan cowl structure likely impacted the fuselage in the area of the passenger window between 0.00 and 3.17 seconds after the FBO (FIGURE 16), followed by the window departing the airplane creating an opening through which pressurized cabin air could escape and the cabin altitude warning to trigger; the maximum time from FBO to cabin altitude warning trigger was estimated to be 5.4 seconds.

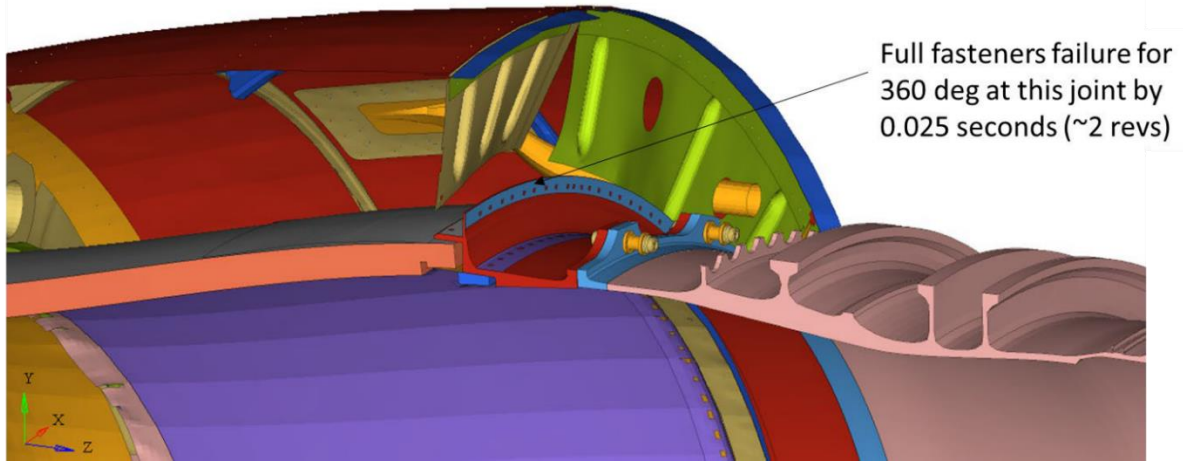
Figure 18 – Simulation Result of Aft Bulkhead-to-Attach Flange Joint Failure

The results of the structural analysis used to simulate the event fan blade release and displacement wave were consistent with the high speed video observations of structural damage occurring to the inlet within two fan revolutions (approximately 25 milliseconds) following the fan blade release during the 1996 engine FBO certification test. **FIGURES 18** and **19** illustrate the simulated results which were consistent with both the CFM56-7B engine FBO containment certification test results (**FIGURE 20**) and the accident inlet damage visual assessment (**FIGURES 21** and **22**); the aft bulkhead damage simulated results are as follows:

- 1) 360° circumferential failure of the aft bulkhead to the inlet attach ring due to fastener shear
- 2) Full failure of 5 of the 7 aft bulkhead circumferential splices
- 3) Two areas of about 40° inner lip skin-to-forward bulkhead joint failure

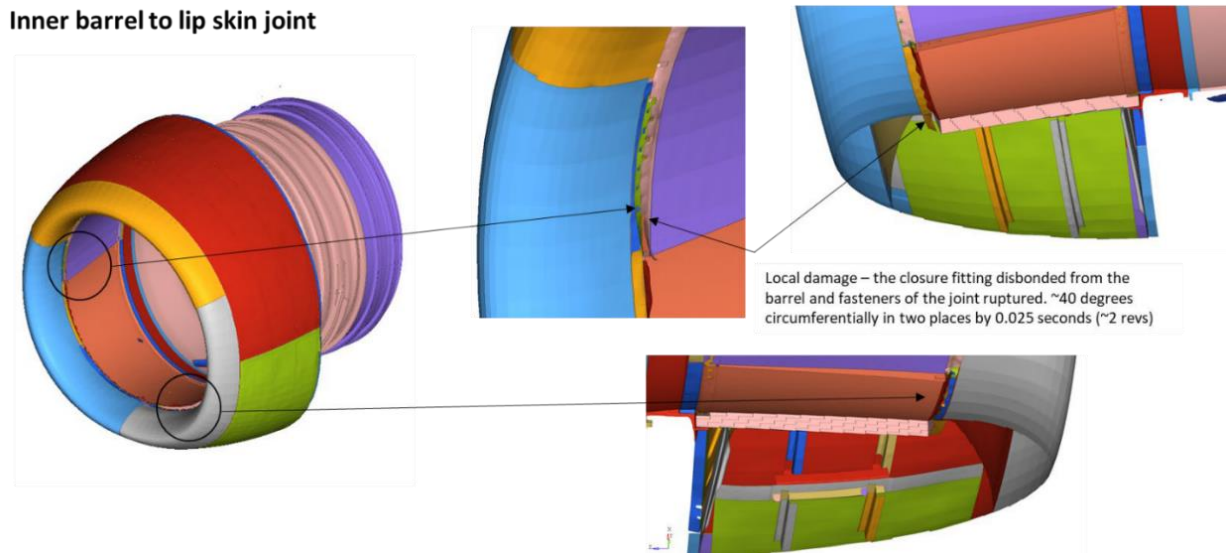
Figure 23 – Simulation Result of Lip Skin-to-Inner Barrel Damage

FIGURE 23 illustrates the simulation results related to the inner barrel-to-lip skin joint. The simulation results were consistent with the lip skin joint failure; however, lip skin joint failure does not appreciably contribute to the inlet separation.

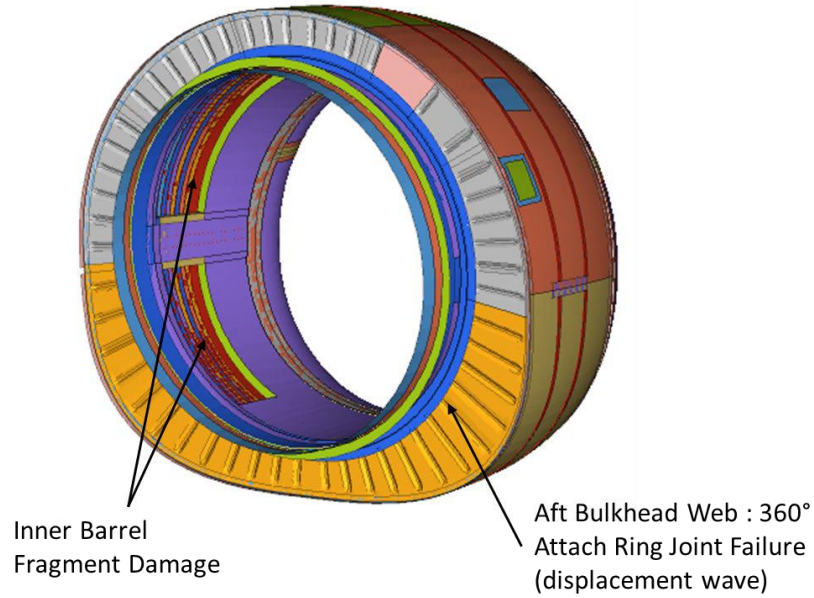
Figure 24 – Simulation Model for the Run Down Analysis with Displacement Wave and Fan Blade Fragment Damage Conditions Applied

FIGURE 24 shows the inlet model that was used for the progressive failure analysis during the run down phase of the accident event and it shows the starting condition state that included the damage to the inlet from fan blade fragments and displacement wave loading (See **FIGURE 8**). The run down simulation was consistent with damage propagating within 0.5 seconds after fan blade release and the damage propagation was sufficient to separate the forward portion of the inlet.

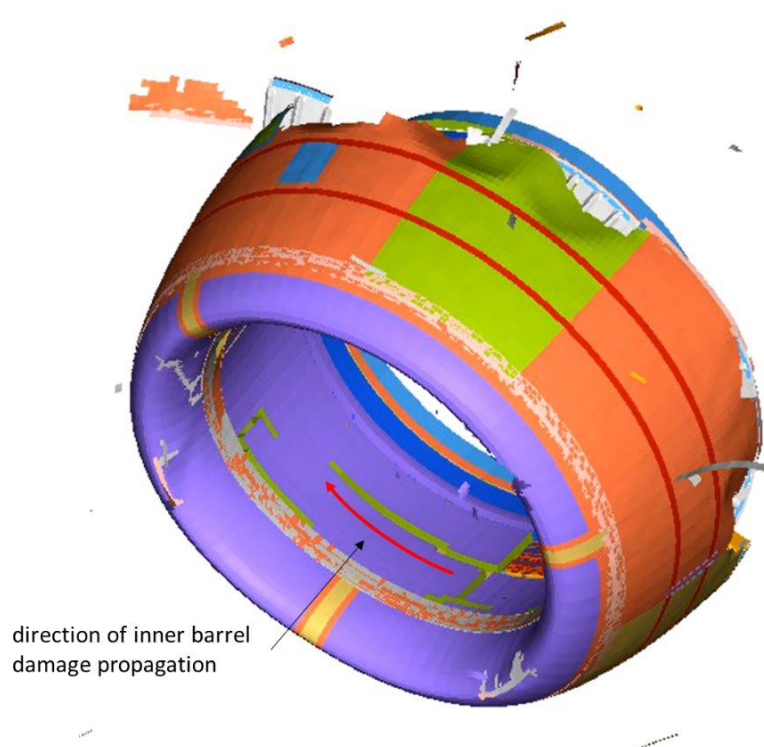
Figure 25 – Simulation Run Down Progressive Failure Analysis at Mid-State – Inlet Still Attached

FIGURE 25 shows the state of the inlet mid simulation, which illustrates damage propagation in the inlet inner barrel as well as damage accumulation at the aft bulkhead to outer barrel joints.

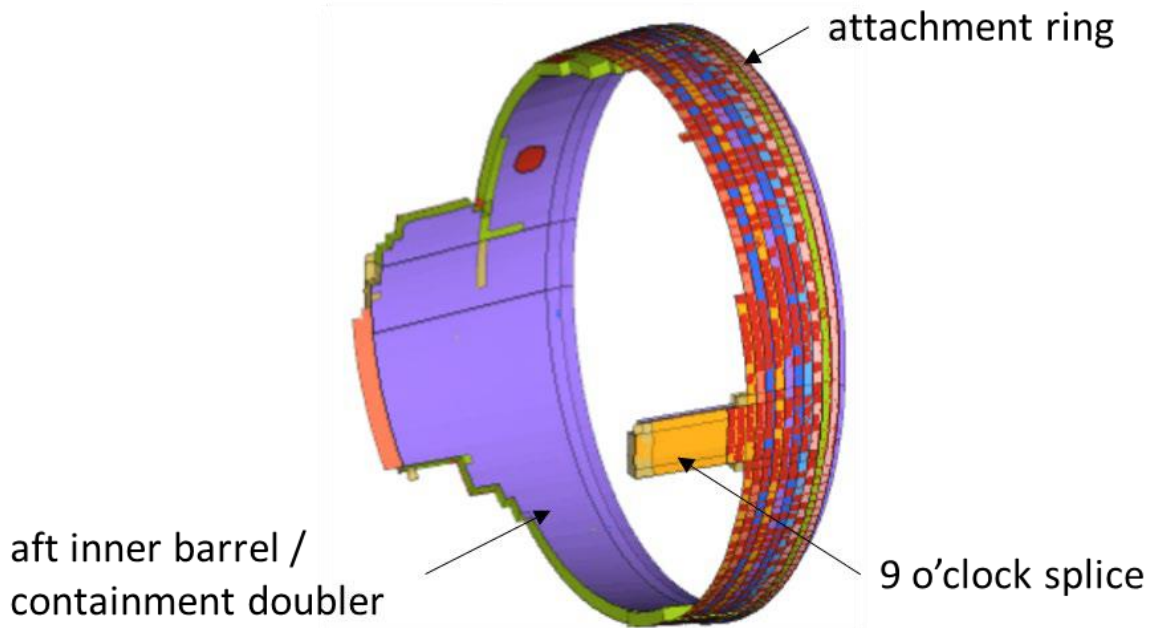
Figure 26 – Inlet Progressive Failure Analysis Simulation – Final State

Figure 26 shows the state of the inlet at the end of the simulation. The only structure that remained attached to the engine was the attach ring, the aft part of the inner barrel (including containment doubler), and the 3:00 and 9:00 o'clock inner barrel splices; this is all consistent with the accident inlet hardware in the as-landed condition.

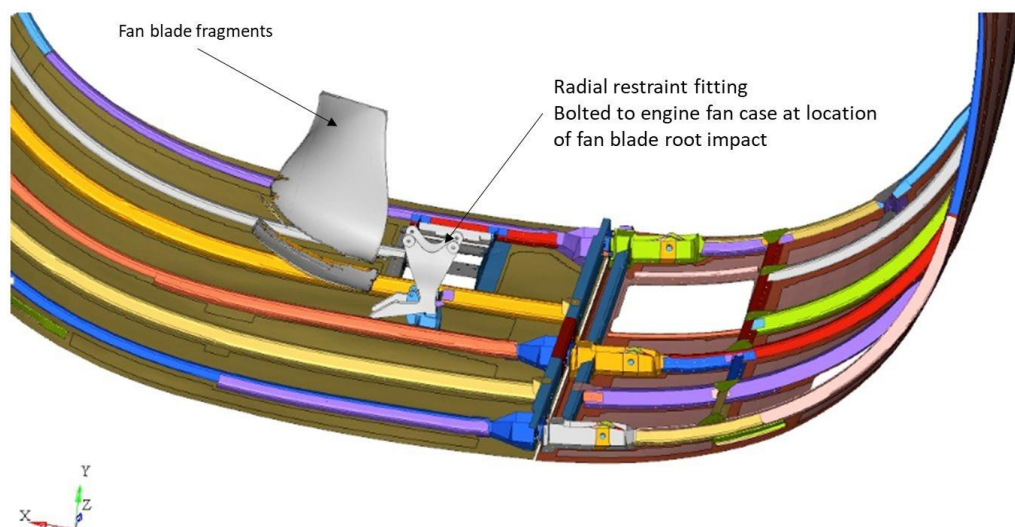
Figure 29 – Fan Cowl Simulation Model for Fan Blade Impact at 6:00 o'clock Position

FIGURE 29 shows the location of fan blade root fragment impacting the fan case at 6:00 o'clock; the engine fan case has been removed from the figure so that the correlation between the fan blade impact location and radial restraint can be more easily observed. This impact location was identified by examination of the hard impact marks in the fan case, assessing which parts of the released fan blade created which marks, and correlating that with FBO rig and FBO engine containment certification results. Fan blade fragment impact at the 6:00 o'clock position of the fan case in close proximity to the fan cowl radial restraint fitting and is the start of the fan cowl analysis simulation.
