Boeing EQA Report AS11733:

Examination of Nose Landing Gear Components Removed from
Southwest Airlines 737-300 Airplane PS765

Subject: EQA Report – Southwest Airlines 737-300 N379SW Wheel Well Structure
Fracture at El Paso – 27 July 2012

SUBJECT: *Examination of Nose Landing Gear Components Removed from Southwest Airlines 737-300 Airplane PS765*

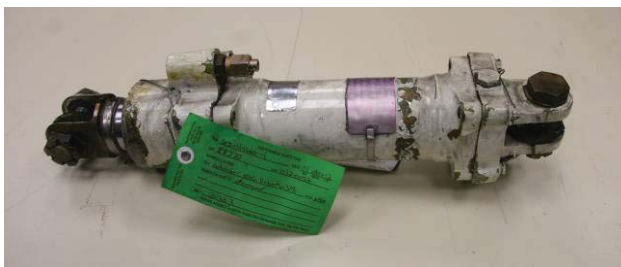
Figure 10: The 65-44461-4 actuator assembly removed from the plastic bag.

The actuator assembly was visually examined. The hydraulic ports were capped with metal caps and they were beyond hand tight. The unit was dirty and there was paint flaked off of the exterior but there was nothing to indicate that the unit was excessively damaged. A green SWA “Repairable Parts Tag” was attached to the actuator assembly.

The green tag was removed and the actuator was subjected to a digital radiographic (DR) examination. The examination did not reveal any obvious disruption or internal damage to the actuator.

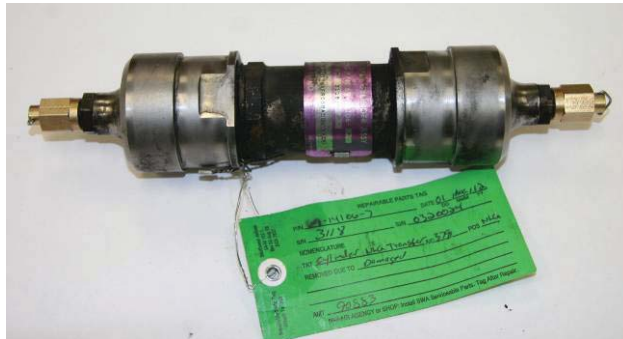
Figure 12: The 69-14106-7 transfer cylinder removed from the plastic bag.

The transfer cylinder passed the CMM Leakage and Operational Tests with no faults found. The group decided that disassembly of the cylinder was unnecessary.

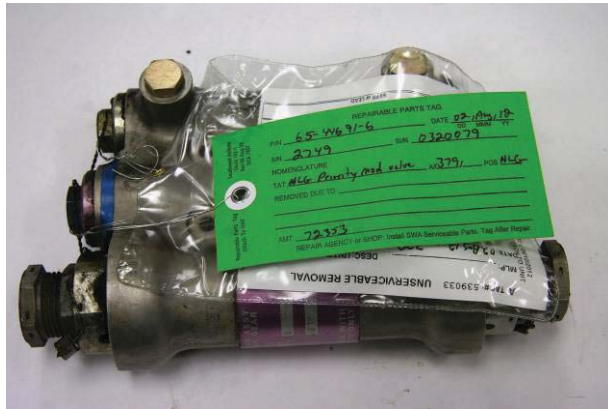
Figure 14: The 65-44691-6 modular package assembly removed from the plastic bag.

The hydraulic modular package assembly passed all ten elements of the functional test, with no faults found. Based on this finding, the group determined that a disassembly of the unit was not necessary.

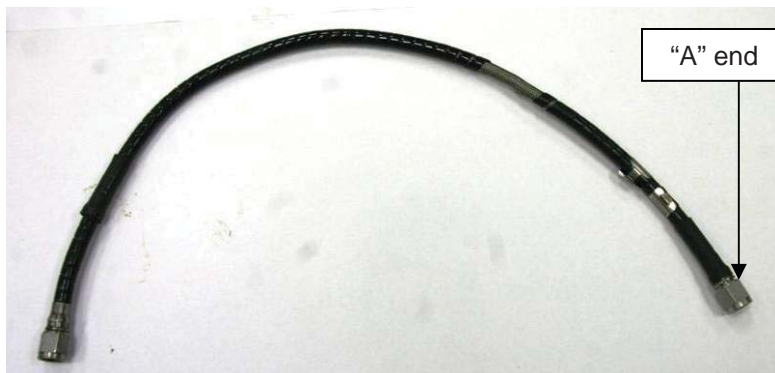
Figure 16: The BACH8A04EE-0263S retract actuator hose assembly removed from the bag.

The hose was covered with a black spiral wrap, as required by the specification for hoses with an “S” suffix. A two-inch segment of the spiral wrap was missing approximately 8 to 10 inches from the “A” end of the hose; see Figure 17.

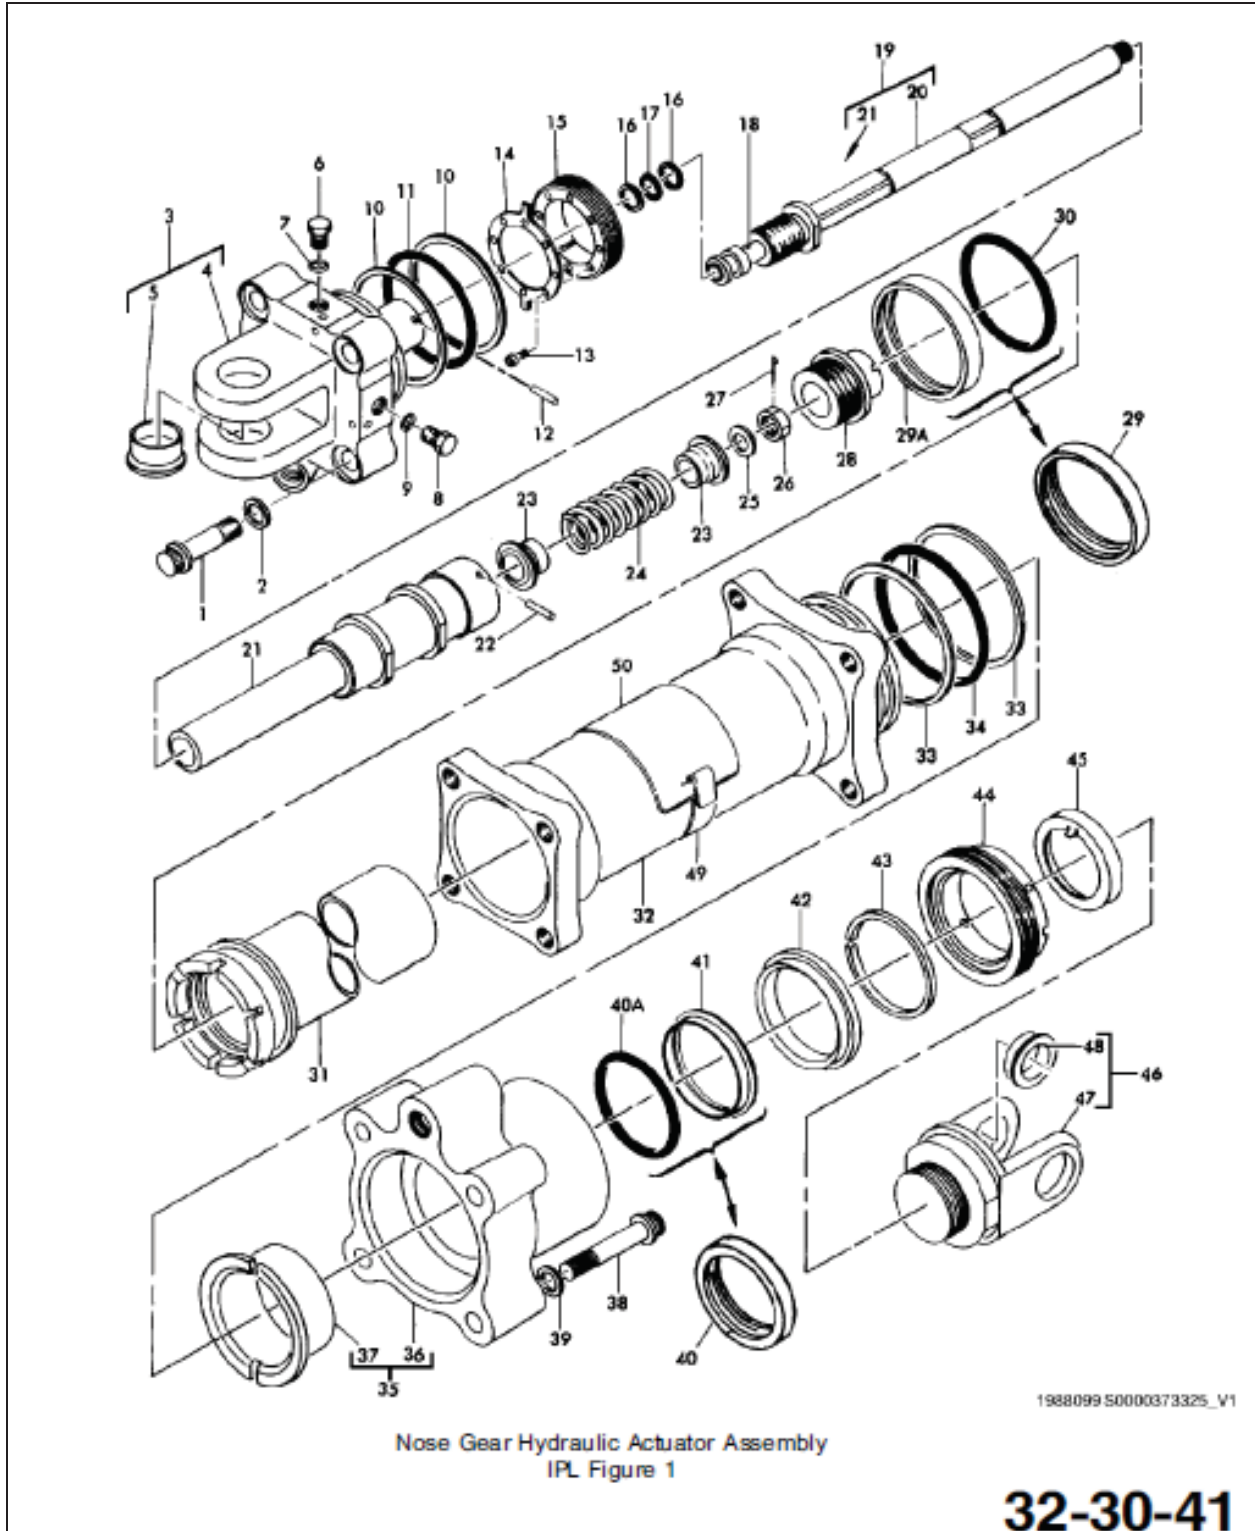
Figure 22: Illustrated parts list for the retract actuator.

The fitting was removed from the head end. It was noted that the fitting had a restricted orifice; see Figure 24. Per the IPL, the fitting in the head should have been a non-restricted union. The fitting installed in the cap was removed. A visual examination of

the fitting noted that it was a restrictor fitting. An examination of the fitting under magnification found a vibro-engraved part mark on the fitting; 66-22711-1. The orifice was measured using pin gages; the orifice measured 0.070 inch which is correct for the 66-22711-1 restrictor. Per the IPL, the non-restricted union should be installed in the cap.

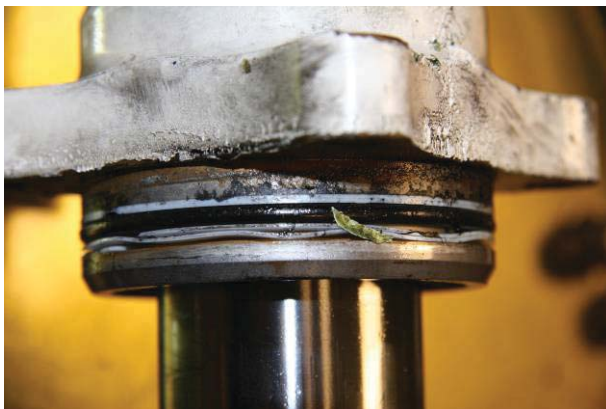
The head (item 4) was removed from the cylinder (item 32). The back-up rings and packing in the head were in good condition; see Figure 26.

Figure 26: The back-up rings and packing in the head.

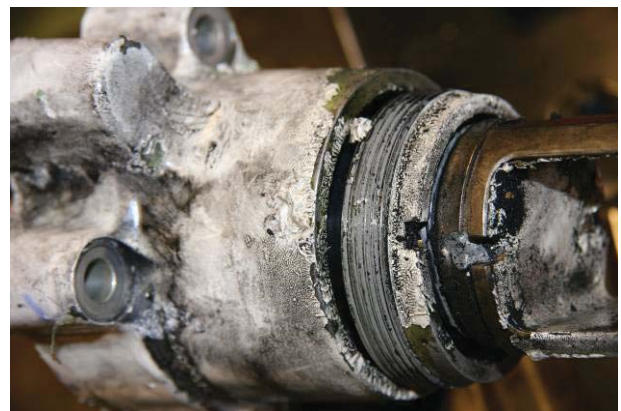
The bushing (item 37) was loosened from the cylinder (item 32); see Figure 27. The parts were unremarkable.

Figure 27: The bushing loosened from the cylinder.

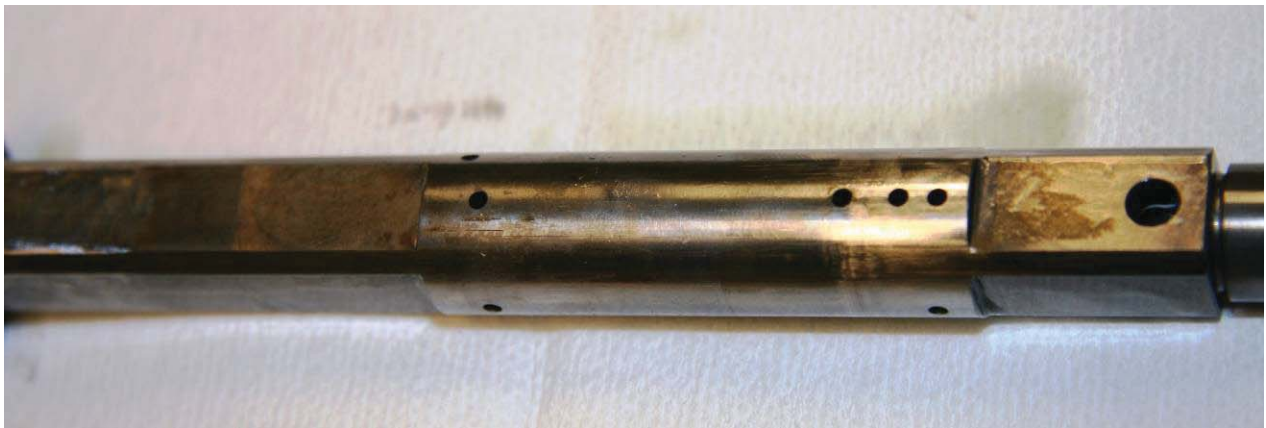
The cotter pin (part 27) the nut and washer (parts 25 and 26) the spring guides and spring (parts 23 and 24) were removed from the slide (part 20). The slide was removed from the sleeve; see Figure 34. The slide was unremarkable.

Figure 34: The slide removed from the sleeve.

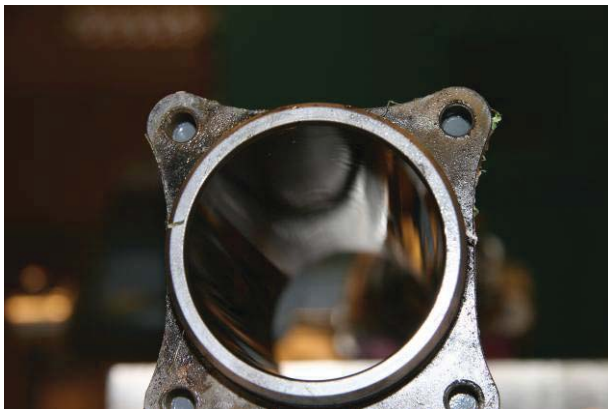
The bore of the cylinder was also unremarkable; see Figure 35.

Figure 35: The bore of the cylinder.

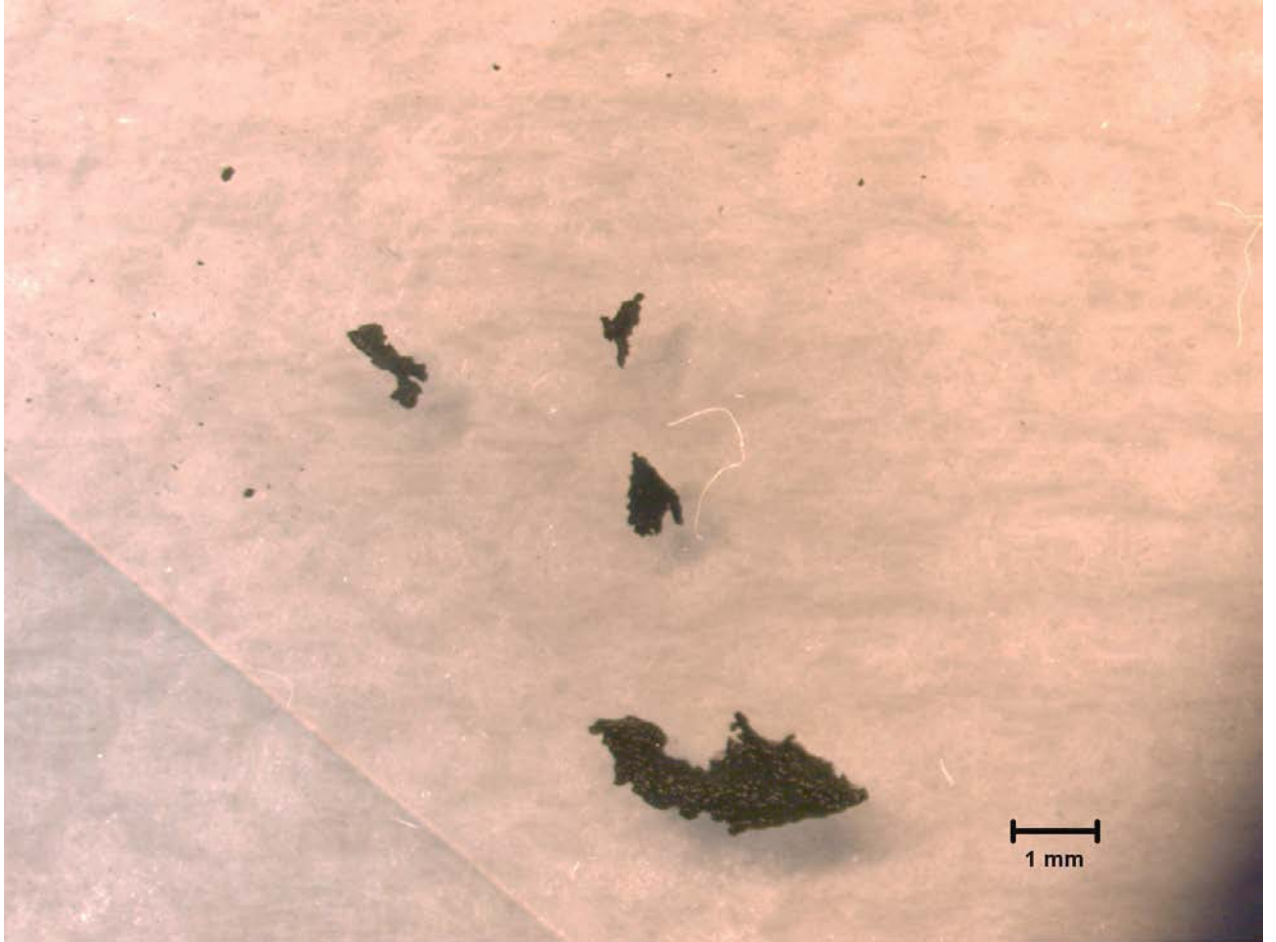
Figure X. EQA 11733 samples as submitted

FTIR comparison of the reference nose gear tire material and the EQA 11733 sample material indicates the materials are consistent. EPMA data also indicates common elements between the reference material and the samples; there are no elements contained in the reference material that are not contained in the sample material. The sample contains additional elements, however environmental exposure may explain the presence of those elements. EPMA scans of the surface of the black spiral wrap on the outside of the braided wire are very similar to the EQA 11733 samples material, while internal scans indicate the material does not contain any inorganic fillers. This suggests similar environmental exposure which accounts for additional elements observed on the EQA 11733 samples
