**Submission of CFM International
To the National Transportation Safety Board**

**Accident Involving
Southwest Airlines Flight 1380
17 April 2018**

NTSB Public Docket: DCA18MA142

July 17, 2019

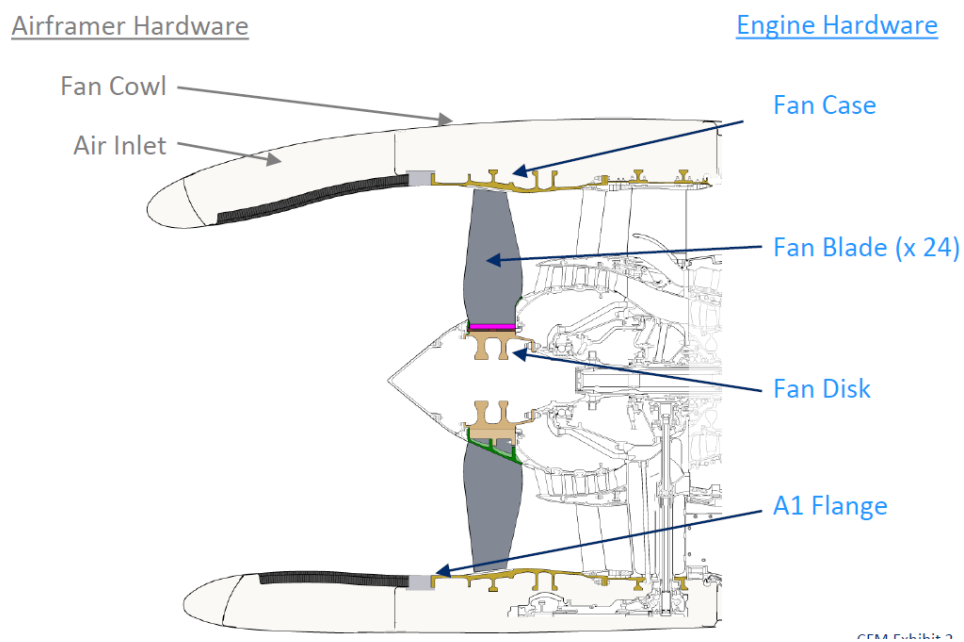
Figure 1: Engine and Nacelle Cross-Section Schematic⁵

Figure 1 depicts the forward portion of the engine and surrounding nacelle structures.

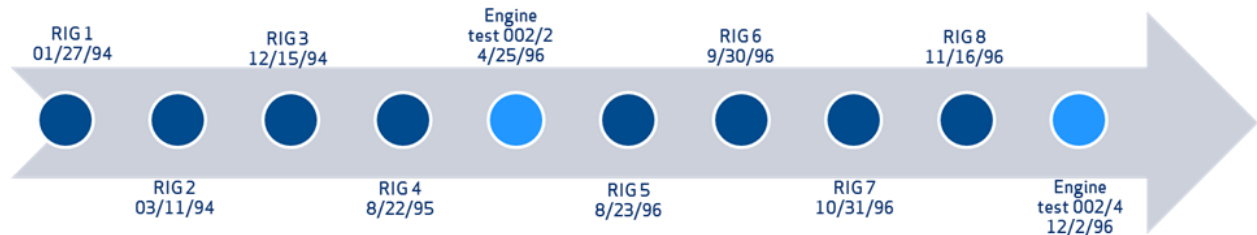
Figure 2 : FBO Rig and Certification Test Timeline

During CFM56-7B engine development, CFM conducted a total of eight (8) FBO rig tests and two (2) FBO certification tests (engine level) as depicted in Figure 2.

The first four (4) rig tests were conducted between January 1994 and August 1995 and were used to assess the fan blade fragmentation, fan case radial containment capability, fan blade axial retention, and fan blade interaction.

As a result of the loss of additional blades in the 874-002/2 certification test, CFM modified the fan module design to improve fan blade axial retention capability during a FBO event. Four additional rig tests were conducted to validate the modified fan blade axial retention capability (see Figure 2).

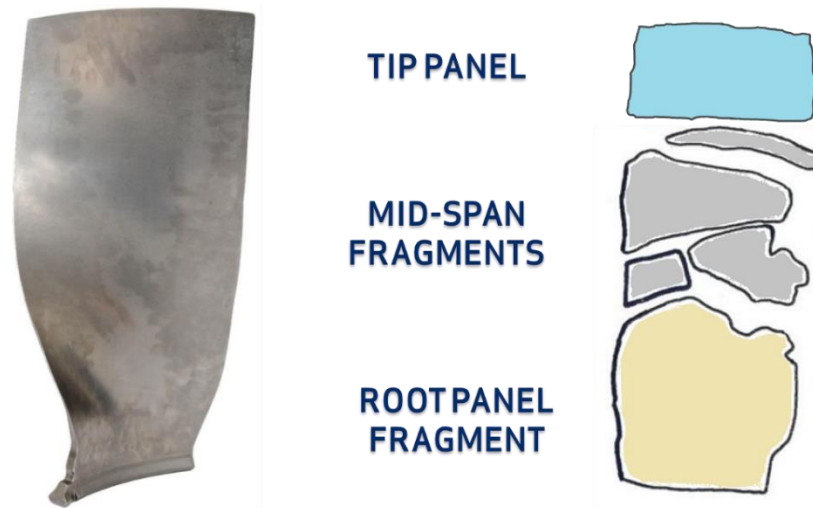
Figure 3 : Typical Fan Blade Fragmentation During FBO¹⁰

After the fan blade is released, the fan blade circumferentially impacts the engine fan case several times and is fragmented into several pieces: tip fragment, mid-span fragments and root panel (see Figure 3).

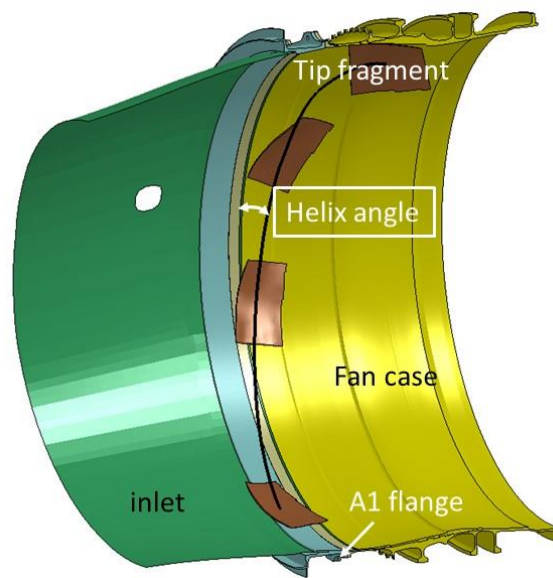
Figure 4 : Fragment helix angle definition

The fan blade impact marks on the engine fan case represent the impact locations on the fan case and load transmission of the fan blade fragments. After each test, these marks were noted and evaluated to gain information about fan case and fan blade fragmentation behavior. Although not required by the regulations, in order to obtain additional technical information, an initial Boeing production inlet was installed by CFM on the fourth rig test in August 1995. Important data concerning the FBO capability of the production inlet design was obtained. During that test, a fan blade tip fragment penetrated through the inlet structure, suggesting that Boeing should modify the design of the inlet to avoid penetration in the event of an FBO. To assist, CFM shared the CFM56-7B fan blade fragmentation experience based on the first four (4) rig tests, FBO design loads (forcing functions), transient analysis and the estimated spiraling helix angle (15°) for the tip fragment (see Figure 4). Details of the mid span fragment mass, quantity and direction were also shared.¹¹
