Subject: Boeing Submission for FedEx MD-10-10F N370FE Left Main Landing Gear
Collapse at Fort Lauderdale, Florida - 28 October 2016

Submission to the
National Transportation Safety Board
for the

**FedEx MD-10-10F N370FE
Left Main Landing Gear Collapse at
Fort Lauderdale, FL
28 October 2016**

**The Boeing Company
27 April 2018**

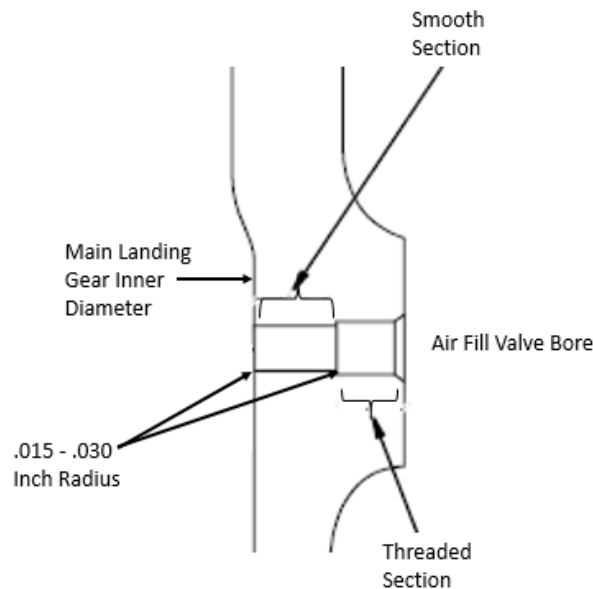
were found, the service bulletin provided instructions for repair or replacement of the main landing gear shock strut cylinder assembly.¹¹ Terminating action for the repetitive inspections was the repair of the air fill valve bore per the service bulletin's instructions. These instructions include making two 0.015-0.030 Inch radii. One radius is at the junction of the air fill valve bore's smooth section to the inner diameter of the main landing gear cylinder. The second radius is at the junction of the air fill valve bore's smooth section to the air fill valve bore's threaded section. The service bulletin's instructions also include brush cadmium plating the air fill valve bore's smooth section, threaded section, and the two radii. Cadmium plating is intended to protect the base metal from corrosion.

Maintenance records show Boeing Alert Service Bulletin DC1032A259 was complied with during the left main landing gear's last overhaul, which was completed in February of 2008. A review of the work cards completed during the overhaul found a work step statement to "maintain radius of bore at I/D wall and thread junction 0.015-0.030".¹² After rework, the radius at the junction of the air fill valve bore's smooth section to the air fill valve bore's threaded section was recorded on the work card as 0.030 inch and the radius at the junction of the air fill valve bore's smooth section to the inner diameter of the main landing gear cylinder was recorded as 0.090 inch. This recorded radius at the junction of the air fill valve bore's smooth section to the inner diameter of the main landing gear cylinder is beyond the 0.030 inch value required by Boeing Alert Service Bulletin DC1032A259. No additional records were found that addressed the exception.¹³ Additionally, it was noted a work card step to "brush cad plate the valve bore holes"¹⁴ was stamped, indicating the work card step was completed.

- The radius where the corrosion pit occurred was beyond the limits specified by Boeing Alert Service Bulletin DC1032A259.
- The left wing fire was predominantly fed by jet fuel leakage from a breached left engine pylon fuel pipe and damage to the left wing's lower skin.
