**HIGHWAY FACTORS GROUP CHAIRMAN'S
FACTUAL REPORT**

HWY18FH011

**NATIONAL TRANSPORTATION SAFETY BOARD
OFFICE OF HIGHWAY SAFETY
WASHINGTON, D.C.**

Location: Southbound US Highway 101 (US-101) south of North Shoreline Boulevard at the exit ramp transition to State Route 85 (SR-85), milepost 48.38, Santa Clara County, Mountain View, California.

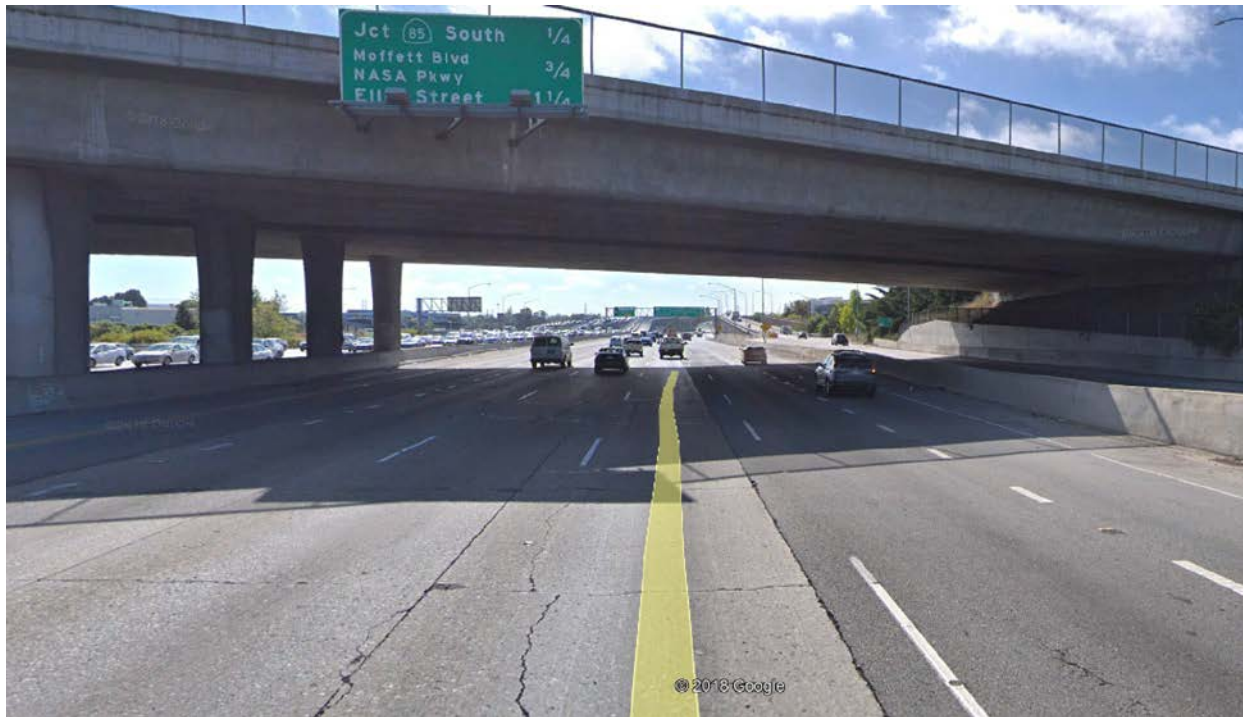
Figure 2C – This guide sign was attached to the north edge of the North Shoreline Boulevard overcrossing at milepost 48.61 about 0.23 miles north of the crash location (Source: Google Maps Street view image from March 28, 2018).

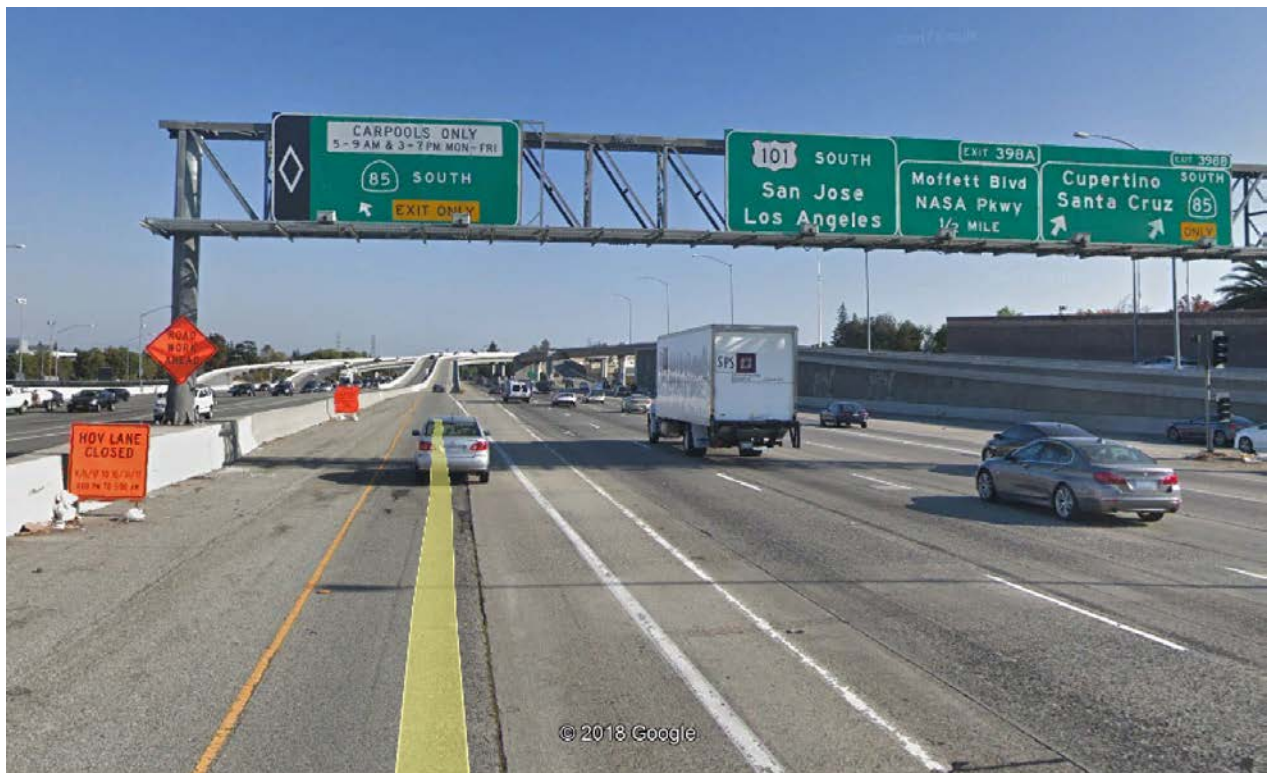
Figure 2D – These guide signs extend across the southbound US-101 travel lanes and were located about 460 feet north of the previously damaged crash cushion (Source: Google Maps Street View image from March 28, 2018).⁸

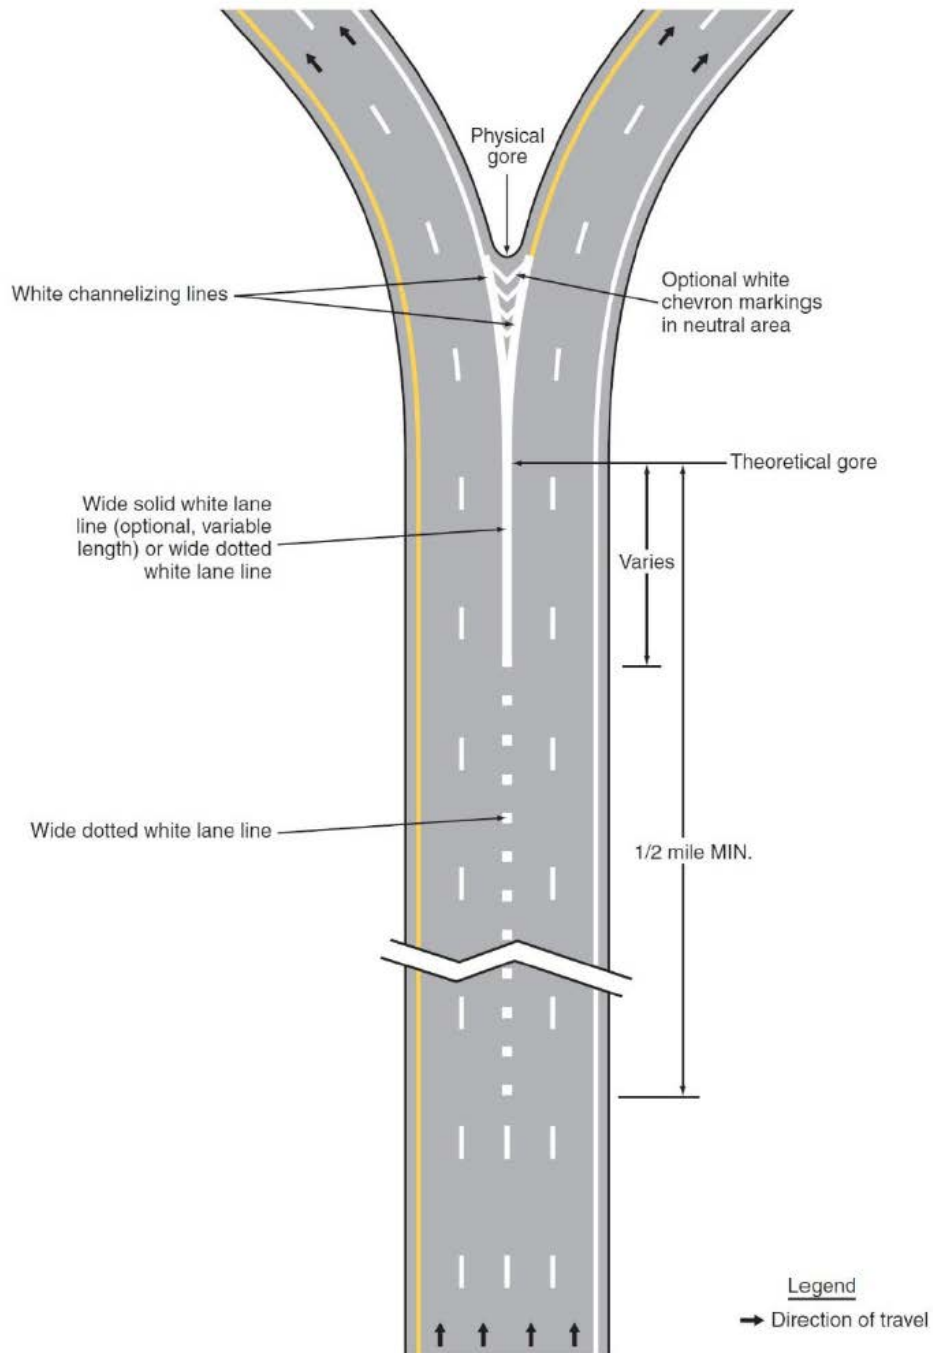
Figure 3A – This graphic is from the FHWA *MUTCD*. The wide dotted white lane lines (lane drop markings) began 910 feet from the beginning of the theoretical gore. Additionally, the optional white chevrons shown were not present at the crash site.

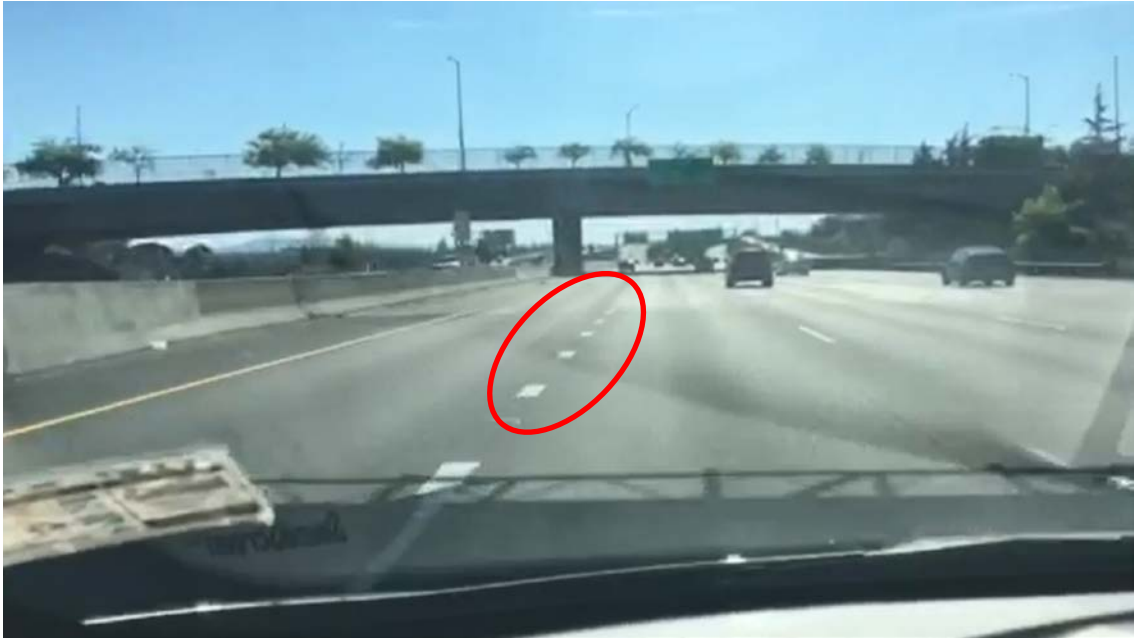
Figure 3B – Still image from video drive through at 1,540 feet from crash cushion. 8-inch wide lane drop markings (circled in red) separating the two left HOV lanes begin at this location.

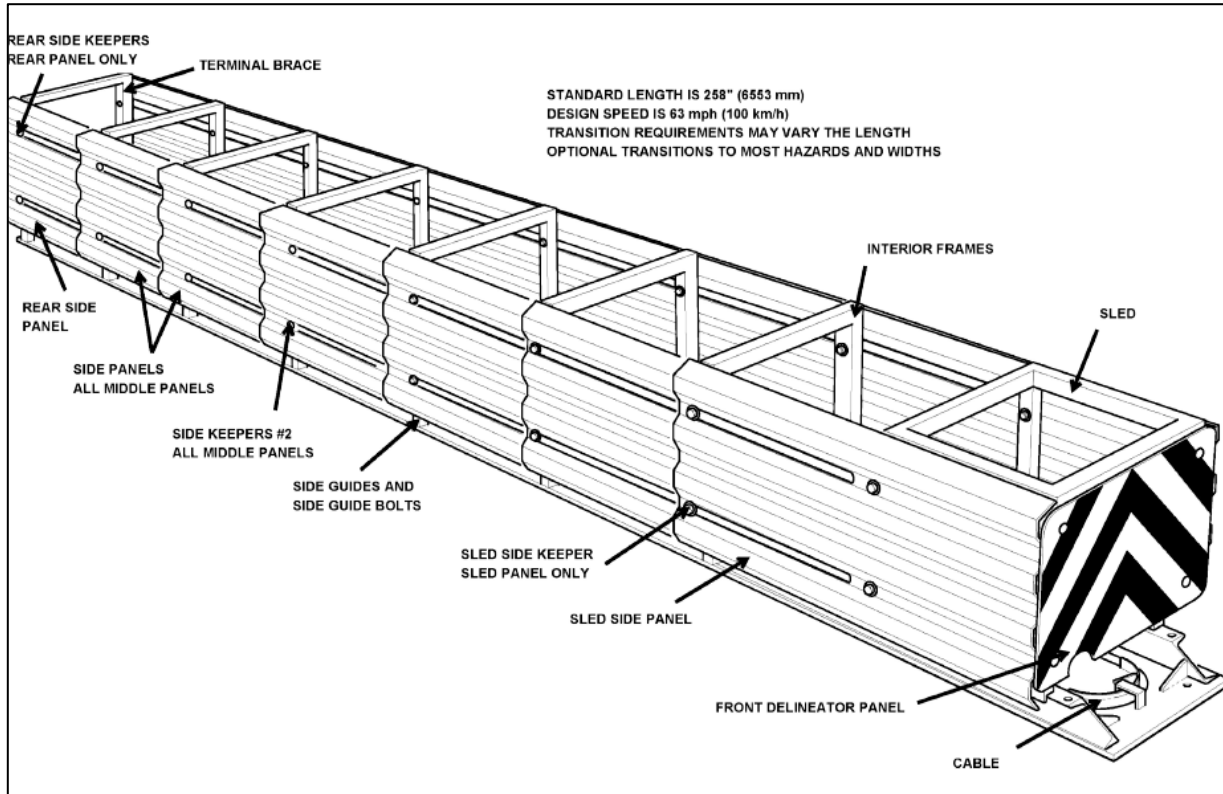
Figure 6A – Diagram depicting the components of the SCI SmartCushion® SCI100GM crash cushion.

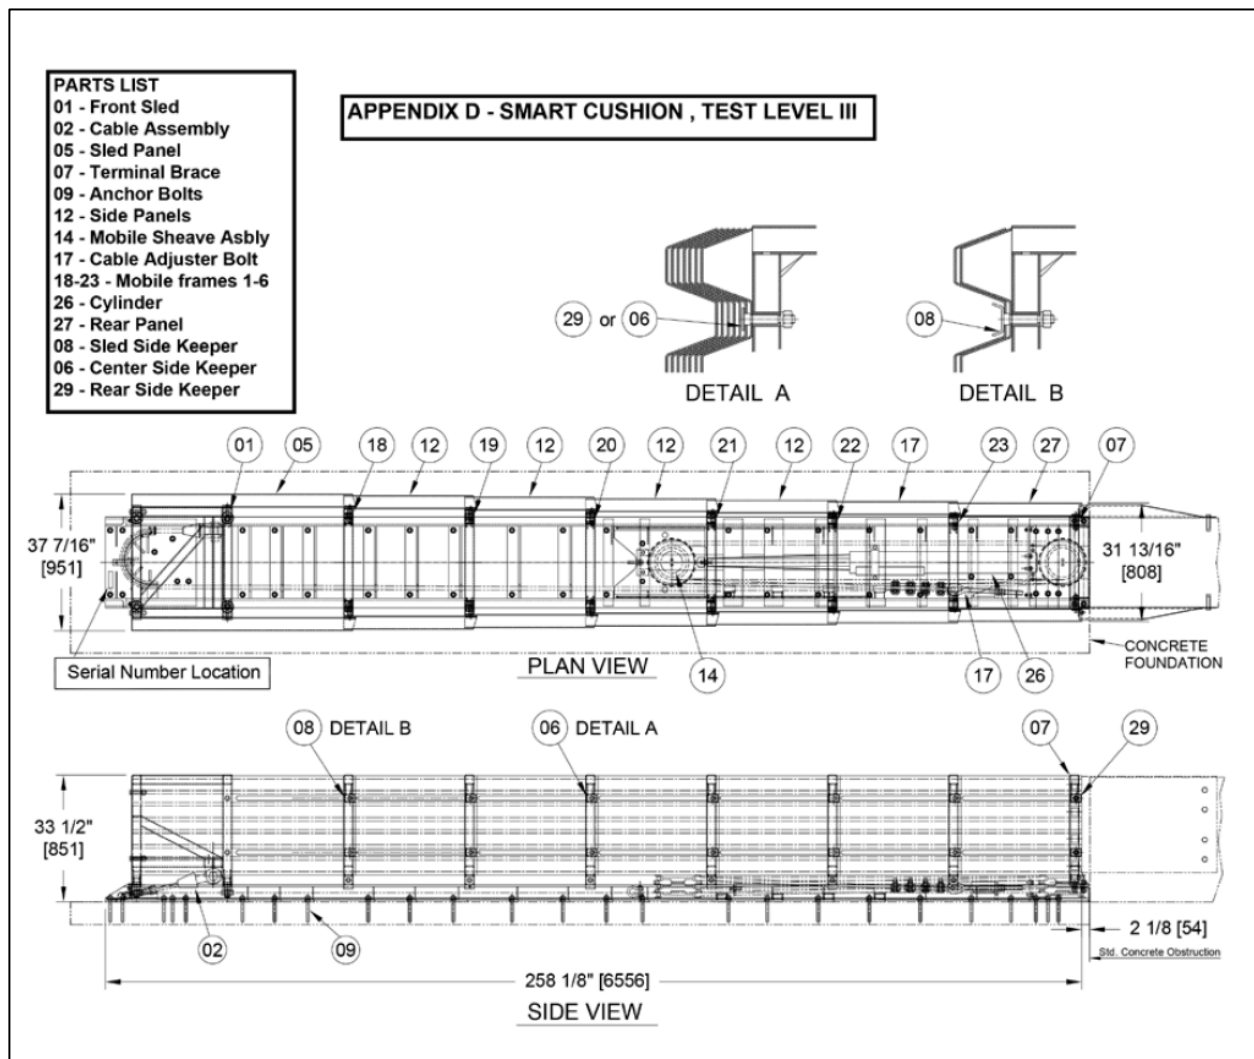
Figure 6B – Plan and side view schematic diagrams of the SCI SmartCushion® SCII00GM crash cushion.
