NATIONAL TRANSPORTATION SAFETY BOARD

2022

SAFER SEAS Digest

Lessons Learned from
Marine Investigations

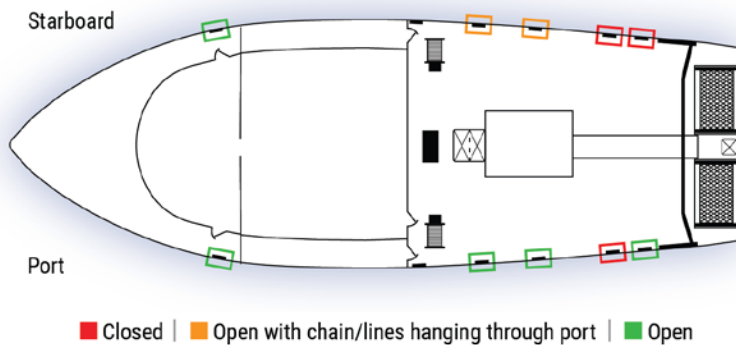
Figure 6. Status of *Emmy Rose* freeing ports during ROV survey.

We found that at the time of the sinking, the *Emmy Rose*'s freeing ports did not meet regulatory requirements for freeing port area and freeing port cover design, thus making the vessel more susceptible to accumulating water on deck. Additionally, we found that the vessel's lazarette hatch had a nonwatertight cover that had no securing mechanism, which meant the *Emmy Rose* was not being operated in accordance with its stability instructions and fishing vessel regulations, and water likely began flooding the vessel through the hatch that was likely opened by the sloshing seawater on the stern. As a result, we **recommended** that the Coast Guard increase the scope of commercial fishing vessel safety examinations to include inspections of freeing port covers and hatch covers.

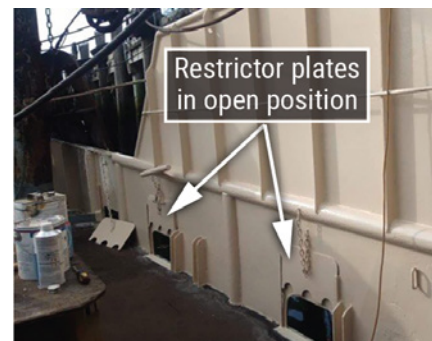
Figure 7. Freeing ports on portside bulwarks.

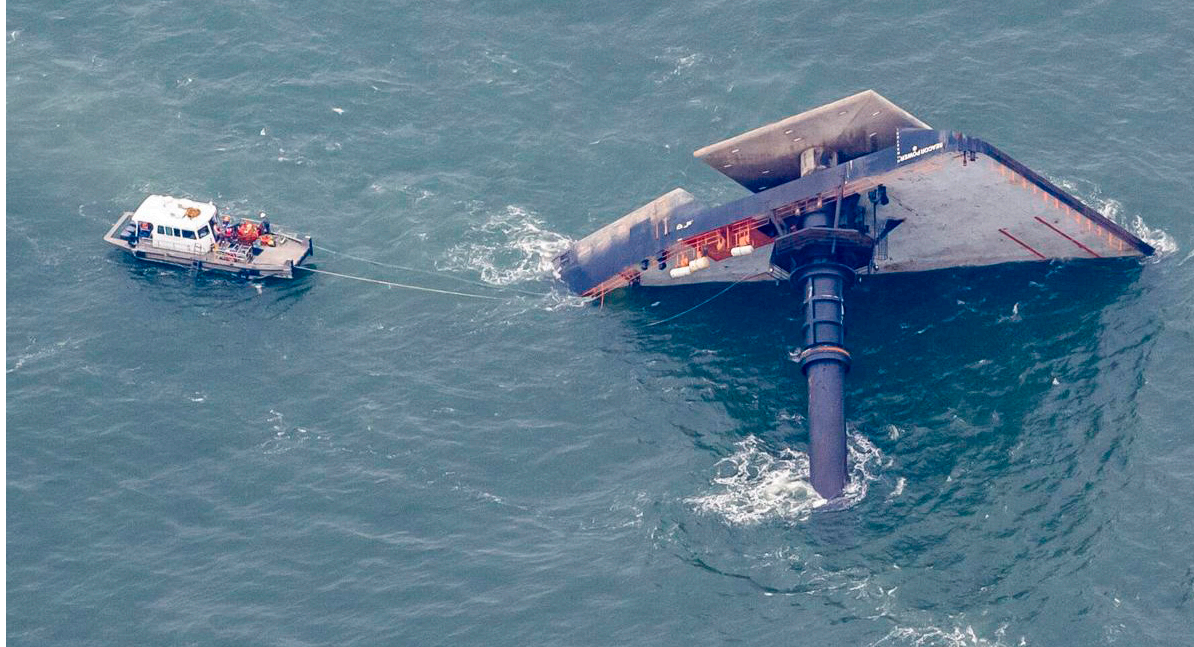
Figure 10. *SEACOR Power* after capsizing in the Gulf of Mexico when struck by severe thunderstorm winds.

THE PROBABLE CAUSE of the capsizing of the liftboat *SEACOR Power* was a loss of stability that occurred when the vessel was struck by severe thunderstorm winds, which exceeded the vessel's operational wind speed limits. Contributing to the loss of life on the vessel were the speed at which the vessel capsized and the angle at which it came to rest, which made egress difficult, and the high winds and seas in the aftermath of the capsizing, which hampered rescue efforts.

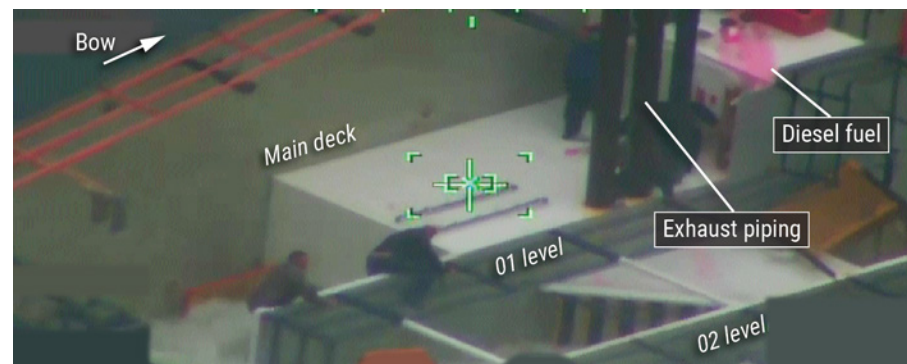
Figure 13. Left: Port side of the capsized hull about 1755. Some personnel are visible.

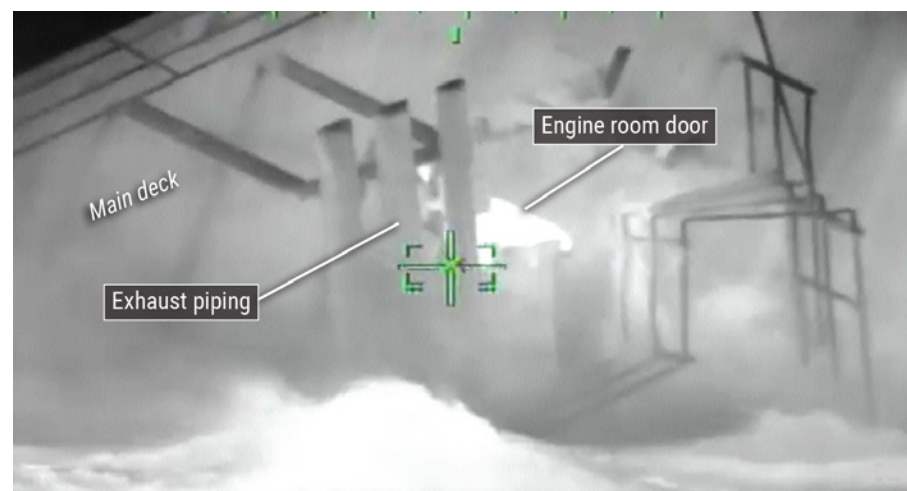
Figure 14. Door to engine room as it was opened at 2153, as seen by the Glen Harris.

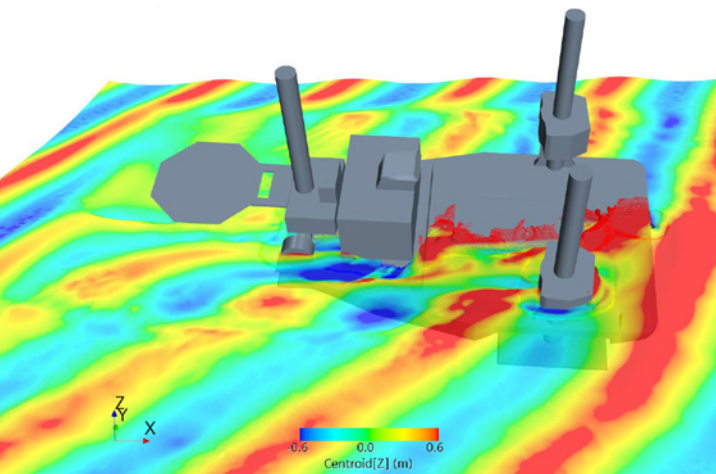
Figure 15. Illustration of the computational fluid dynamics model simulating the effect of wind gusts with swells. Colors indicate wave height, with blues in low areas and reds in high areas. The vessel capsized in the simulation.

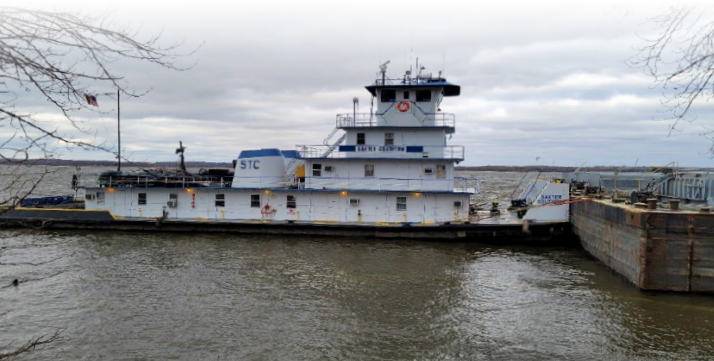
Figure 19. The *Baxter Southern* after the casualty.

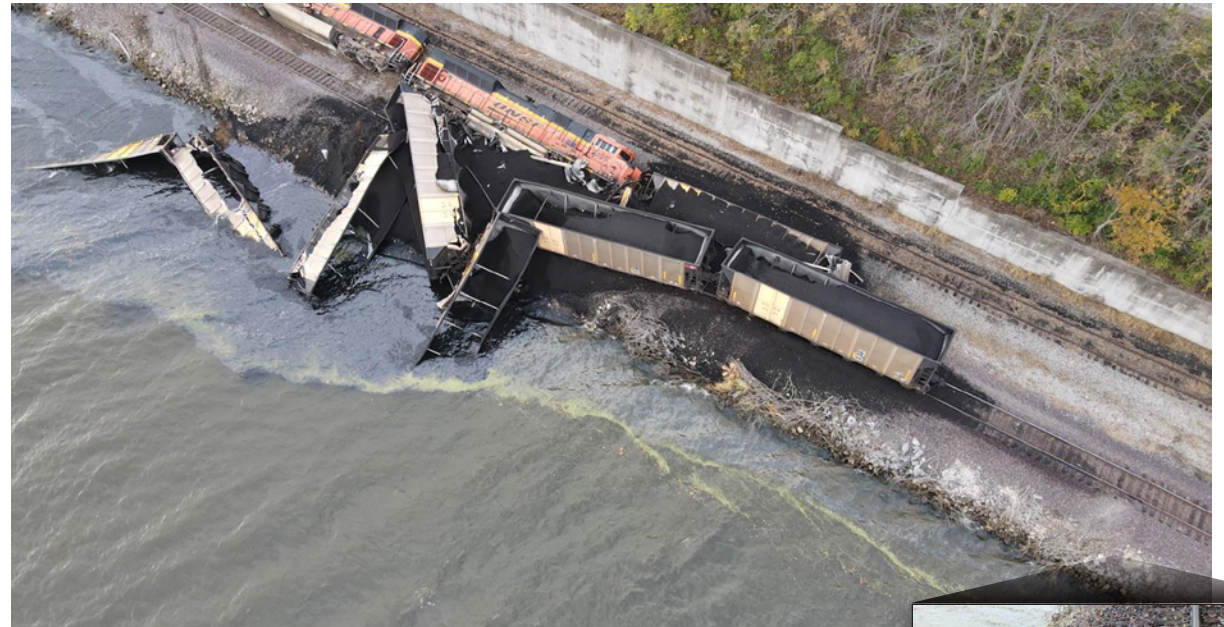
Figure 20. Drone view of the postcollision derailment of the two locomotives and eight hopper cars. Two additional hopper cars are submerged in the river. SOURCE: BNSF
Inset: Location and close-up of the indentation from the forwardmost barge *STC 3020* in the shoreline next to the railroad track. SOURCE: COAST GUARD

On November 13, 2021, about 2343 local time, the towing vessel *Baxter Southern* had pushed its tow of four empty barges against the shoreline of the Upper Mississippi River at mile 372 near Galland, Iowa, when a BNSF coal train transiting the track along the shoreline struck the bow rake of a forward barge that was overhanging the railroad track. Two locomotives and ten hopper cars (loaded with coal) derailed, and six of the derailed hopper cars entered the river. A sheen was observed in the river following the derailment. The two train personnel sustained minor injuries. Damages to the locomotive and freight cars were estimated at \$1.9 million. The barge sustained minor scrapes.

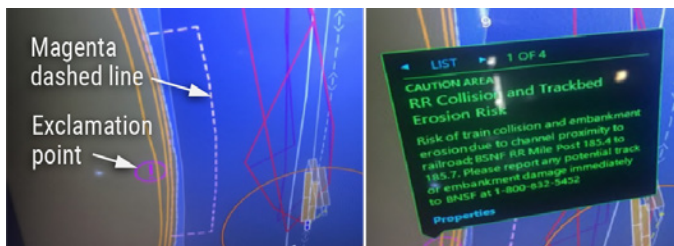
Neither the pilot nor the captain queried (cursor-picked) the exclamation point near the area on the ECS to gather further information related to the dashed magenta line. Thus, they missed the cautionary information that stated the area presented a “Railroad Collision and Trackbed Erosion Risk.” Had they queried and read the associated information on the ECS, they likely would have realized the risk of pushing up against the riverbank in the caution area and may have sought another location to push up. Additionally, the captain and pilot each had over 20 years of experience on the Mississippi River and had extensively used the ECS over the last several years and completed training in its operation and interpreting its information. They should have been familiar with the magenta dashed line identifying the caution area and how to query the chart to see additional information about marked areas.

Figure 21. *Baxter Southern* Rose Point in nighttime display showing the area marked by the magenta dashed line and exclamation point (left, annotated by NTSB) and information contained in the corresponding caution note (right). SOURCE: SOUTHERN TOWING COMPANY

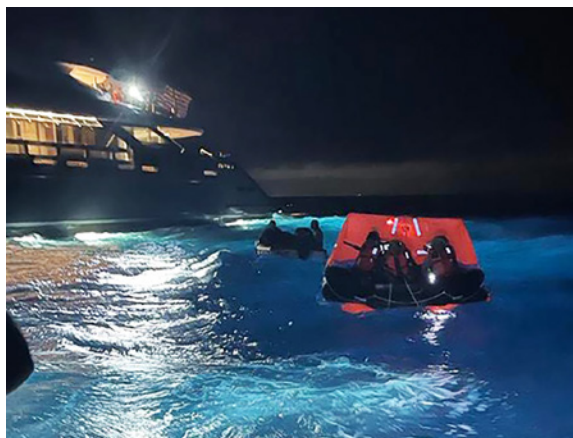
Figure 30. *Tropic Breeze* crew wearing lifejackets in the liferaft and rescue boat before rescue. The *Utopia IV* is in the background. SOURCE: AMARA

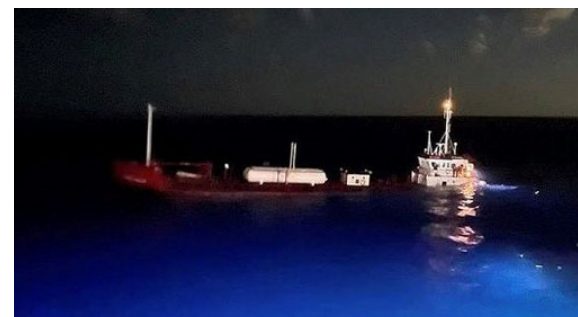
Figure 31. *Tropic Breeze* sinking by its stern about 15 minutes after the collision. SOURCE: AMARA

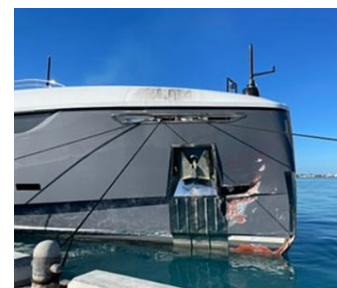
Figure 32. Damage to *Utopia IV*'s bow. SOURCE: COAST GUARD

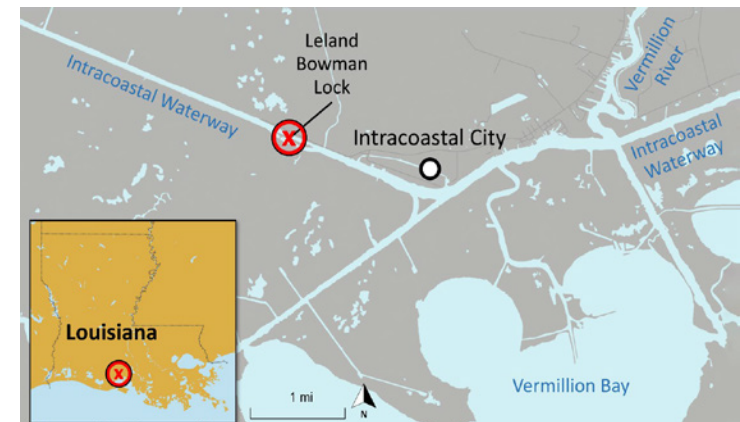
Figure 35. Area where the *Ava Claire* tow contacted the Leland Bowman Lock gate, as indicated by the red X.

When the tow was about 200 feet from the gates, the captain put the engines at full astern. The tow continued to slow but did not fully stop before the starboard bow of the *HFL 439* struck gate no. 3 on the northwest side of the lock at 0522. The tow's speed when it contacted the gate was 1.2 mph.

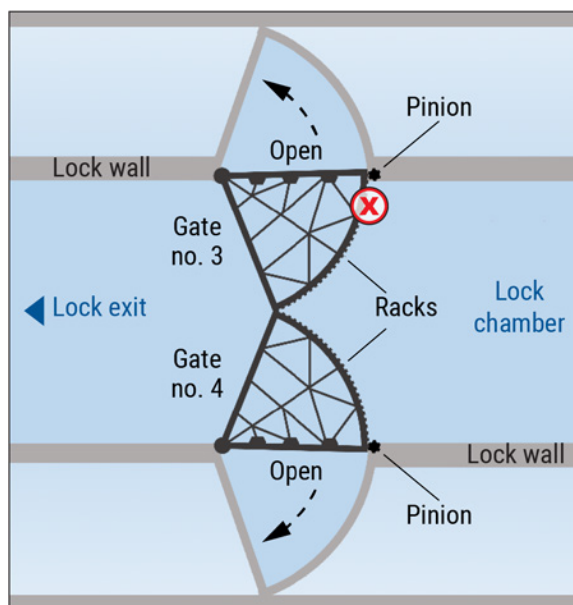
Figure 37. Left: Simplified illustration of Leland Bowman Lock western gates showing the point of contact by barge *HFL 439*, as indicated by the red X.

Figure 38. Below: Damaged steel plating and rack on gate.

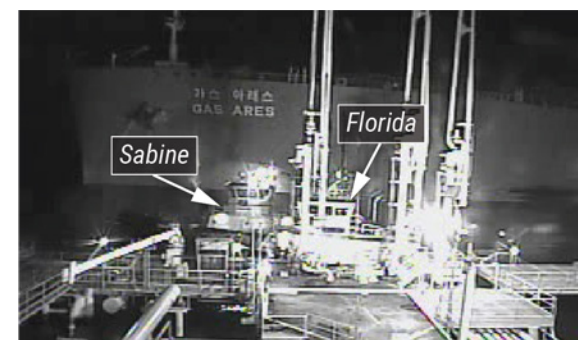
Figure 43. Image recording system views from the Motiva no. 1 dock seconds after the *Gas Ares* collided with the *Sabine*, which broke from its moorings.

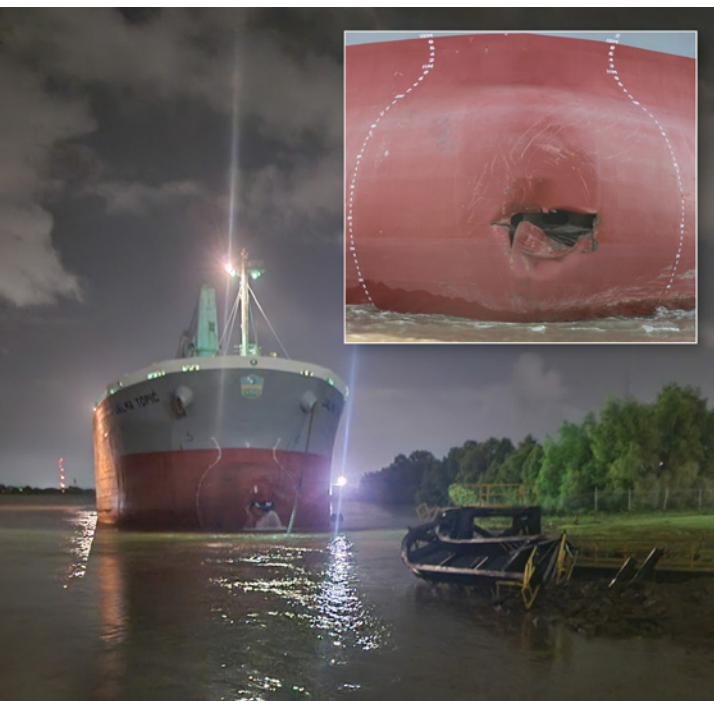
Figure 45. Postcasualty damage to office barge moorings, catwalks, and gangways.

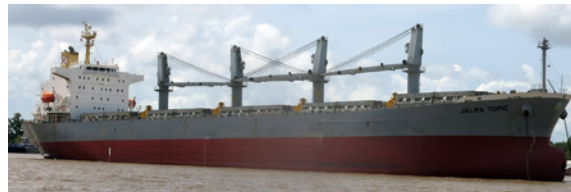
Figure 46. *Jalma Topic* at anchor after the contact.

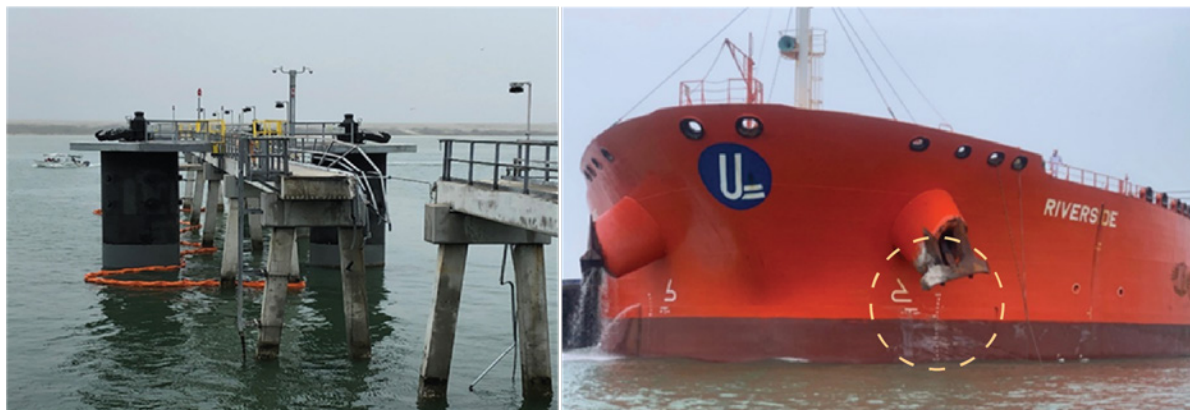
Figure 58. Damage to the no. 4 Moda dock catwalk (left) and the *Riverside* (right, circled). SOURCE: COAST GUARD

The captain informed pilot 2 that they had "lost the engine." Pilot 2 contacted a nearby tug, *Honor*, which pushed against the *Riverside*'s port bow and affected the vessel's direction back toward the channel. Pilot 2 ordered dead slow astern, and the chief engineer tried to start the engine astern locally, but it failed to start. At 1302, the *Riverside*'s port bow struck the mooring dolphin and catwalk at the end of the no. 4 Moda dock at 5 knots.

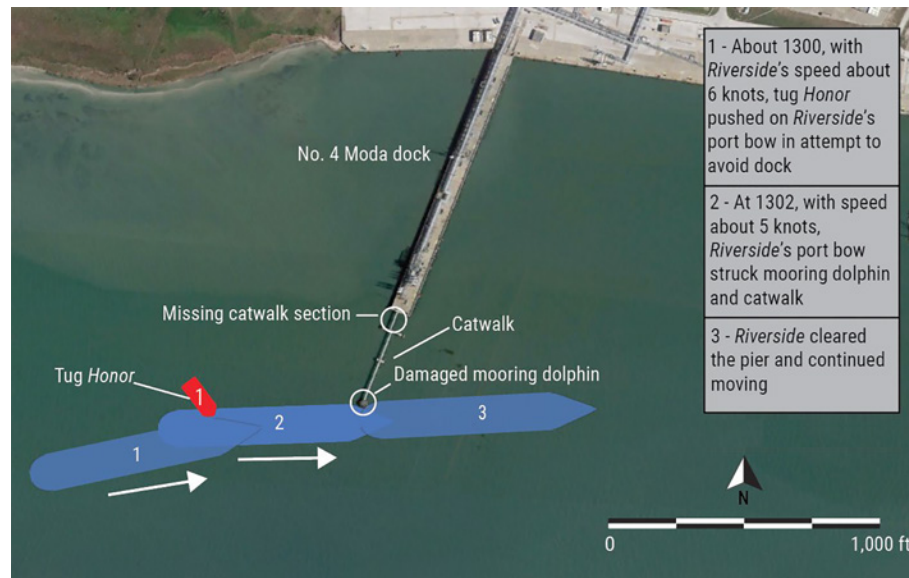
Figure 60. Final events surrounding the *Riverside*'s contact with the no. 4 Moda dock.

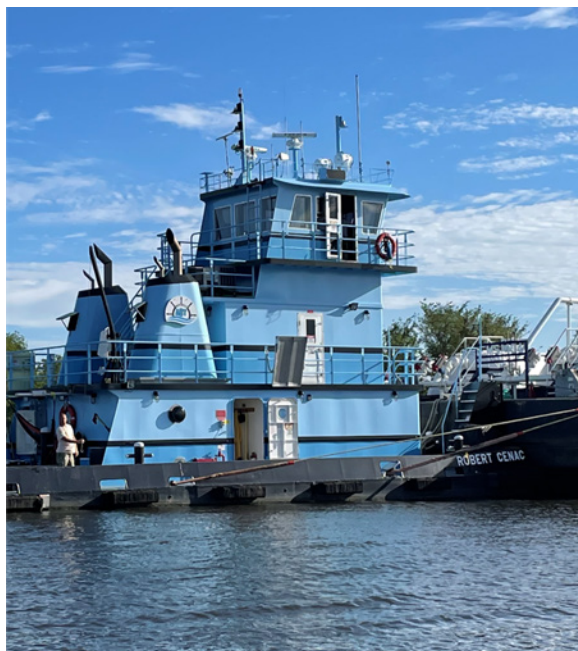
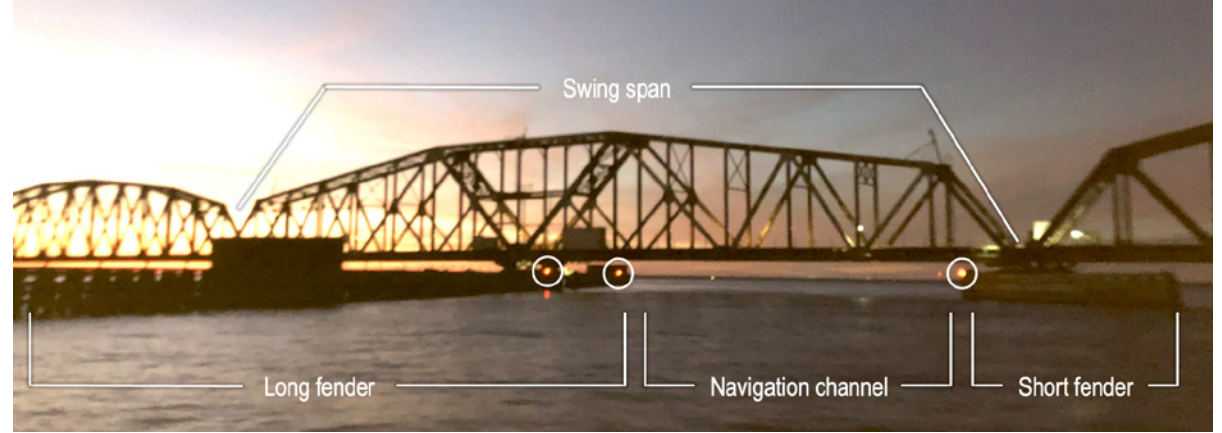
Figure 62. January 29, 2021, post-casualty photo of the Rigolets Bridge (*in the closed position*), as it would have been approached from the south, heading north. Red navigation lights on the long and short fenders are circled. Note there are no navigation lights at the top of and each end of the swing span, and there are no red navigation lights at either end of the short or long fenders, nor anywhere on the south side of the bridge on the short or long fenders.

The captain and pilot stated it was difficult to see the channel through the bridge fenders, and investigators determined that required navigation lights were not located at the fender ends. Investigators also found that the swing span was not fitted with any navigation lighting, as required by regulation, to indicate that it was in the open or closed position. Had the swing span been lighted as required, the captain would likely have been able to visually determine the position of the swing span throughout its opening sequence.

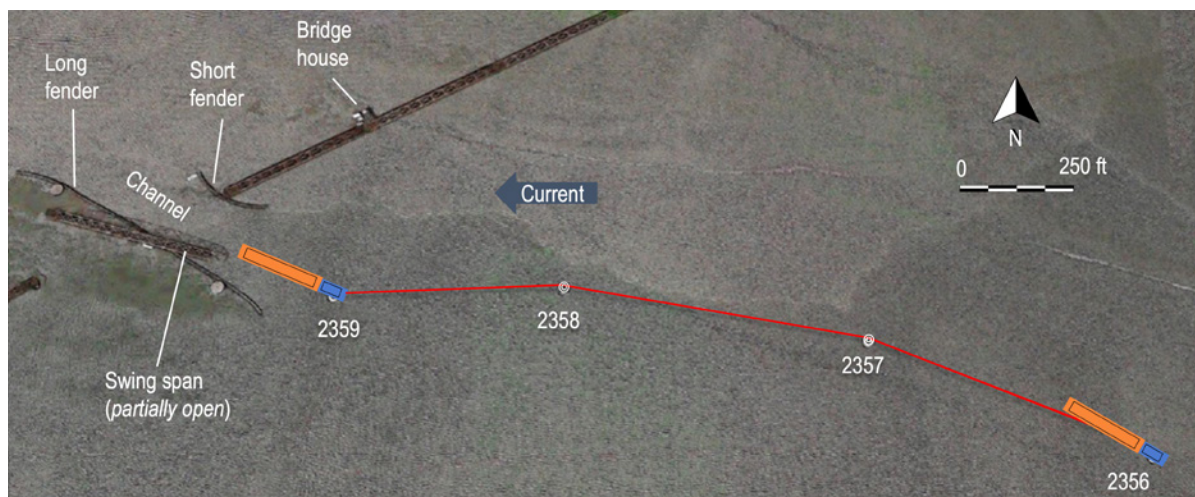
Figure 63. (Above) Trackline of the *Robert Cenac*, based on AIS course over ground data and the approximate position of the tow upon its contact with the Rigolets Bridge. Bridge position in the photo is about three-quarters of the way open. Tow headings are estimated. BACKGROUND SOURCE: GOOGLE EARTH

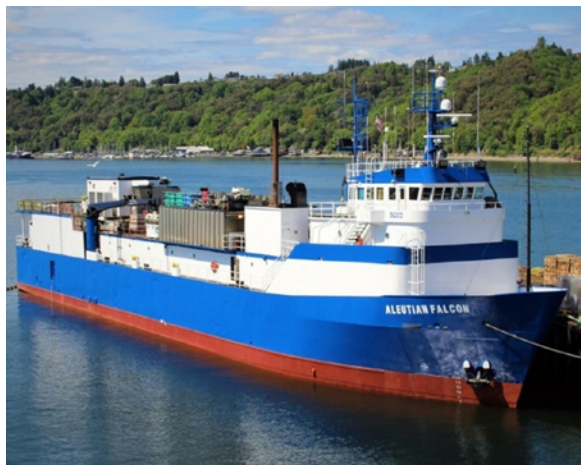
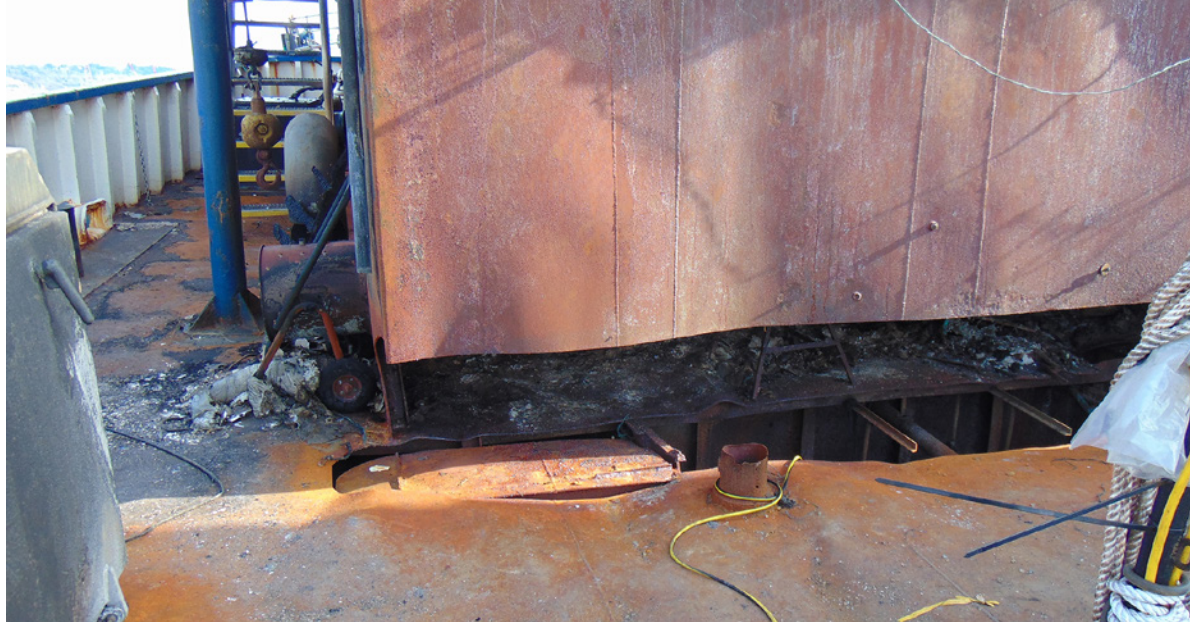
Figure 66. *Aleutian Falcon* bridge deck post-fire, depicting hot work area on the day of the casualty.

On February 17, 2021, workers planned to continue ongoing hot work by removing corroded steel deck plating located on the bridge deck above the pantry, dry stores area, and walk-in refrigerator. Because the work was in an area that adjoined foam insulation below, a marine chemist had previously been brought

THE PROBABLE CAUSE of the fire aboard the fish processor *Aleutian Falcon* was the company's supervisory personnel inadequately planning for hot work, as well as shoreside workers' inadequately protecting hot work areas, allowing slag from hot work to ignite combustible material near an insulated wooden bulkhead of a walk-in refrigerator that had not been removed or sufficiently protected. Contributing to the casualty was the ineffective communication between the supervisory personnel, marine chemist, and workers.

LESSON LEARNED: Preparing for Hot Work
It is critical for supervisory personnel to evaluate hot work areas for fire hazards to ensure that affected spaces are completely understood, prepared, and protected for planned hot work in accordance with regulatory guidelines, company policies, and marine chemist certificates. Adherence to proper policies and procedures is vital to completing a safe hot work operation. Additionally, crewmembers and personnel involved in hot work should be able to identify hazards and take action to remove or mitigate potential risks to the vessel.

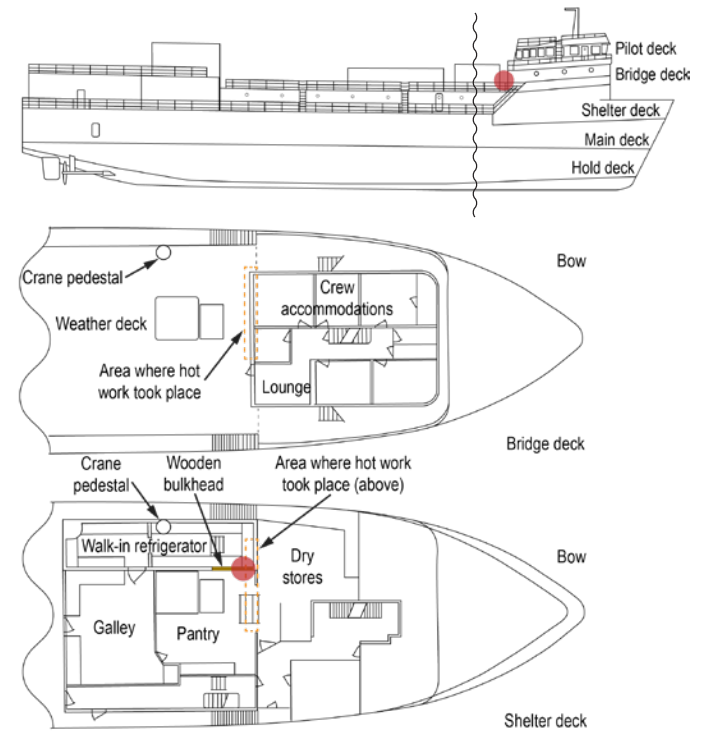
Figure 67. Profile (top) and bridge and shelter deck arrangements (bottom) of *Aleutian Falcon*. The area where the fire began on the shelter deck is indicated by a red circle. The area of the bridge deck where the deck was being cut is highlighted with orange dashed lines.

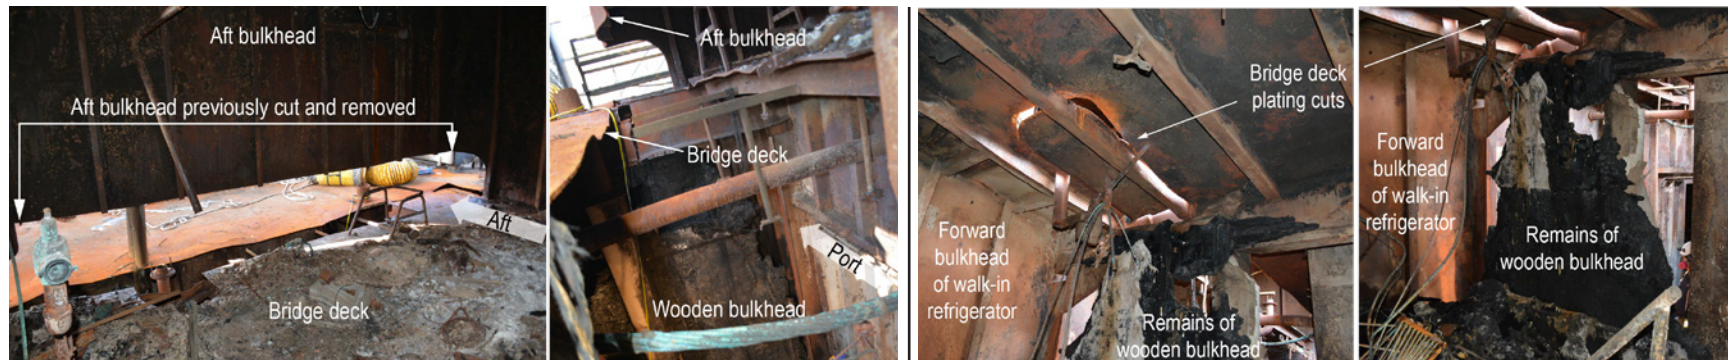
Figure 68. *Aleutian Falcon* post-fire, depicting hot work area on the day of the casualty. The bridge deck (left two photos) and forward end of walk-in refrigerator on the shelter deck (right two photos).

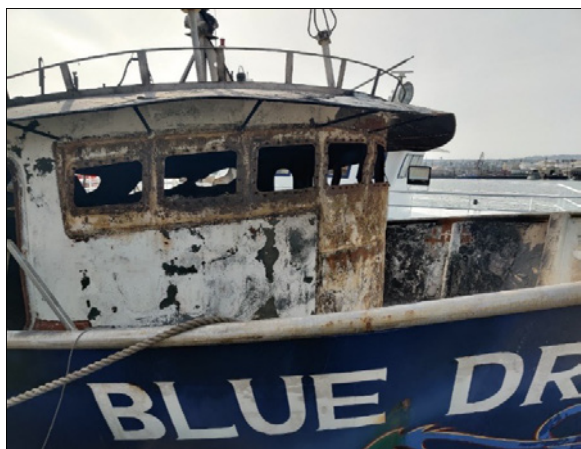
Figure 73. *Blue Dragon* wheelhouse exterior (top) and interior looking forward (bottom), following the fire. The framing of the false deck below indicates the location of what was the wheelhouse deck. SOURCE: COAST GUARD

THE PROBABLE CAUSE of the fire aboard the fishing vessel *Blue Dragon* was from an unknown source, likely electrical in nature, which ignited the wooden wheelhouse console. Contributing to the extent of the fire damage was the substantial use of combustible materials in the joinery, outfitting, and furnishings in the wheelhouse and accommodation spaces.

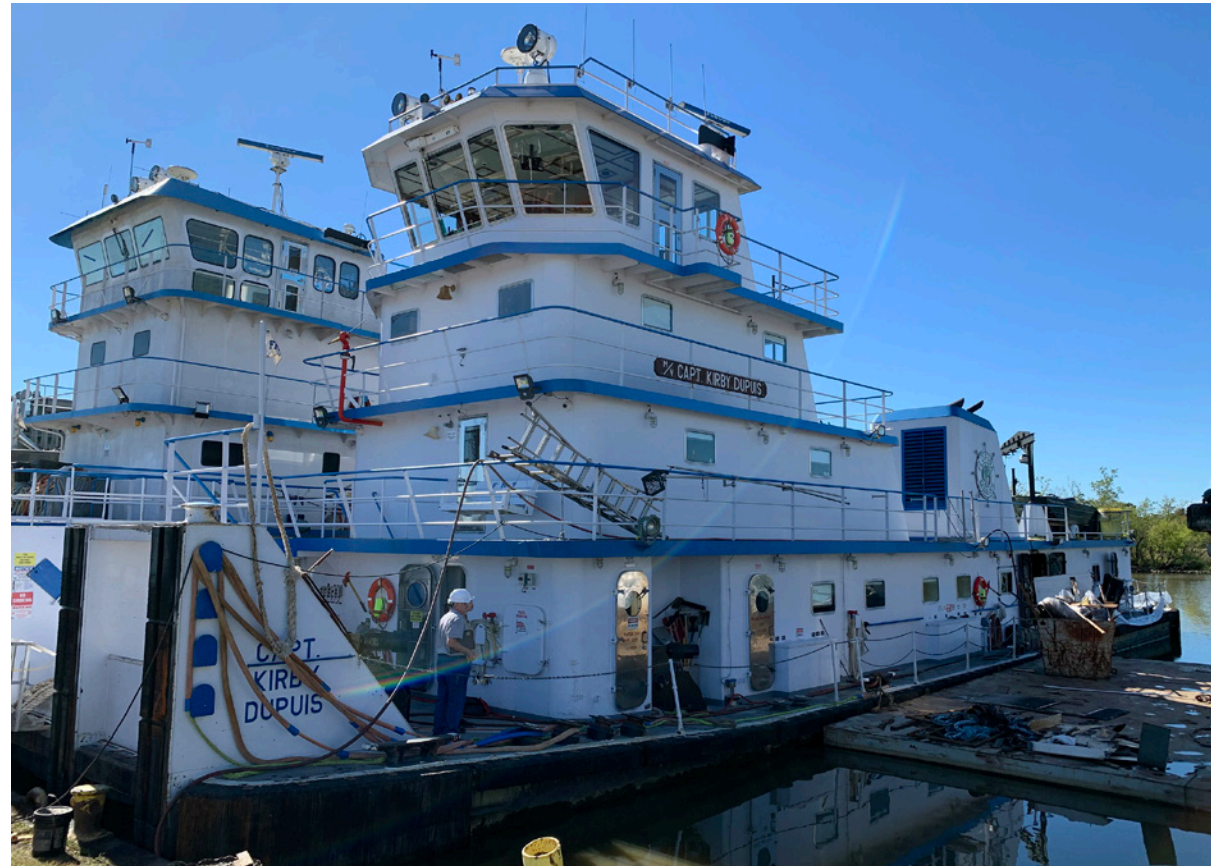
Figure 76. *Capt. Kirby Dupuis* docked following the casualty.

Post-casualty, a service manager from Louisiana Cat (Caterpillar) determined that a broken O-ring was missing from a lube oil tube on the port engine. The tube was also missing a retaining ring and supporting hardware. A sheared bolt indicated that the supporting clips and hardware had originally been installed on the engine but had failed at some point. Without the clips and hardware, the tube was unsupported and more susceptible to vibration and associated movement. It is unknown how long the engine had been operating without the retaining ring, supporting clips, and hardware on the lube oil tube. The technician concluded that the cause of the fire was "a severe oil leak" that sprayed onto the exhaust manifold and ignited.

THE PROBABLE CAUSE of the engine room fire aboard the towing vessel *Capt. Kirby Dupuis* was a lube oil tube on the port main engine that vibrated out of a joint due to a missing retaining ring and mounting bracket, spraying pressurized oil that made contact with a hot exhaust surface and ignited. Contributing to the severity of the fire damage was the crew's unfamiliarity with activation procedures for the fixed fire-extinguishing system, which resulted in an unsuccessful attempt to release the fire suppression fluid and extinguish the fire.

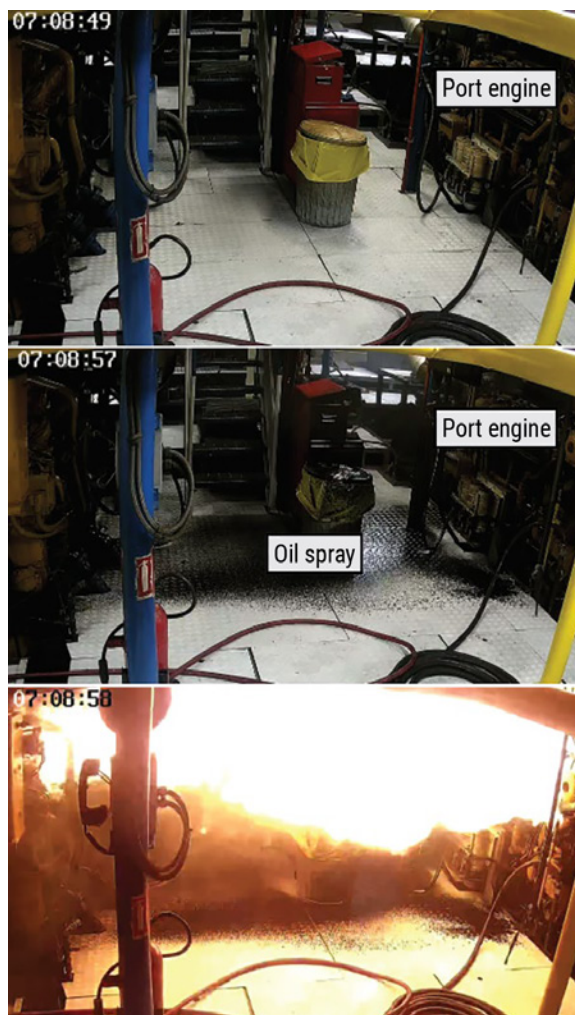
Figure 77. Screenshots from the *Capt. Kirby Dupuis* engine room video camera (looking aft).

However, investigators determined that the system was not activated during the fire. The deckineer did not hear the system's sirens nor product discharging into the engine room. After the fire, both suppression fluid cylinders were full, and the nitrogen pilot cylinder lever was found in the "set" position with its cylinder still fully charged.

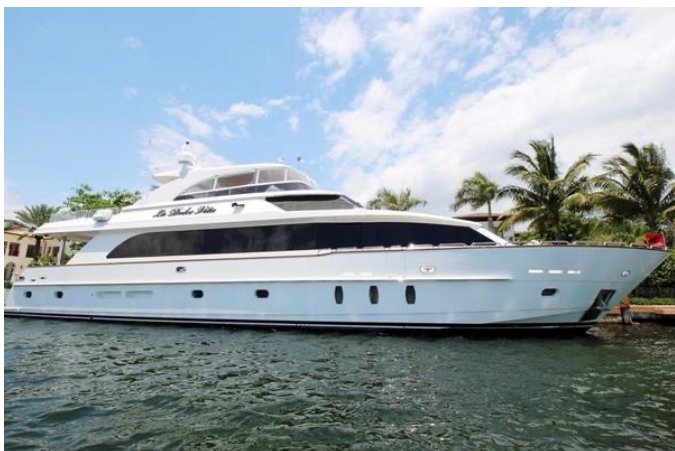
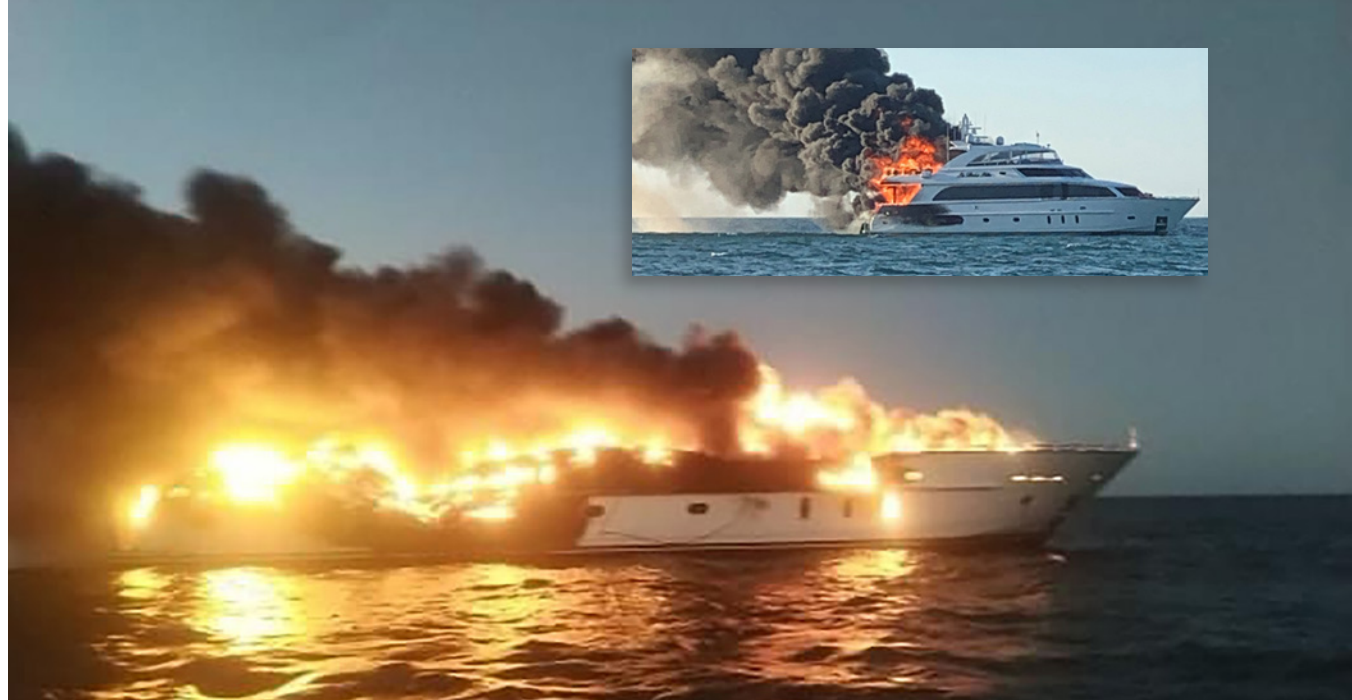
**Figure 79.** *La Dolce Vita* on fire shortly after passengers and crew abandoned the vessel (inset), and the yacht afire shortly after sunset on March 16. SOURCE: LINDSEY SCHULT, CAPTAIN OF *LA DOLCE VITA*

The captain's and mate's descriptions of the smoke and flames suggest that the fire may have originated in the electric generator end of the starboard genset enclosure. Per the generator's manual, it was dangerous to operate the generator for extended periods in an area of high humidity. It is possible that the engine room ventilation system, which drew air through vents (fitted with louvered moisture eliminators) in the side of the hull about 4.5 feet above the waterline, could have led to high humidity in the space. The generator manual also recommended inspections and maintenance to keep the unit free of oil, dust, and moisture. However, the vessel owners did not have documentation of any maintenance to the generator since its installation, so it is possible that loose, moist, or dusty connections went undetected.

THE PROBABLE CAUSE of the engine room fire aboard the yacht *La Dolce Vita* was an undetermined electrical source within the sound enclosure for the starboard generator. Contributing to the severity of the fire and total loss of the vessel was the inability to secure ventilation to the engine room, which reduced the effectiveness of the yacht's fire extinguishing system and allowed the fire to spread beyond the engine room.

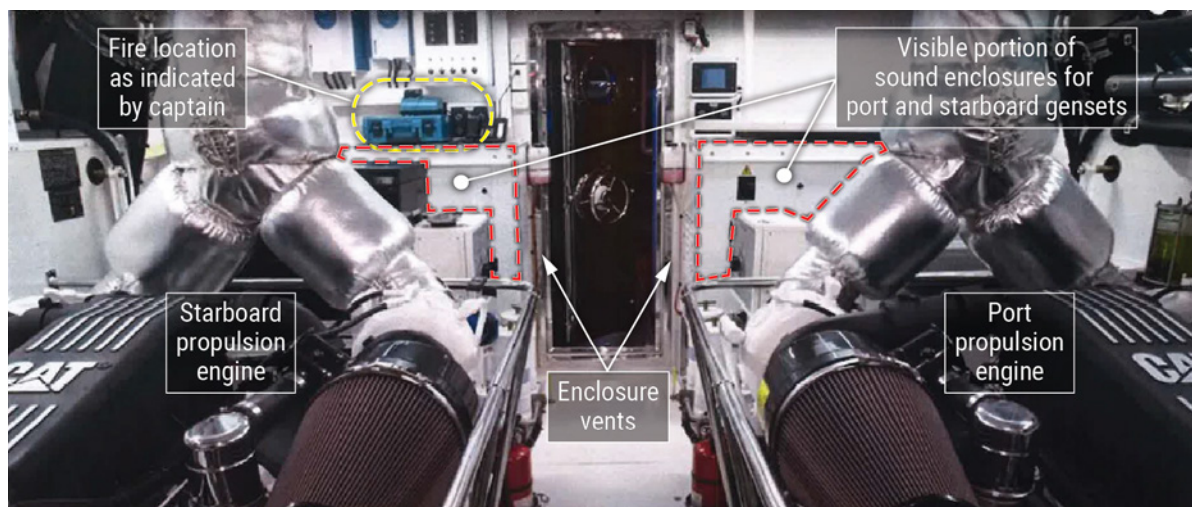
Although the captain activated the vessel's fixed fire-extinguishing system, the vessel continued to burn. Because the system worked by discharging a gas into the engine room, it required the closure of all doors and hatches before releasing the extinguishing agent. However, the only means to start or stop the engine room's intake and exhaust fans was located within the space, and the fans remained running until the captain secured the electrical generators. Further, the engine room vents did not have dampers to close off natural ventilation to the space. With no effective way to close all the openings (in this case the vents) before the release of the fire suppressant into the engine room, it is likely the air movement generated by the fire's draft introduced a continuous supply of oxygen into the engine room to feed the fire and hindered the fire-suppression gas from effectively stopping the fire. Under the Cayman Islands Shipping Registry, a vessel of *La Dolce Vita's* size certified for commercial use would have been required to meet certain regulatory requirements, including having a way to remotely stop the engine room's intake and exhaust fans and the capability to close off natural ventilation to the space.

Figure 81. View of *King Baby* (later renamed *La Dolce Vita*) engine room space looking aft toward the engine room door, 2009. BACKGROUND SOURCE: CAYMAN ISLANDS SHIPPING REGISTRY

Fixed fire-extinguishing systems in machinery and other hazardous spaces require a minimum concentration of extinguishing agent to either halt the chemical reaction producing the fire, displace the oxygen feeding the fire, or effect a combination of both. To ensure the effectiveness of the system and prevent the reintroduction of oxygen to the space, vessel designers and owners should ensure that the ventilation, both natural and forced draft, can be completely and remotely secured to all fire-protected spaces, and that all machinery within these same fire-protected spaces can be remotely stopped from outside the space where the machinery is situated.

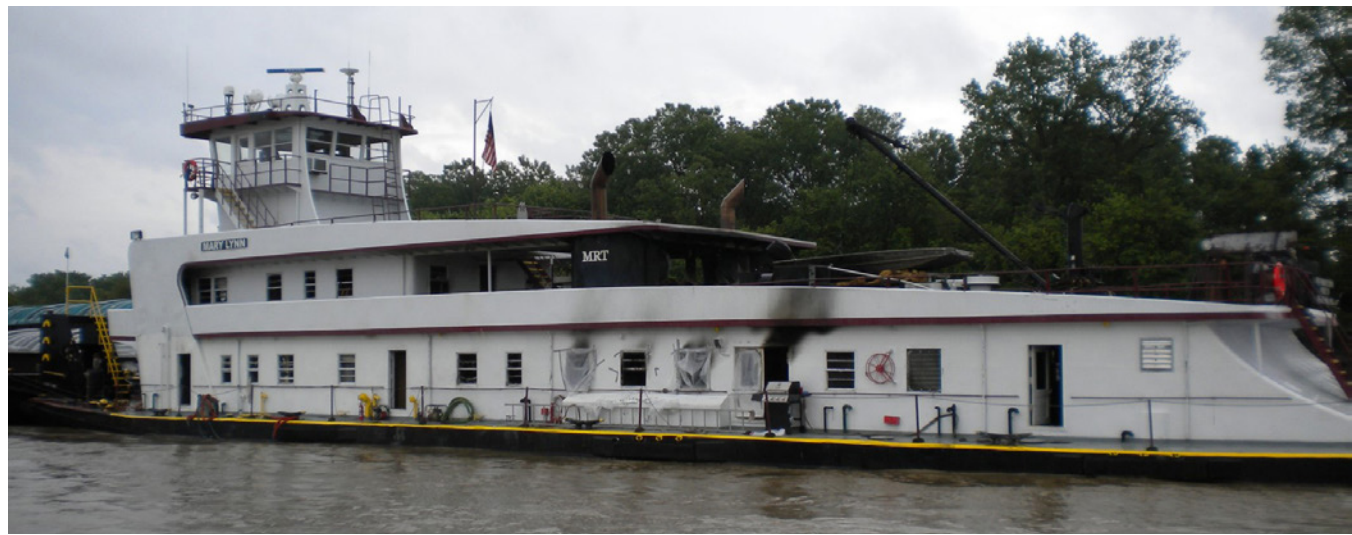
Figure 83. *Mary Lynn*'s port side, postcasualty, with some of the plastic window coverings remaining over the engine room windows. SOURCE: COAST GUARD

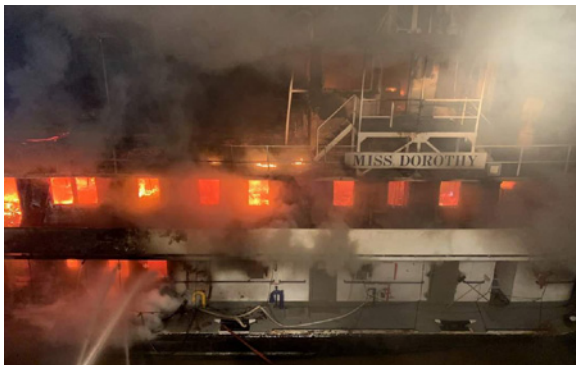
Figure 88. Starboard side of the *Miss Dorothy* during firefighting efforts from a Good Samaritan vessel.

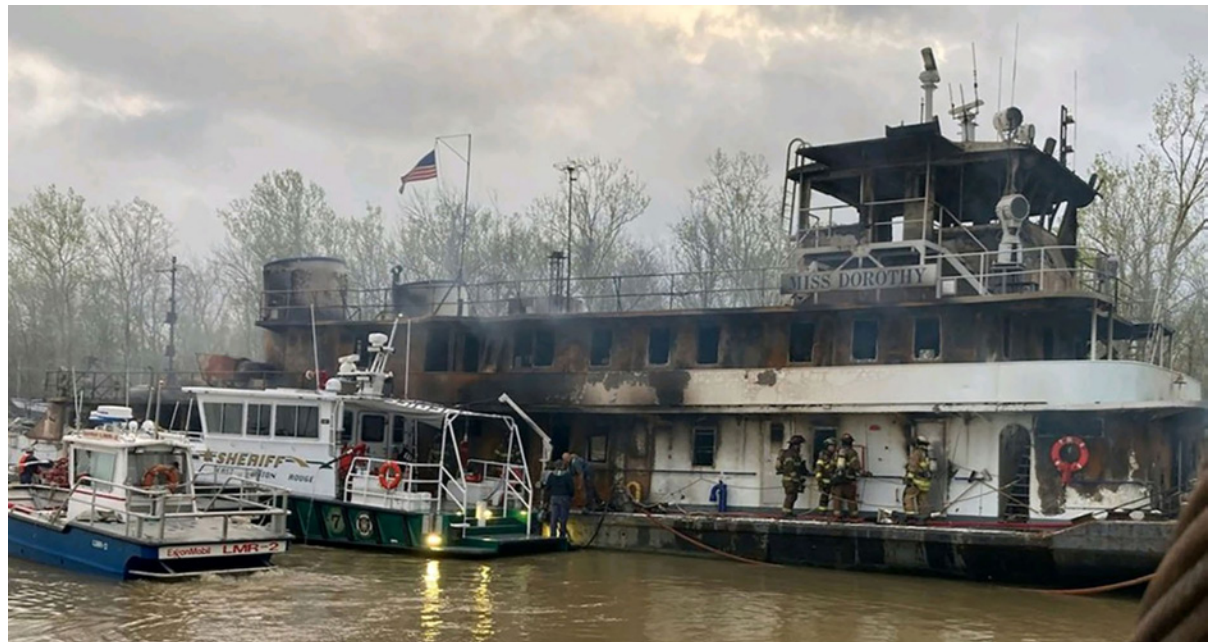
Figure 89. East Baton Rouge Sheriff's Office and ExxonMobil fire boats alongside the burned-out *Miss Dorothy* after the fire had been extinguished. SOURCE: WESTERN RIVERS BOAT MANAGEMENT INC.

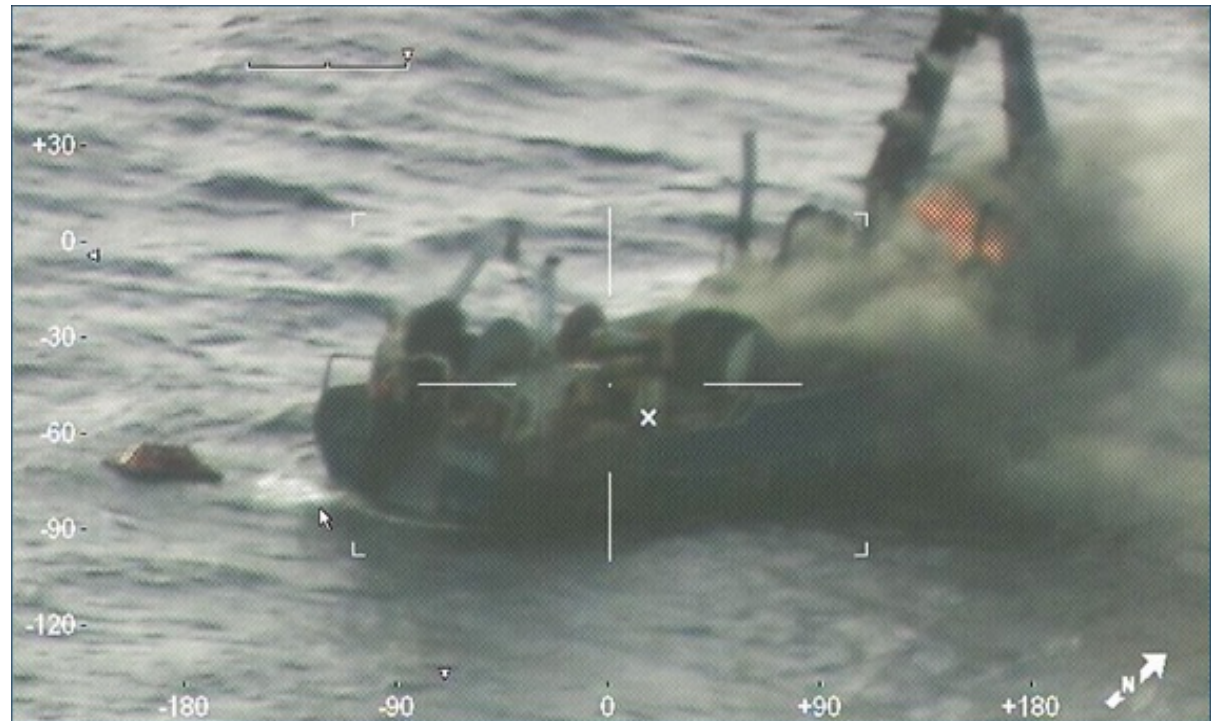
Figure 93. Photo taken from the Coast Guard HC-144 aircraft at 1827 shows the bow of the *Nobska* on fire before the rescue. The deployed liferaft appears on the left. SOURCE: COAST GUARD

THE PROBABLE CAUSE of the fire aboard the fishing vessel *Nobska* was a failure of a hydraulic hose within the engine room that allowed hydraulic fluid to spray onto a hot surface, likely the exposed main engine exhaust pipe. Contributing to the failure of the hydraulic hose was possible heat damage from a fire that occurred earlier in the day.

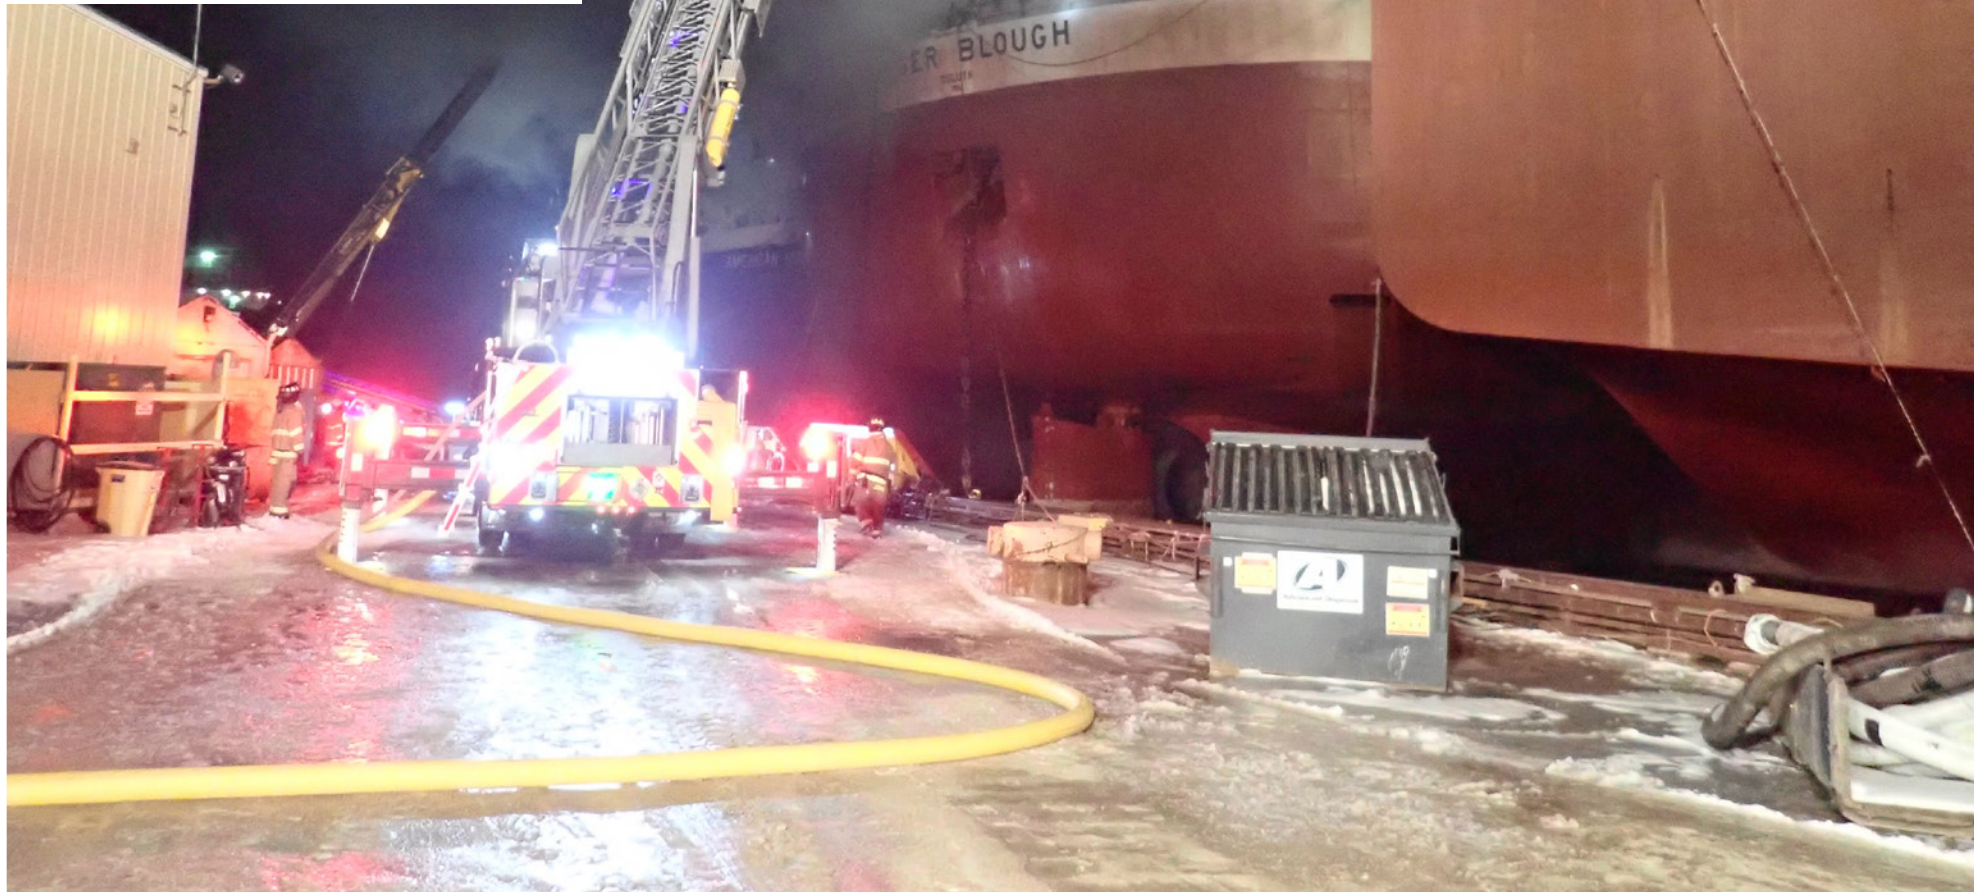
Figure 99. Stern of the *Roger Blough* during firefighting efforts. SOURCE: COAST GUARD
