NATIONAL TRANSPORTATION SAFETY BOARD

2022

SAFER SEAS Digest

Lessons Learned from
Marine Investigations

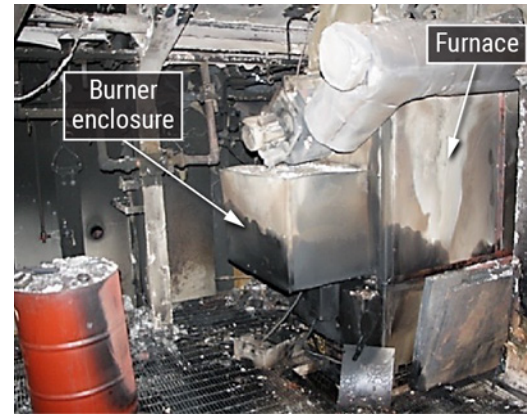
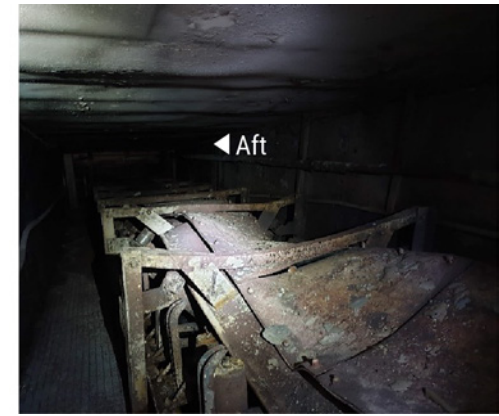
THE PROBABLE CAUSE of the engine room fire aboard the bulk carrier *Roger Blough* was likely the repeated removal and reinstallation of the furnace's burner that led to the failure of its mounting coupling, resulting in the operating burner dropping to the bottom of its enclosure and fracturing its fuel supply line, which allowed diesel fuel to ignite. Contributing to the casualty was the absence of a fire-activated automatic fuel oil shutoff valve on the fuel oil inlet piping before the burner, which would have stopped the fuel feeding the fire shortly after it started and limited the spread of the fire.

Figure 104. Left to right: Fire-damaged furnace and conveyor belt within the conveyor belt trunk above the furnace. SOURCE: COAST GUARD

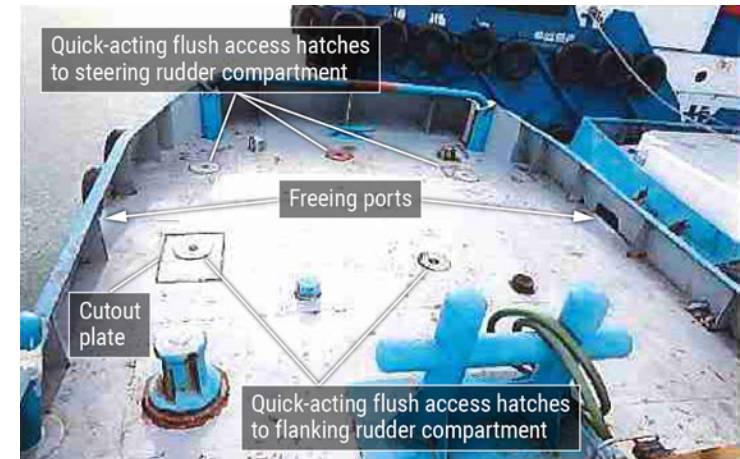
Figure 109. Main deck at the stern of the *Proassist III*.

Investigators found no structural hull defects that could have allowed for significant flooding; thus, the only other explanation would have been if a cover for one of the five aft main deck flush hatches were not in place. The crew told investigators that all deck hatches were closed when the vessel departed, but given the rate of flooding observed, at least one was likely not closed. With a reported 4–6 inches of water on deck, an open hatch would have allowed a significant amount of water to flood into the compartments below.

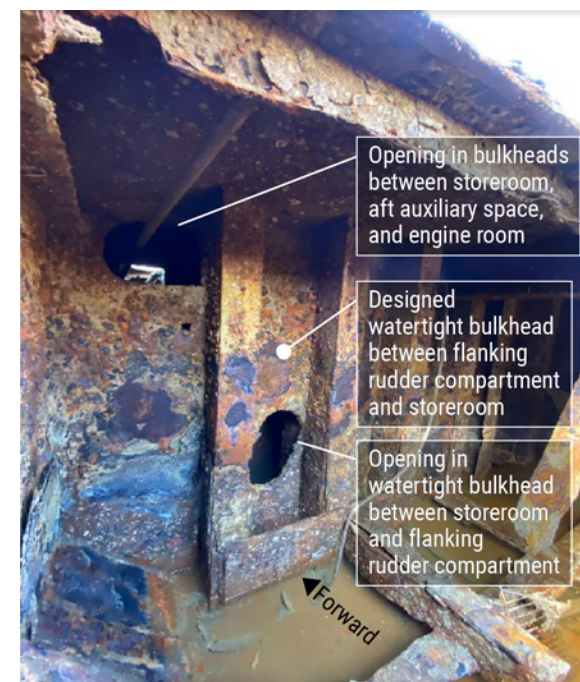
About 2.5 hours after departing, the crew noticed the vessel was down by the stern. They removed the flush access hatch to the flanking rudder compartment and found about 3 feet of water. A postcasualty examination of the vessel showed that portions of the transverse bulkhead between the flanking and steering rudder compartments were missing, and, therefore, the water that was found in the flanking rudder compartment would have also been in the steering rudder compartment at an equal level. Based on the approximate size of the two compartments, the volume of water accumulated in the spaces would have totaled roughly 36,500 gallons. Calculated from when the weather worsened, the average flooding rate would have been 304 gallons per minute.

The postcasualty examination also showed lack of gaskets and securing mechanisms for the deck hatches. The watertight and structural integrity deficiencies identified showed that the vessel was not adequately maintained. Additionally, after the casualty, hull and deck integrity issues were identified on three of the *Proassist III* owner's other vessels,

Figure 112. Flanking rudder compartment after recovery. Openings in bulkhead shown are also typical of other bulkheads below the main deck separating compartments. BACKGROUND SOURCE: COAST GUARD

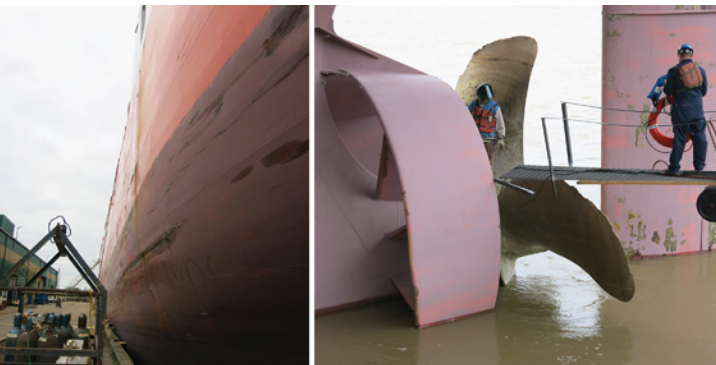
Figure 114. Below, left to right: Postcasualty damage to the *Bow Tribute*'s portside aft hull and propeller.

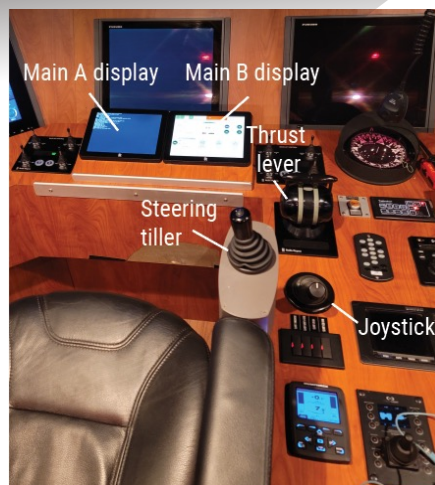
Figure 121. *Commodore's* main control station during postcasualty examination. Above: main A display screen's reboot failure (left) and the red failure log tab, red triangle over the port inner water jet icon, and the failure management pop-up screen on the main B display screen (right). Below: main control station's hand controls and water jet display screens.

The control system manufacturer concluded that a software problem led to a failed SD card for the touchscreen, causing a reboot failure, meaning that the touchscreen went blank and could not restart. This also resulted in the loss of the primary controls (thrust lever, joystick, and steering tiller) for the port hull's engines and water jets. The manufacturer later issued a service letter mandating that vessels with the same touch control system software receive an update.

The investigation found that the control system displays showed active failures for several days before the casualty. The vessel operating company's SMS

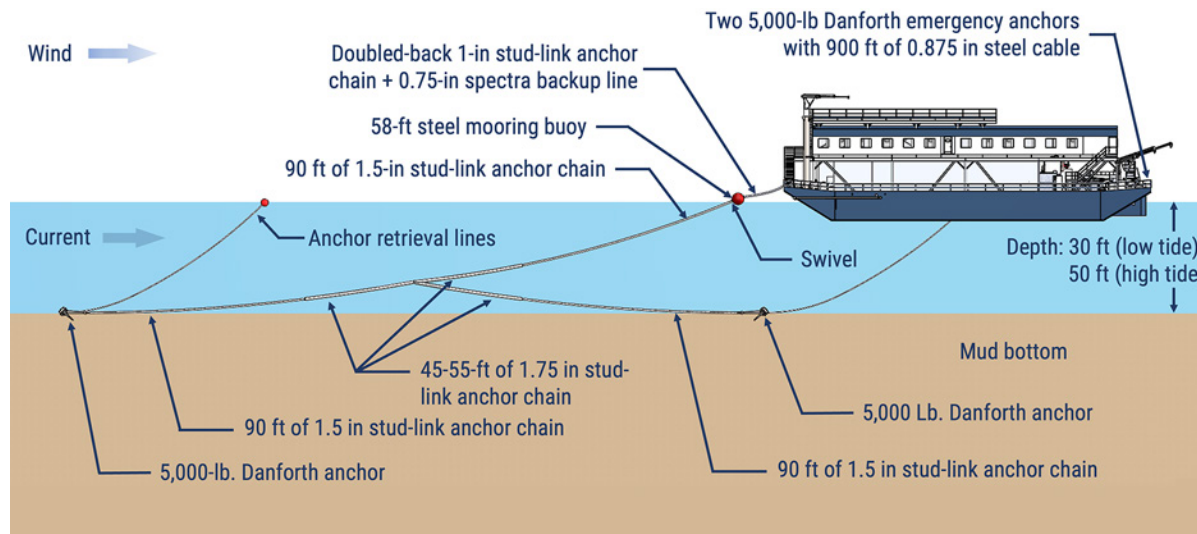
Figure 132. *SM-3* ground tackle system at the time of the casualty when the water depth was about 40 feet.

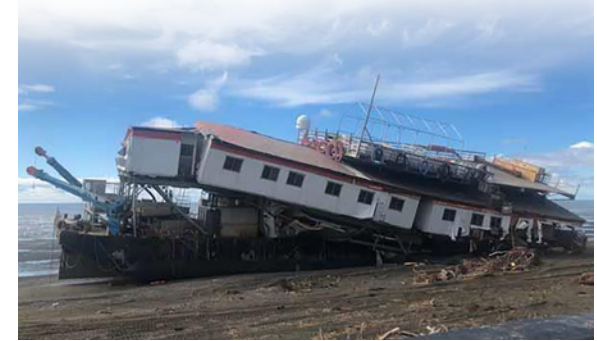
Figure 133. *SM-3* after the grounding.

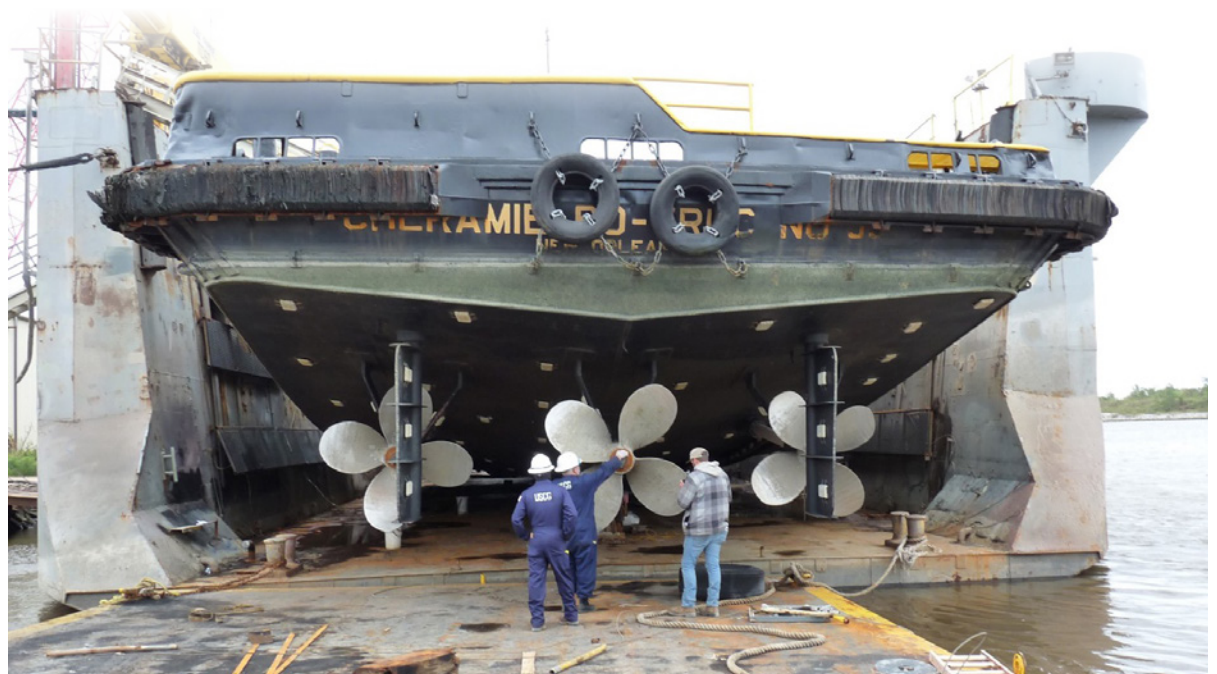
Figure 143. Coast Guard personnel inspecting the *Cheremie Bo-Truc* No. 33.

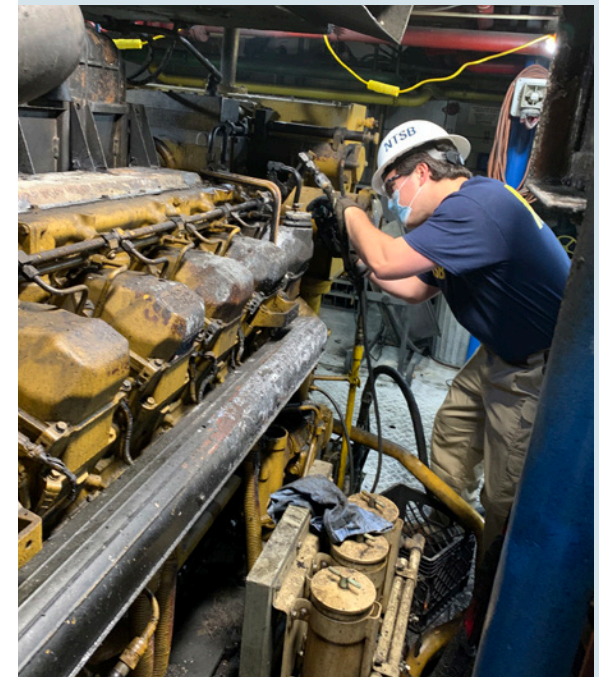
Figure 145. NTSB marine investigator examining the main diesel engine during the *Capt. Kirby Dupuis* investigation.

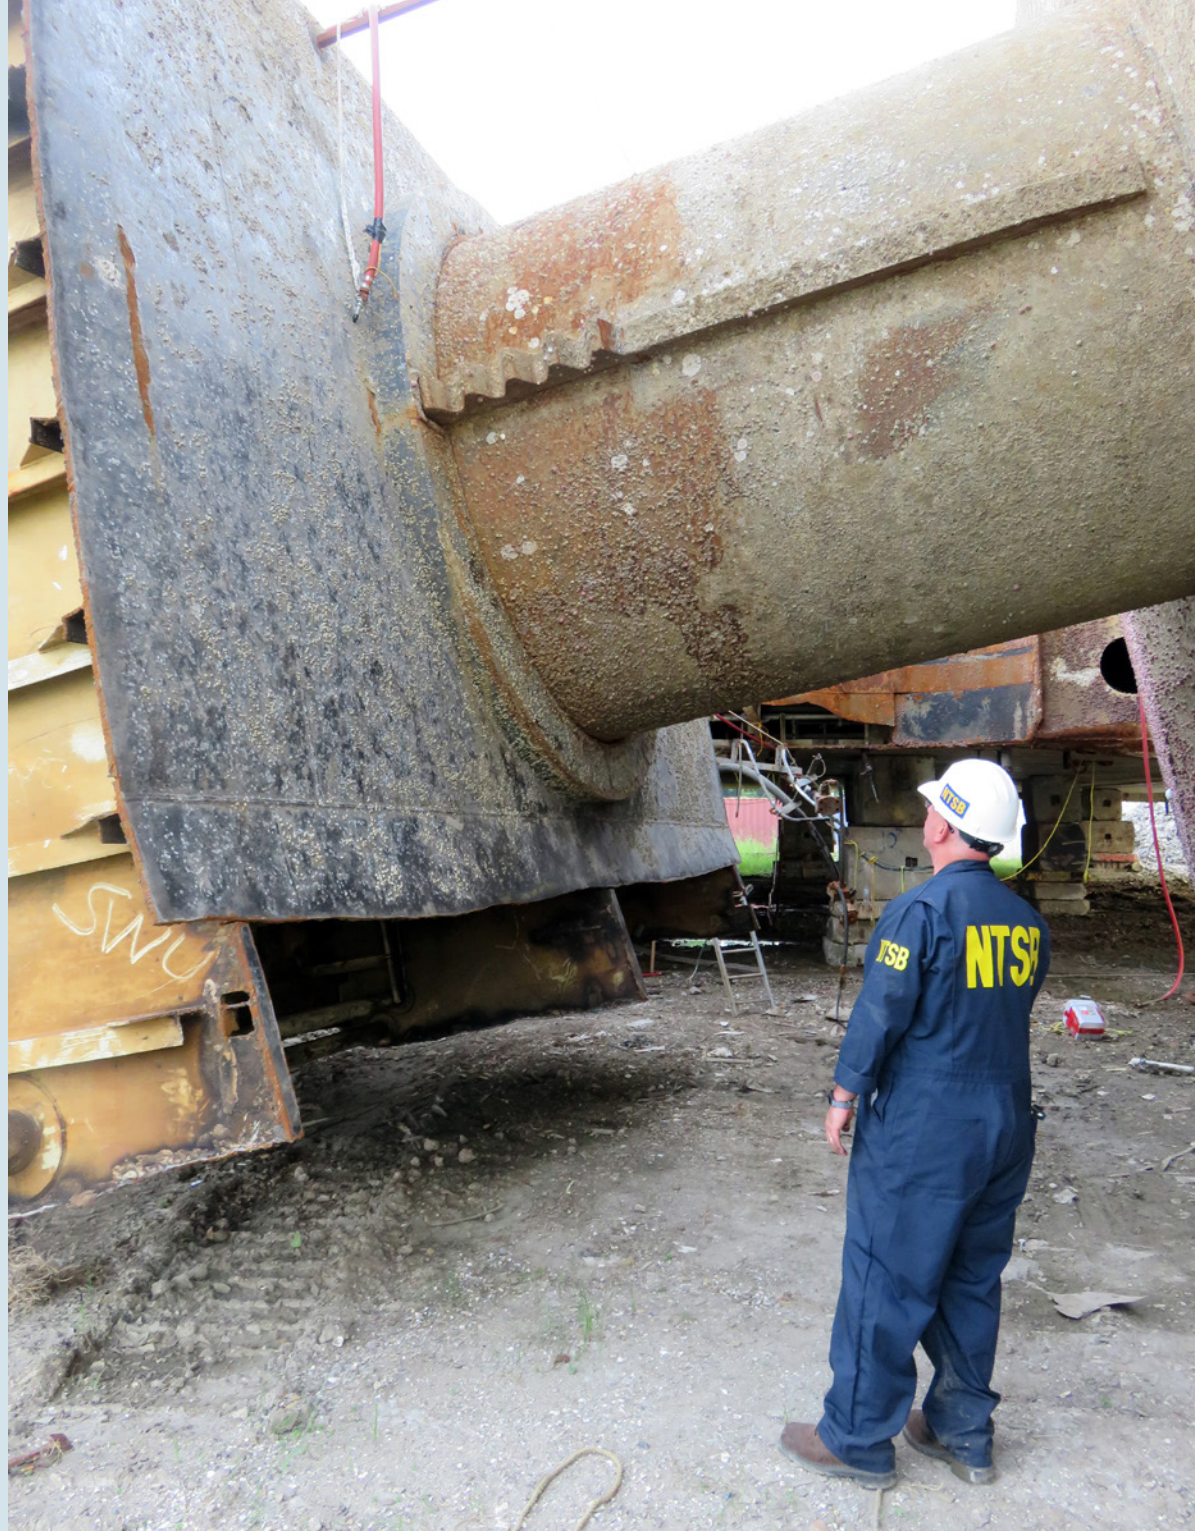
Figure 146. NTSB marine investigator inspecting the *SEACOR Power's* leg post-casualty.
