NATIONAL TRANSPORTATION SAFETY BOARD

2021

SAFER SEAS Digest

Lessons Learned from
Marine Investigations

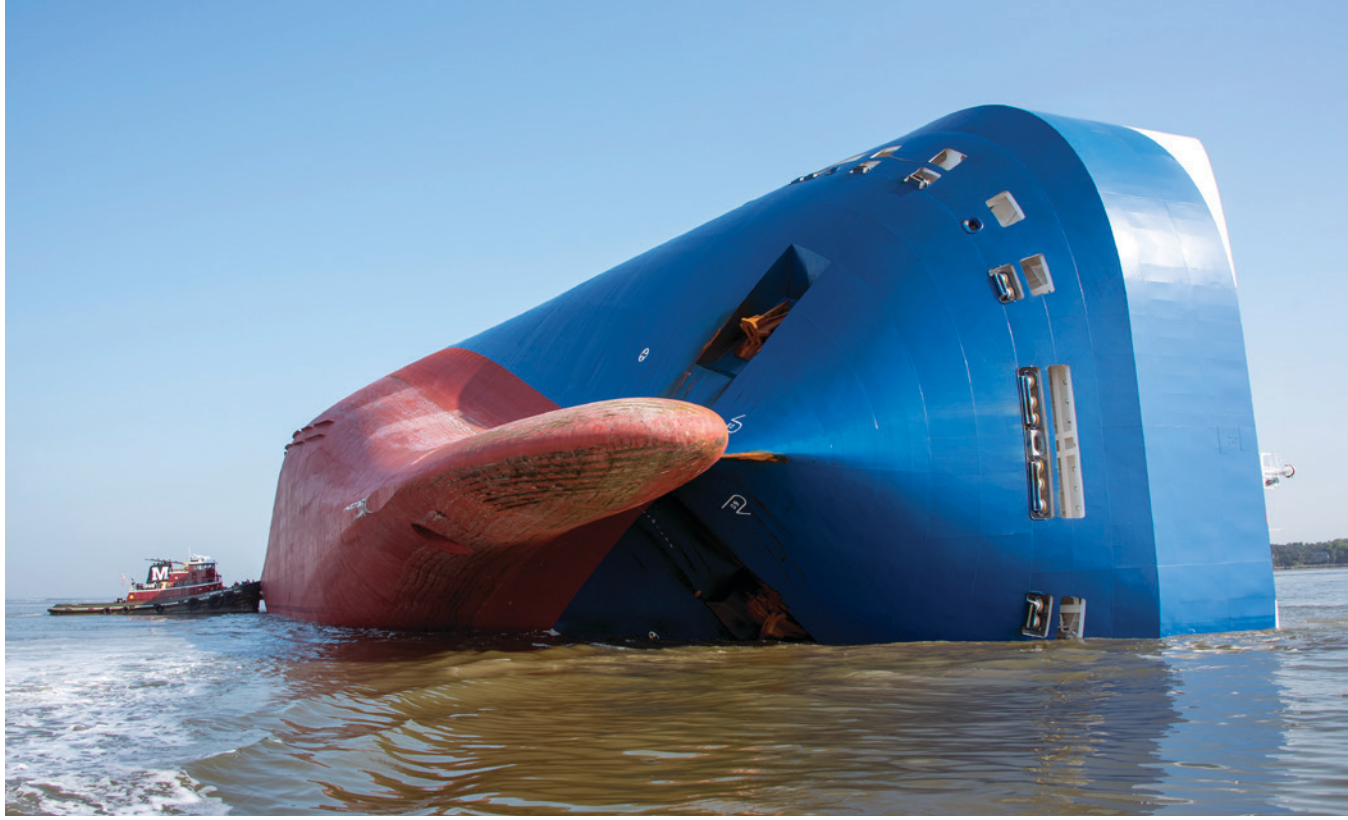
Figure 2. The *Golden Ray* heeled to its port side. SOURCE: COAST GUARD

The pilot and the vessel's master began rapidly issuing rudder commands in an attempt to counter the heeling. However, the *Golden Ray* continued to heel over, the rate of turn to starboard increased, and the vessel heeled to port to about 60° in less than a minute. Water entered deck 5 through the vessel's open portside pilot door and flooded through open watertight doors to the engine and steering gear rooms. The vessel eventually settled on its port side at an angle of 90°.

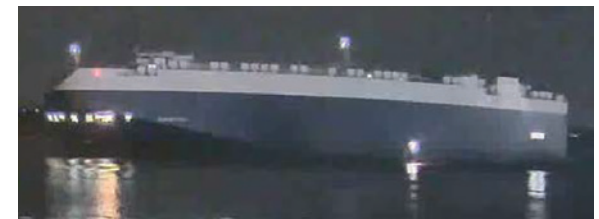
About the same time, the master ordered the crew to open the 7-foot-high-by-7-foot-wide portside pilot door (side port), located on deck 5, in preparation for the pilot's planned departure just outside of the Port of Brunswick at the sea buoy. After supervising the opening of the portside pilot door, the chief officer went to his stateroom. No one remained at the open door as the vessel proceeded outbound.

Figure 4. The *Golden Ray* departing Jacksonville, Florida, about 0130 on September 7. The light amidship is the open portside pilot door. (The lights on the blue hull at the bow and stern are mooring line stations.)

The NTSB also found that the open watertight doors on deck 5 of the *Golden Ray* allowed flooding into the vessel and blocked the primary egress from the engine room, thus trapping engineering personnel. Watertight integrity is critical to the safety of a vessel and its crew, so the NTSB recommended that G-Marine revise its SMS audit process to verify crew adherence to the company's Arrival/Departure Checklist regarding the closure of watertight doors.

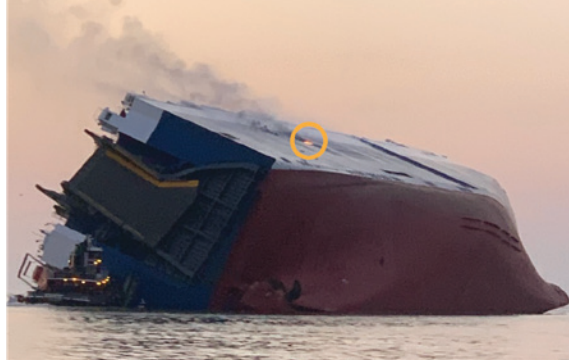
Figure 5. *Golden Ray* 6 hours after the heeling event. Flame and smoke emanate from the starboard side in the area of the cargo decks. SOURCE: COAST GUARD

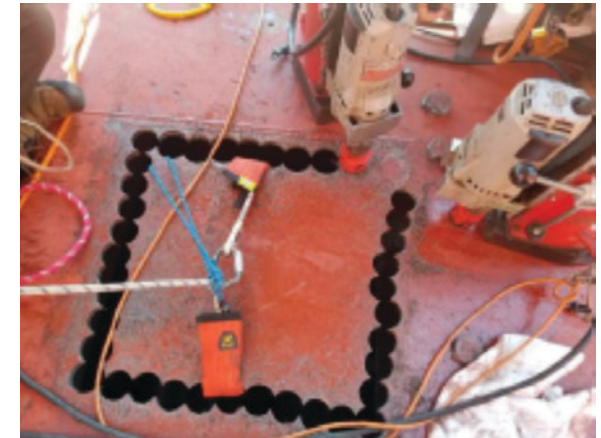
Responders initially rescued the pilot and 19 of the 23 crewmembers on board. Four engineering crewmembers remained trapped in the engine room until the following evening, September 9, when responders cut into the vessel's hull to rescue them.

Figure 7. Responders drilled holes into the hull to access the engineers. SOURCE: COAST GUARD

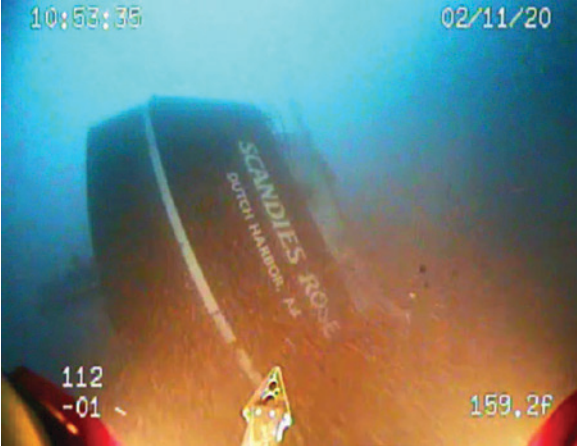
Figure 10. The *Scandies Rose* wreck, located on February 11. SOURCE: GLOBAL

The probable cause of the capsizing and sinking of the commercial fishing vessel *Scandies Rose* was the inaccurate stability instructions for the vessel, which resulted in a low margin of stability to resist capsizing, combined with the heavy asymmetric ice accumulation on the vessel due to localized wind and sea conditions that were more extreme than forecasted during the accident voyage.

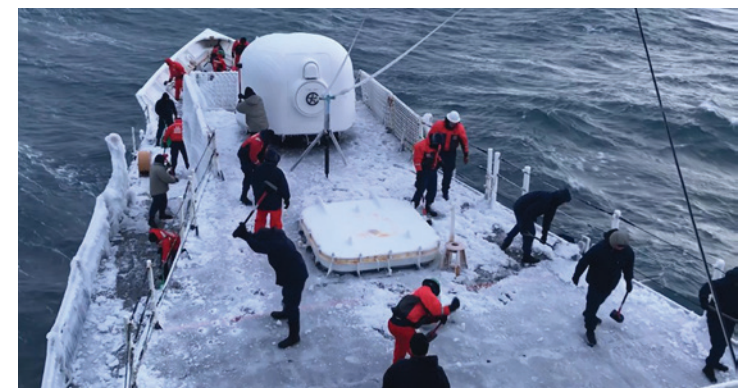
◆ **The effect of extreme icing conditions.** Sea spray icing is a serious hazard to marine vessels because the ice accumulates over exposed decks and exterior surfaces of a vessel, adding weight that may ultimately capsize a vessel. The *Scandies Rose* was carrying a full stack of pots that reached about 20 feet above the main deck, and ice from freezing spray formed asymmetrically on the starboard side and built as the voyage progressed. The added weight of accumulated ice high on a vessel—in this case, up the stack of pots, the fo’c’sle, bulwarks, and portions of the house—rapidly raises a vessel’s center of gravity and diminishes its stability. The asymmetrical icing on the starboard side of the *Scandies Rose* caused the vessel to develop an increasing starboard list, and the course change at 2145 brought the 60–70 knot winds onto the port side, adding to the existing list from icing. The sudden increase in list shortly later indicated that the vessel’s stability had been overcome and that the vessel was capsizing. The added weight from ice accumulating asymmetrically on the vessel and the stacked crab pots on deck raised the *Scandies Rose*’s center of gravity, reducing its stability and contributing to the capsizing.

Figure 16. Coast Guard Cutter *Mellon* crew breaking ice during search efforts late afternoon on January 1.

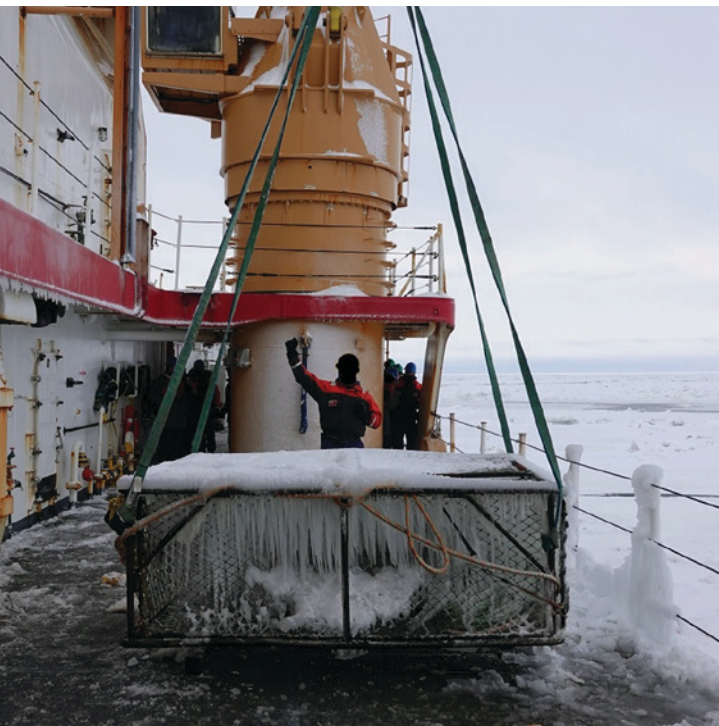
◆ **Need to update regulatory guidelines on calculating and communicating icing for vessel stability instructions.** Stability regulations factor in a minimum set amount of added weight for accumulated ice from freezing sea spray on continuous horizontal and vertical surfaces. However, the regulations do not provide guidance on how to apply ice accumulation on crab pots, which consist of tubular frames and mesh and have additional internal ice accumulation. Nor do they account for reported asymmetric ice accumulation on exposed vessel surfaces and pot stacks. Additionally, stability instructions are currently not required to present the accumulated ice thicknesses used to calculate vessel stability, which, if communicated to masters, would better prepare them in decision making.

Figure 17. Crewmembers aboard Coast Guard Cutter *Polar Star* weigh a crab pot following a 3-day freezing spray experiment. SOURCE: COAST GUARD

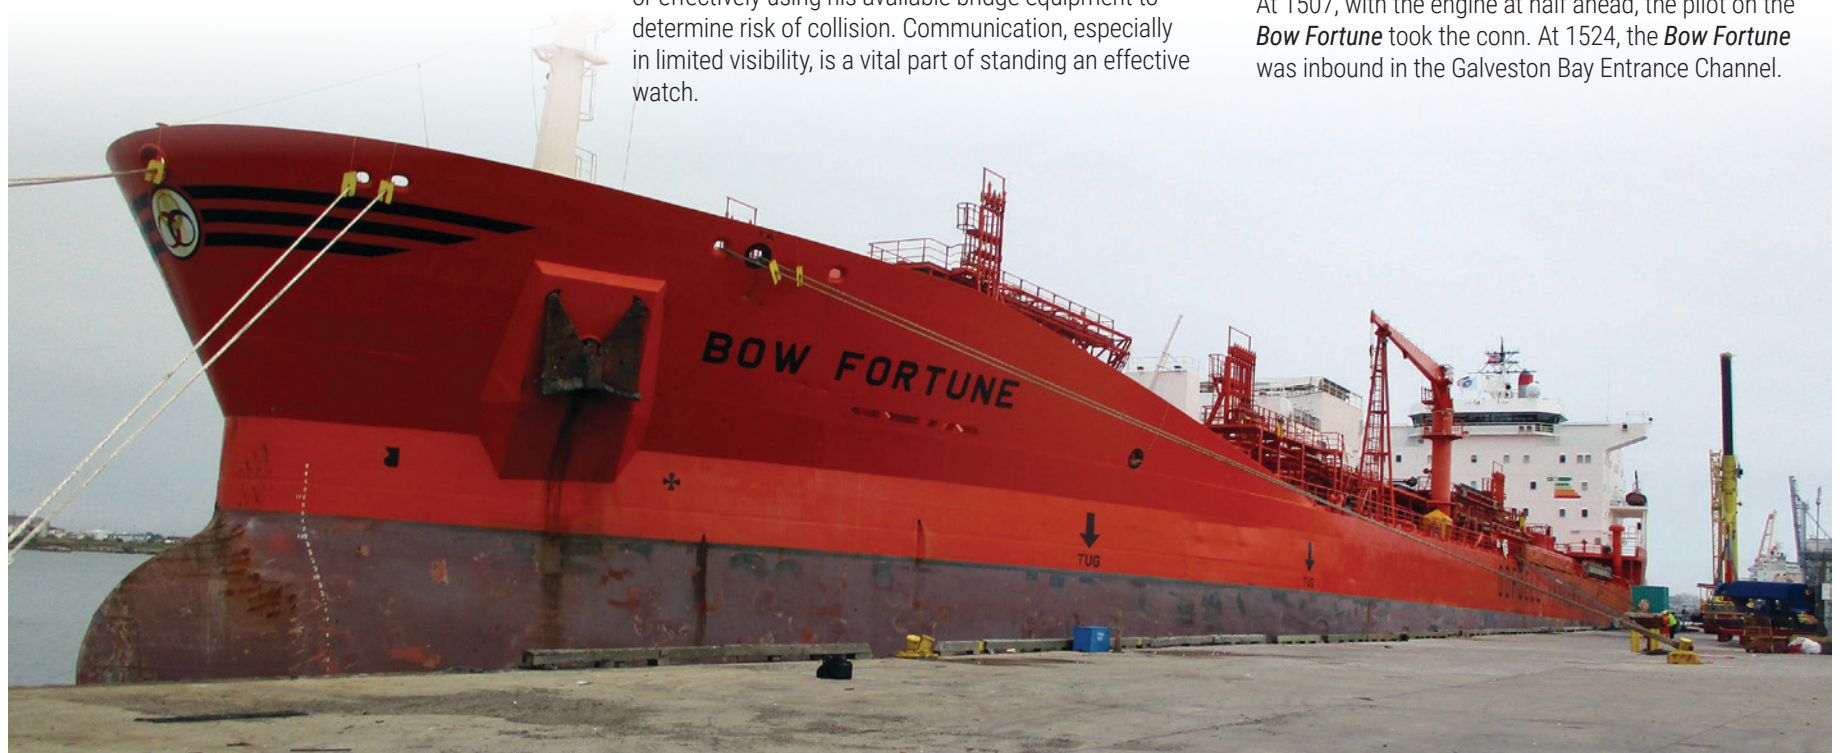
Figure 18. *Bow Fortune* docked after the casualty.

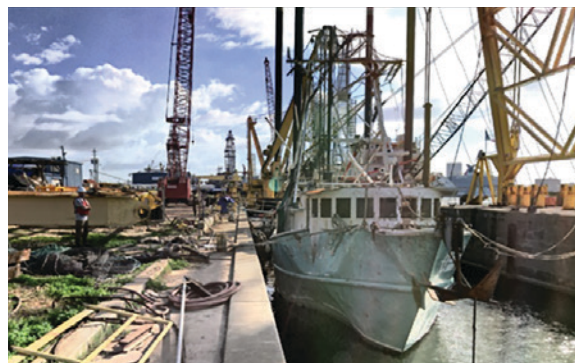
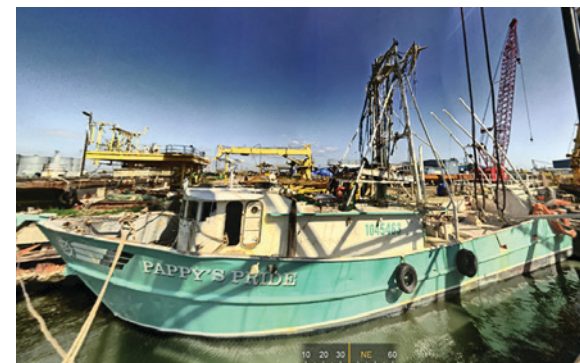
Figure 21. *Pappy's Pride* postaccident damage. SOURCE: COAST GUARD.

At 1537:32, the vessels collided just outside the Outer Bar Channel. The speed over ground of the *Bow Fortune* was 11 knots and *Pappy's Pride* was 8.4 knots, indicating the tanker was beginning to slow but the fishing vessel's captain did not appreciably change the propulsion engine speed or direction before the collision. The damage assessed on both vessels indicates the port side of the tanker's bulbous bow struck the starboard side of the fishing vessel during the collision, which in turn led to the vessel capsizing but remaining afloat as it passed down the port side of the tank. One deckhand was rescued, but the remaining *Pappy's Pride* crew perished.

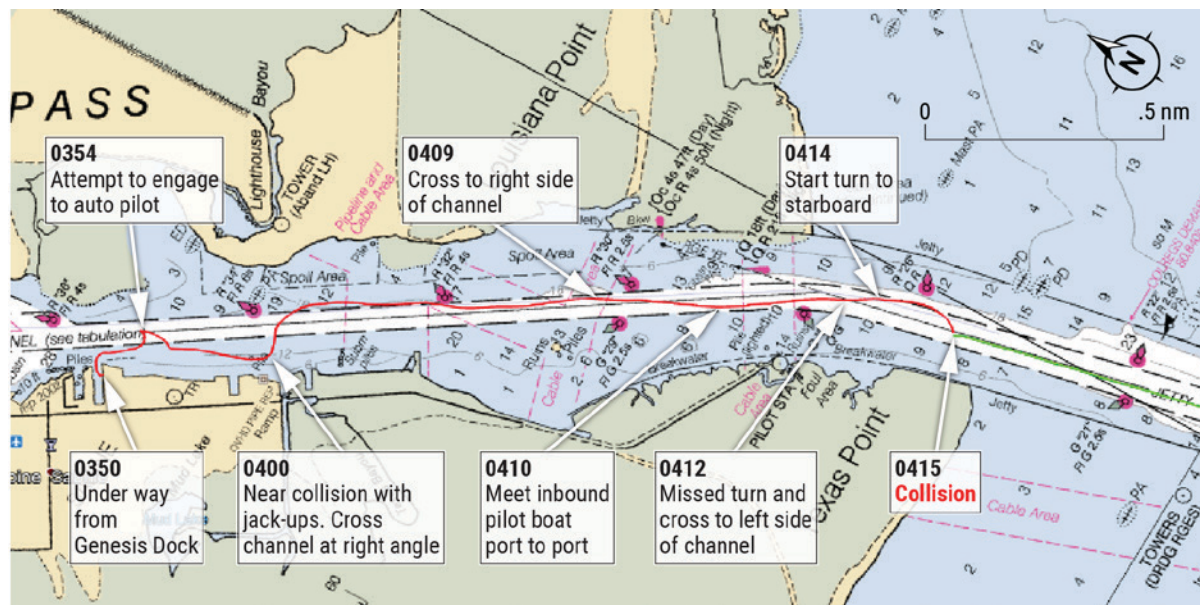
Evidence showed that there was room to pass safely starboard to starboard had *Cheramie Bo Truc No 22* continued parallel to and along the east edge of the channel. Inland Navigation Rules require either a port-to-port passage or communication either by radio or whistle signal for an agreed-upon alternate passage between two vessels. A radio call from the ATB prior to the pilot relieving the mate to confirm the offshore supply vessel's intentions may have kept the *Cheramie Bo Truc No 22* mate from steering across the ATB's bow. After the turn to starboard across the bow of the ATB, the collision was unavoidable.

Figure 26. Sabine Pass chart showing path of *Cheramie Bo Truc No 22* (red) and *Mariya Moran-Texas* (green).

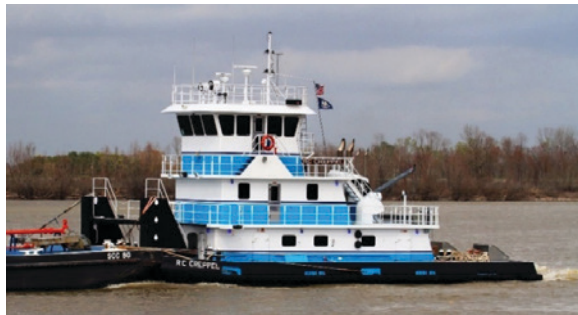
Figure 27. *RC Creppel* under way before the accident.

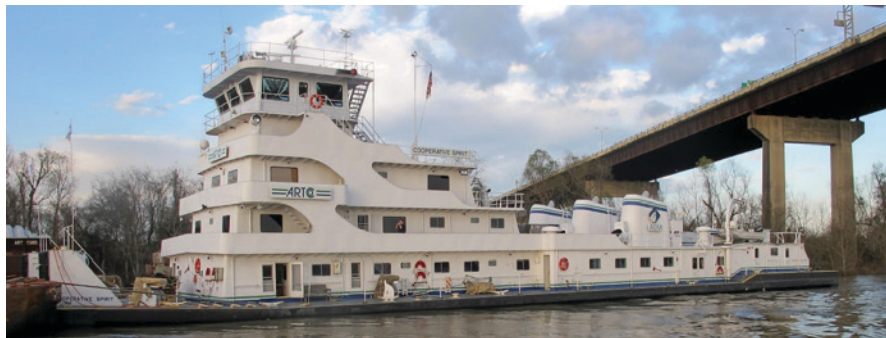
Figure 28. *Cooperative Spirit* moored after the accident.

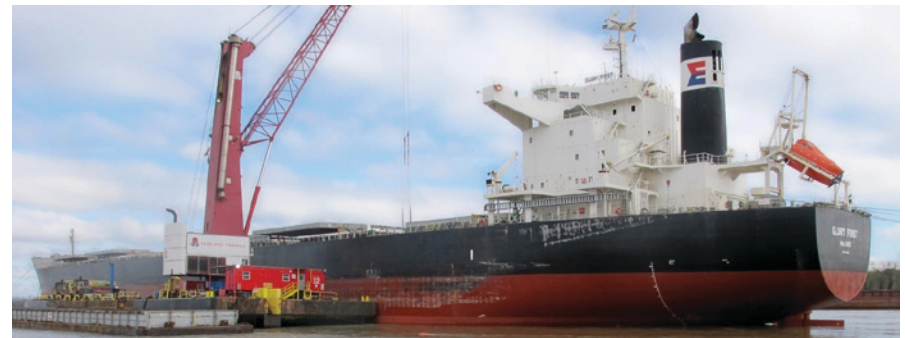
Figure 29. *Glory First* anchored after the accident.

The *Cooperative Spirit* continued to drift down and across the river into the upbound *Glory First*, which had slowed and evasively maneuvered toward the right descending bank, and the *Glory First* struck the aft corner of the starboard string of barges pushed by the *Cooperative Spirit*.

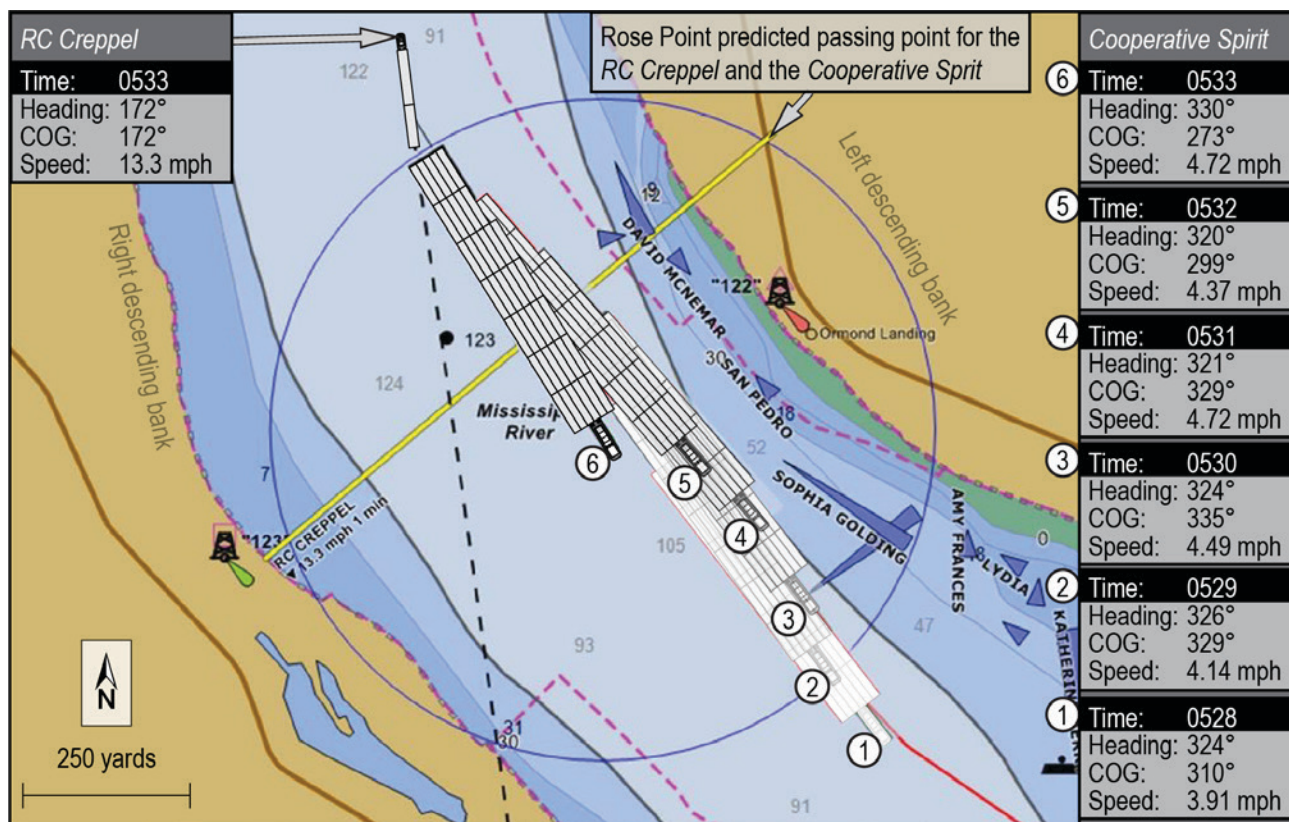
The probable cause of the collision of the *Cooperative Spirit* and *RC Creppel* tows was the two pilots' insufficient radio communication before meeting in a bend and not broadcasting accurate AIS information regarding tow size.

Figure 30. Rose Point ECS display at 0533 screenshot from the *Cooperative Spirit*, with previous positions of the *Cooperative Spirit* starting at 0528 (with *Cooperative Spirit* tow and *RC Creppel* tow icons added to show overall tow dimensions to approximate scale). BACKGROUND SOURCE: ARTCO

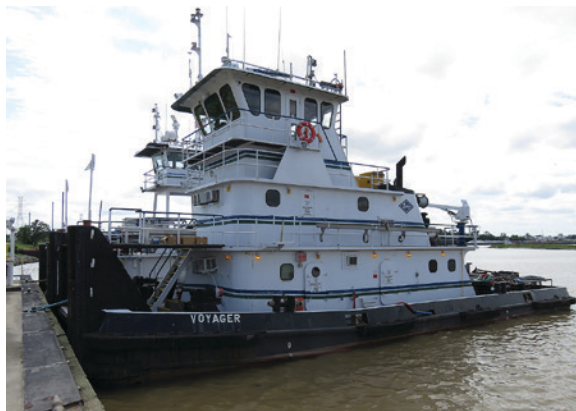
Figure 31. *Voyager* moored in Channelview, Texas, following the accident.

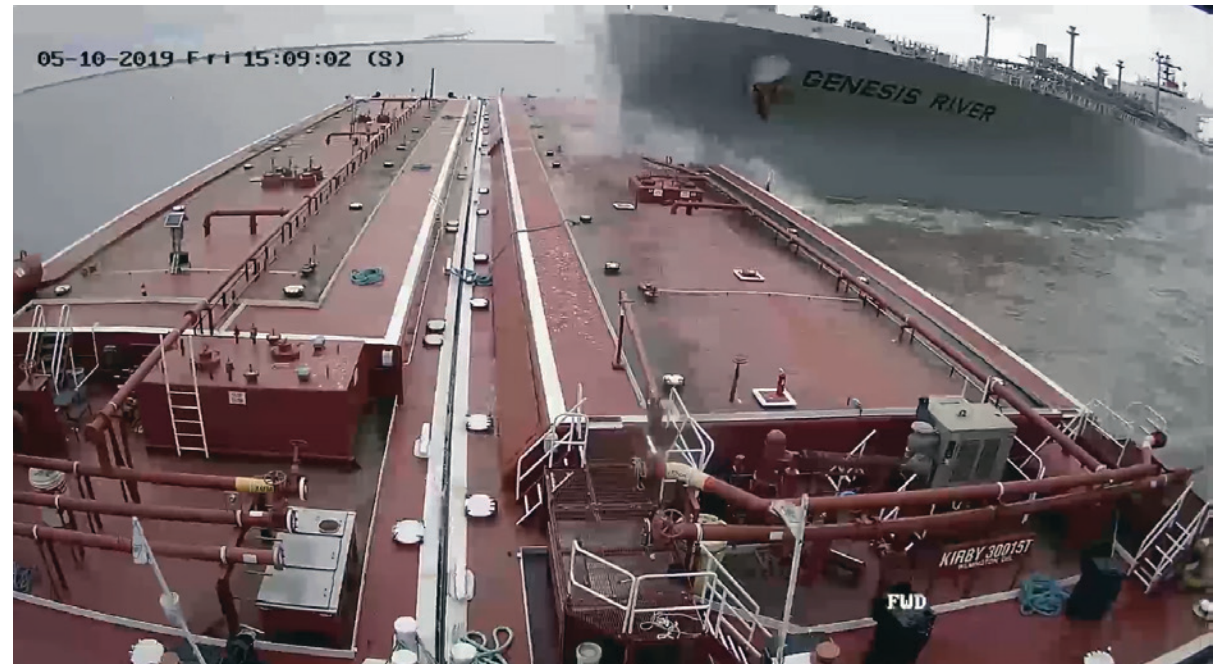
Figure 32. Screen capture from wheelhouse video on board the *Voyager* at the moment that the *Genesis River* struck the *Voyager* tow. SOURCE: KIRBY INLAND MARINE, LP

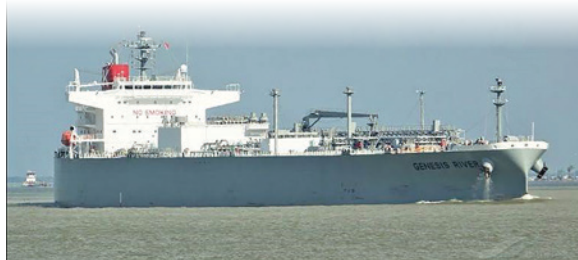
Figure 33. *Genesis River* under way in Bolivar Roads near Galveston, Texas, two weeks after the accident.

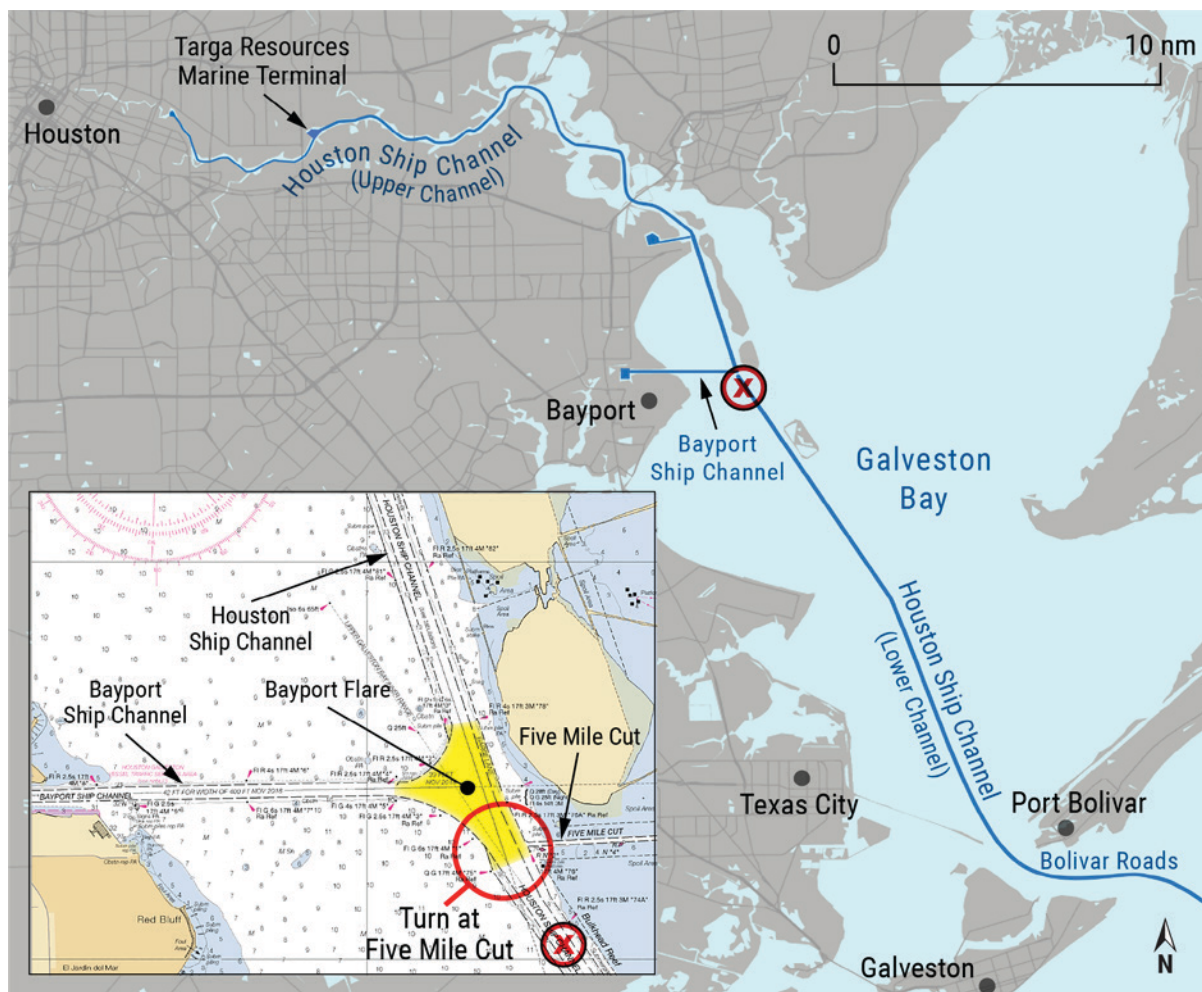
Figure 34. The accident location, as shown by the red X. Inset shows Bayport Flare and turn at Five Mile Cut.

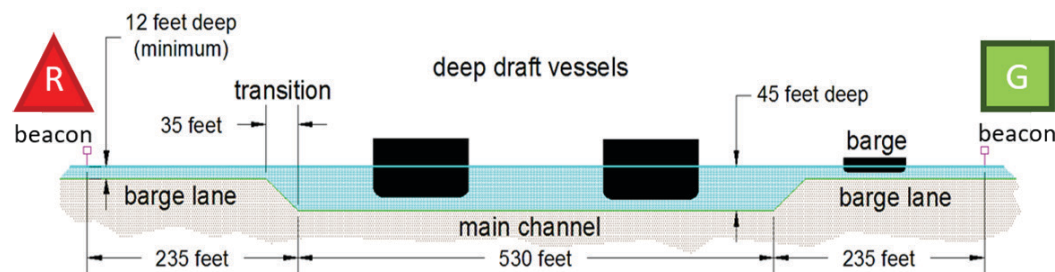
Figure 35. Typical Lower Houston Ship Channel profile with navigation beacons as viewed by an outbound vessel.

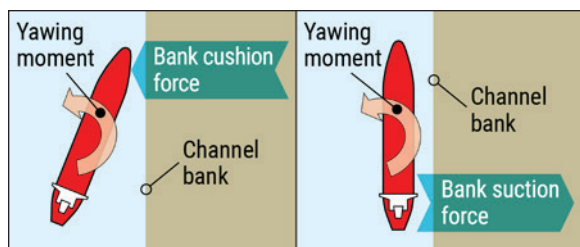
The channel narrowed and turned, which brought the western channel bank abruptly in toward the vessel, and the bank effects on the starboard side quickly increased. The closer a vessel is to the bank, the stronger the bank effect forces. These forces were likely exacerbated by unreported shoaling that had occurred on the western side of the channel at the turn. Additionally, the hydrodynamic effects of the 740-foot-long and 120-foot-wide *BW Oak* acting on the *Genesis River* were greater than the effects created by smaller vessels that the *Genesis River* had passed earlier.

Figure 36. Hydrodynamic bank effects acting on the *Genesis River*: cushion force (left) and suction force (right).

As a result of the combined hydrodynamic effects of the bank and the *BW Oak*, the *Genesis River* sheered to port. In an attempt to stop the shear, Pilot 2 ordered and the helmsman executed a hard starboard rudder, but the vessel did not respond, continuing to turn toward the eastern bank of the channel. Pilot 2 twice ordered increased engine rpm in an effort to improve steering effectiveness. Because the *Genesis River* was at sea speed in Nav. Full mode, this increase could not be accomplished by moving only the EOT as it could if the vessel was in maneuvering mode. Rather, an increase in rpm while at Nav. Full required bridge watchstanders to contact the engineering watchstanders to change the maximum rpm setpoint in the ECR, depress the engine control program bypass button, and advance the EOT.

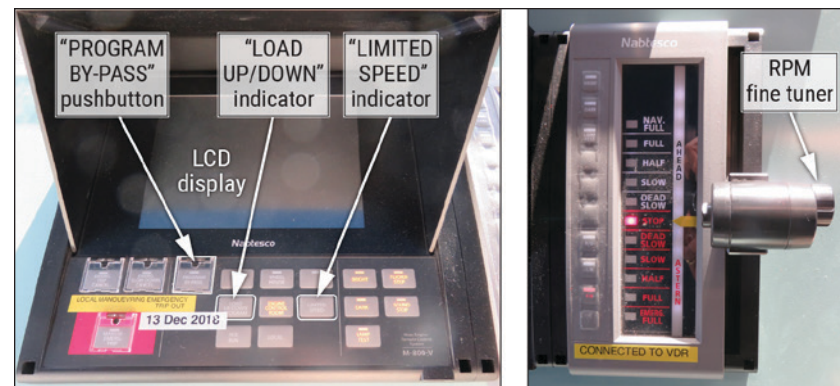
Figure 37. *Genesis River* bridge control panel for remote engine control system (left) and EOT lever (right).

After the pilot's second order for more rpm, *Genesis River* bridge crewmembers contacted the ECR and requested maximum rpm, and engineering watchstanders adjusted the maximum rpm setpoint to 85. However, neither the bridge nor the ECR watchstanders pressed the program bypass button. Thus, the actual engine rpm did not change when the pilot ordered the increase.

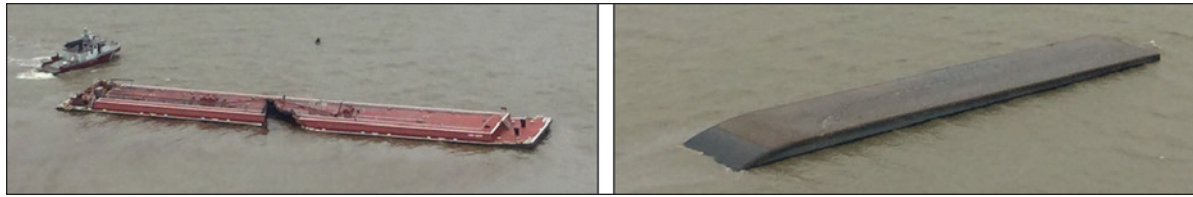
At 1516:09, the *Genesis River's* bow struck the starboard barge midship on the starboard side, penetrating through the double hull and breaching the no. 2 starboard cargo tank (causing reformat to leak) and capsizing the port barge. The Houston Ship Channel was closed to navigation for two days during response operations and did not fully open for navigation until May 15. The total cost of damages to the *Genesis River* and the barges was estimated at \$3.2 million. The cost of reformat containment and cleanup operations totaled \$12.3 million. There were no injuries reported.

Figure 38. Barges from the *Voyager* postaccident.

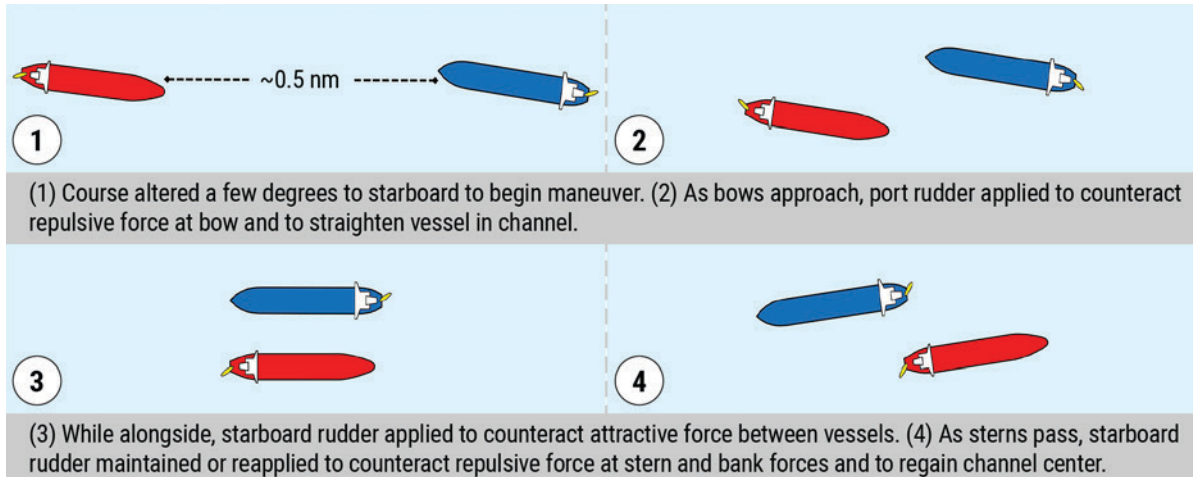
◆ **Vessel speed while transiting a narrow channel.** Transiting a narrow channel at or near a vessel's maximum speed provides little room for error and little ability to increase propeller wash over the rudder to recover if control is lost. The margin for error is even more limited on ships with slow-speed, direct-drive diesel propulsion engines transiting at Nav. Full, an engine mode designed for higher speeds in open ocean waters where the ability to change engine rpm on short notice is significantly restricted. The pilot's decision to transit the wide-beam, deep-draft *Genesis River* in Nav. Full mode at sea speed subjected the vessel to greater hydrodynamic forces than had it been traveling at slower maneuvering speeds through the shallow and narrow lower Houston Ship Channel. Additionally, the higher speed resulted in the vessel trimming further down by the bow, and thus reduced path stability with increased speed due to the trim change. Finally, the maneuvering limitations imposed by being at Nav. Full prevented a rapid increase in engine speed when needed to improve rudder effectiveness.

Figure 39. Typical steering sequence during head-on meeting in a narrow, symmetrical channel. (Not to scale.)

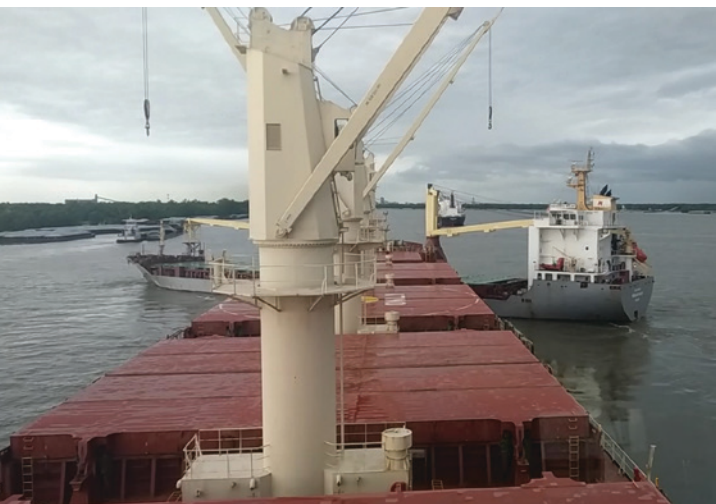
Figure 40. Image from video taken at 1701 from the bridge of the *Atlantic Venus* with the *Nomadic Milde* lying against its bow. SOURCE: ATLANTIC VENUS CREWMEMBER

At 1655, the port side of the *Nomadic Milde* collided with the bulbous bow and anchor chains of the *Atlantic Venus*. With the *Nomadic Milde* broadside to the current and pushing on the bow of the *Atlantic Venus*, both vessels moved towards the right descending bank and closed on a nearby chemical dock about 650 feet away. During efforts to assist the vessels, the *Nomadic Milde* struck the dock before grounding on the right descending bank.

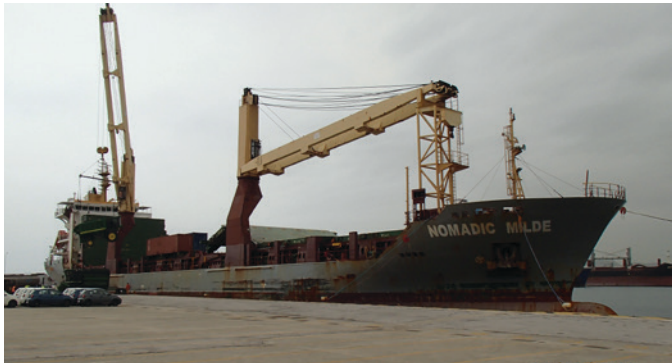
Figure 42. The *Nomadic Milde* loading cargo in March 2018. SOURCE: INTERSHIP NAVIGATION CO. LTD.

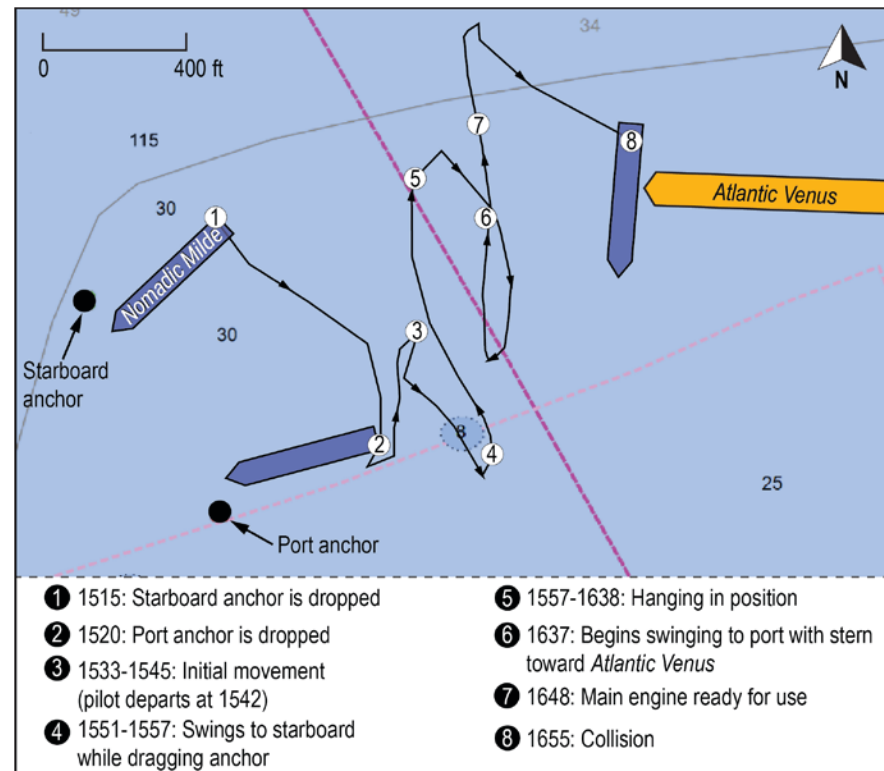
The probable cause of the collision between the *Nomadic Milde* and *Atlantic Venus* was the bridge team on the *Nomadic Milde* not effectively monitoring the vessel's position and therefore not detecting that the vessel was dragging anchor and had moved from its original position during highwater conditions in proximity to other vessels.

Figure 43. GPS positions of the *Nomadic Milde* from the vessel's ECDIS, from the time the *Nomadic Milde*'s starboard anchor was let go at 1515 to the collision with the *Atlantic Venus* at 1655. Note: the GPS receiver is located on the main mast above the bridge of the *Nomadic Milde*. Scale approximate.

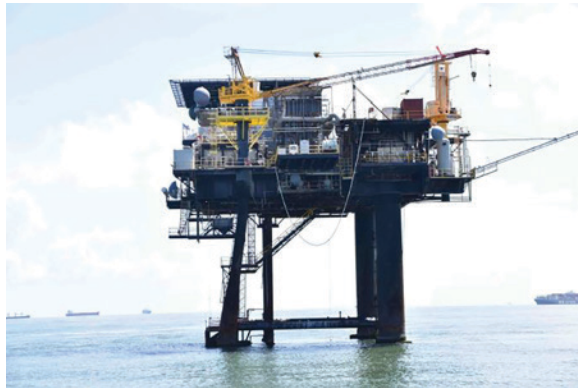
Figure 44. SP-57B preaccident. SOURCE: COX OPERATING

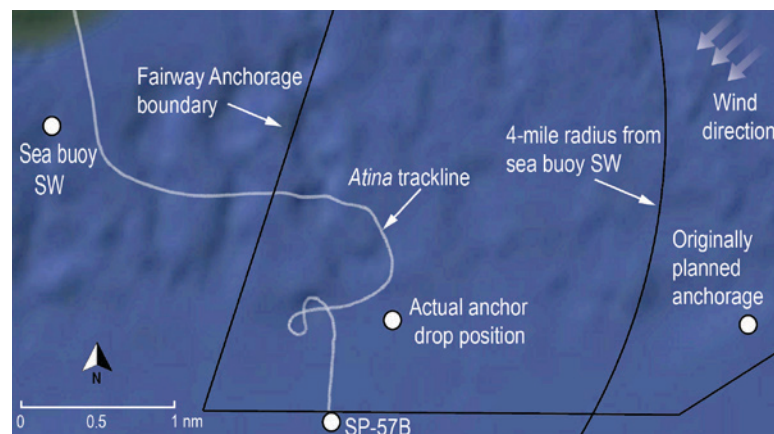
Figure 47. The *Atina's* trackline taken from VDR data showing the tanker's position relative to sea buoy SW and platform SP-57B within the Fairway Anchorage boundaries. The image also shows the *Atina's* originally planned anchorage location, actual anchor drop position, and the 4-mile radius from sea buoy SW.

The probable cause of the contact of tanker *Atina* with the oil and gas production platform SP-57B was the *Atina's* operating company not ensuring sufficient time for the master's turnover, which resulted in the master's acute fatigue and poor situation awareness during an attempted nighttime anchoring evolution.

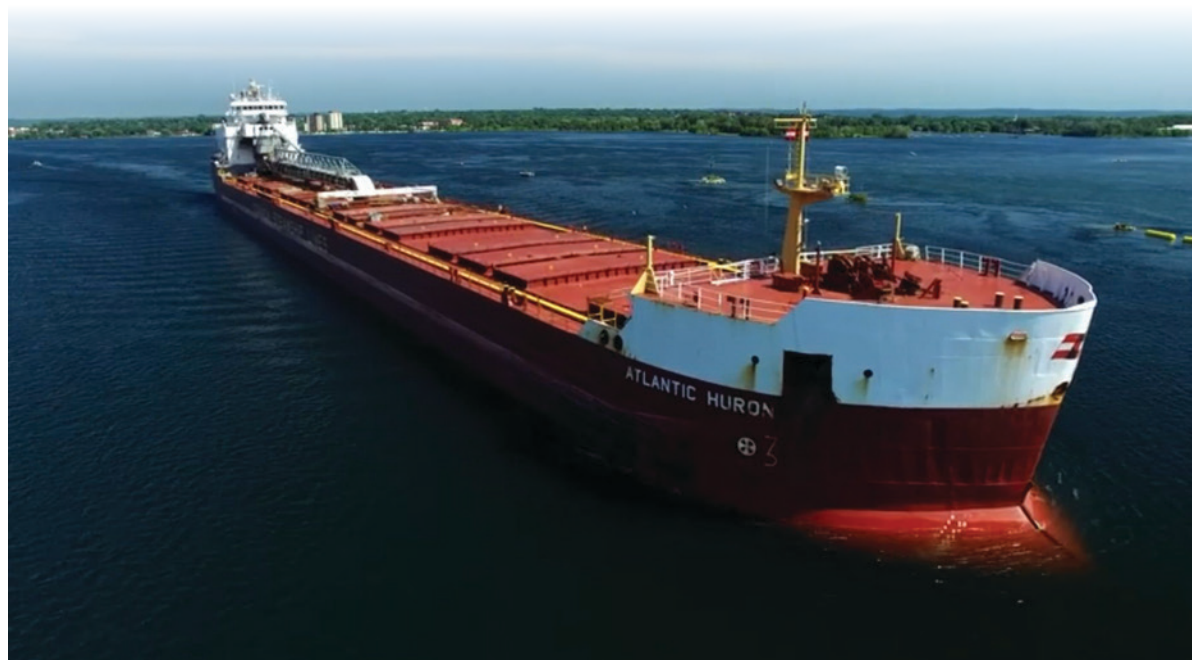
Figure 49. *Atlantic Huron* under way before the accident. SOURCE: SAULTSTEMARIE.COM

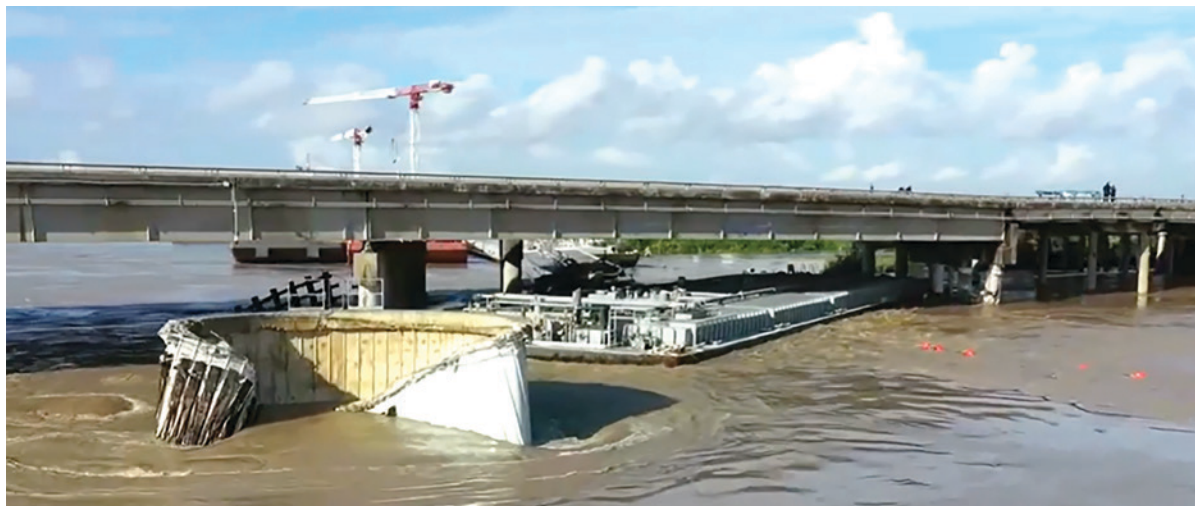
Figure 52. Barges resting against I-10 bridge pilings after striking and damaging a protective cell. SOURCE: KJRH-TV

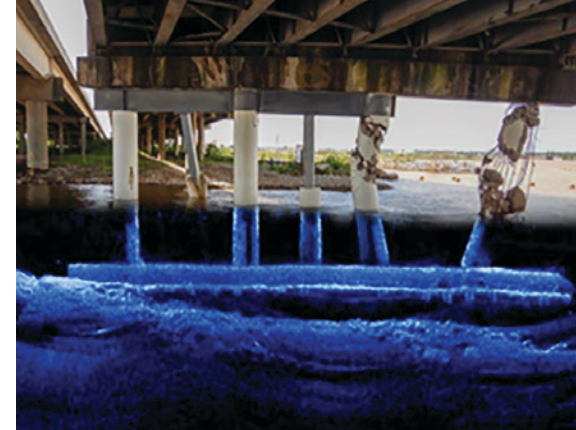
Figure 53. Multibeam sonar images overlaid with above-surface photograph illustrate the damaged columns postaccident (sonar survey taken September 27) on the westbound span of the I-10 bridge. SOURCE: TXDOT

Towboat crews corralled the block of six barges as they drifted down river. At 2337, they contacted and damaged the bridge's protective cell closest to the channel on the eastern bank and then struck and damaged the western bank protective cell. The barges subsequently struck the I-10 bridge fendering system and pilings at 2338. The barges' mooring lines and wires parted upon contact, and two barges became lodged between the I-10 bridge's concrete columns on the west side of the river while four barges continued under the bridge, contacting the bridge's fendering system and concrete pilings as they individually headed down river. Meanwhile, two towing vessels attempted to move two barges to tier 2, but, according to the captains, they were unable to maintain control. The two barges passed under the bridge at 2347 without contacting the bridge structure. Several Good Samaritan towing vessels pushed the six loose barges into the east bank below the I-10 bridge.

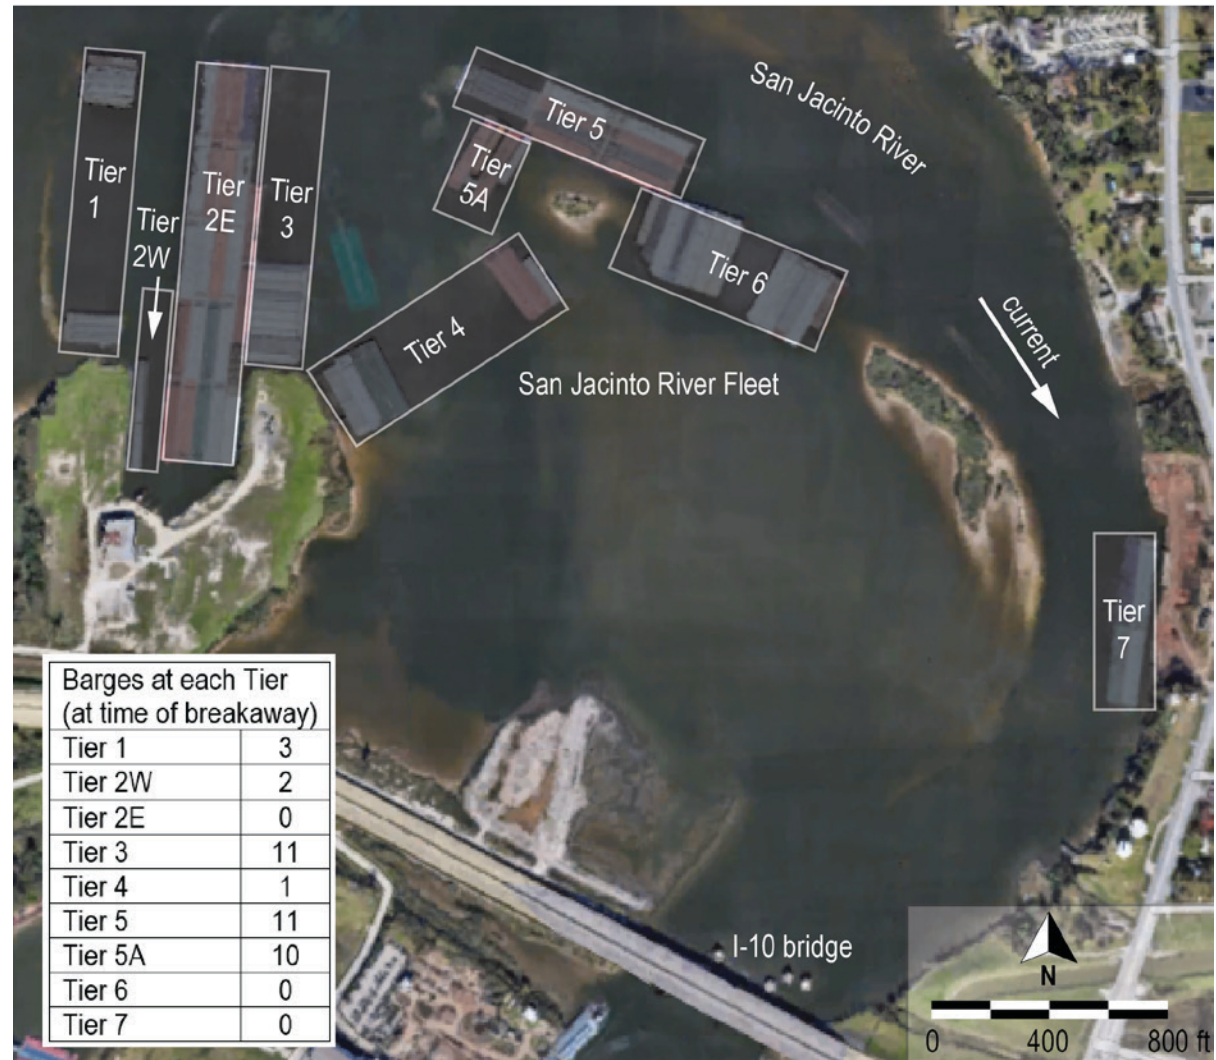
At 2050, a towboat captain and crew observed the 11 barges at tier 3 breaking away. The current's force on the barges had significantly strained the tier 3 moorings and caused the lines to part. Investigators later found parted synthetic mooring lines attached to the pilings and "dead men." It is likely that the strain was not distributed evenly among the lines due to the current, resulting in the mooring lines exceeding maximum load and parting. Once one line failed, the strain would have been placed on the next line, which would also have failed, until the breakaway occurred.

The probable cause of the barge breakaway and contact with the I-10 bridge was the force of the river current acting on the moored barges at the San Jacinto River Fleet, which exceeded the capacity of the mooring lines, due to the extreme rise and flow of water in the San Jacinto River from Lake Houston dam's uncontrolled spillway release of water during a historic rainfall event. Contributing was the operating company not rearranging fleeting area tiers to mitigate the effect of current on barge tiers.

Figure 54. Layout of San Jacinto River Fleet's tiers. Table in lower left corner shows number of barges at each tier at the time of the accident. Photo is not from day of accident. BACKGROUND SOURCE: GOOGLE EARTH

The San Jacinto River Fleet should have followed its SMS policies relating to severe weather and swift/flood water plans, implemented its severe weather plan, and taken earlier action to break down longer tiers and secure the vessels in the fleeting area. Had the longer string of barges at the tier been broken down, the resulting shorter strings would have been less vulnerable to swift currents.

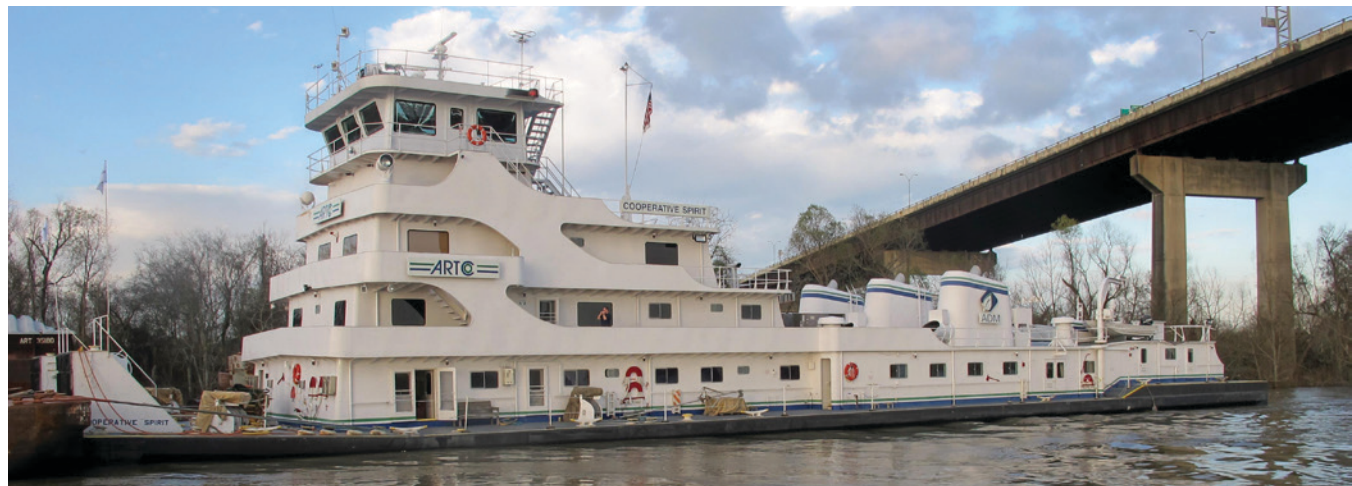
Figure 56. *Cooperative Spirit* moored before the accident.

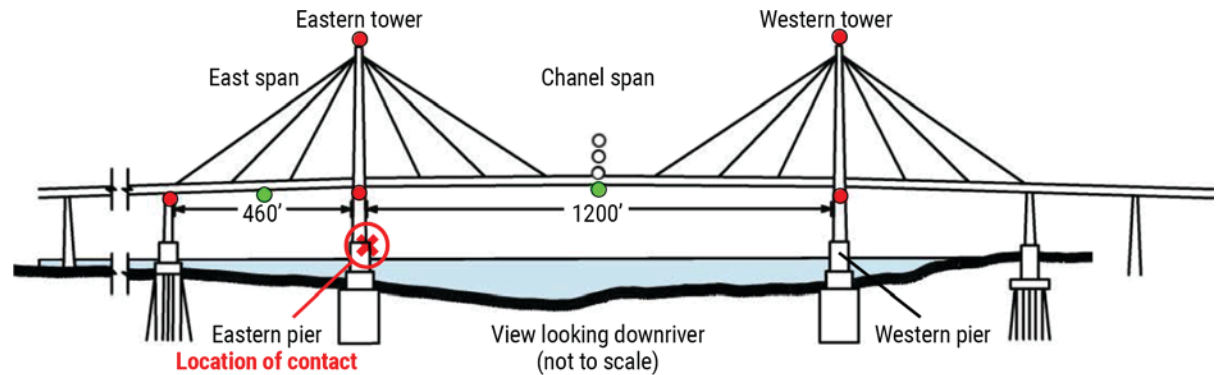
The probable cause of the contact of the *Cooperative Spirit* tow with a pier of the Hale Boggs Memorial Bridge was the pilot not effectively compensating for the strong current while navigating a turn and approaching the bridge in highwater conditions.

Figure 57. The Hale Boggs Memorial Bridge, with location of bridge strike on eastern tower pier indicated by a red X.
