NATIONAL TRANSPORTATION SAFETY BOARD

2021

SAFER SEAS Digest

Lessons Learned from
Marine Investigations

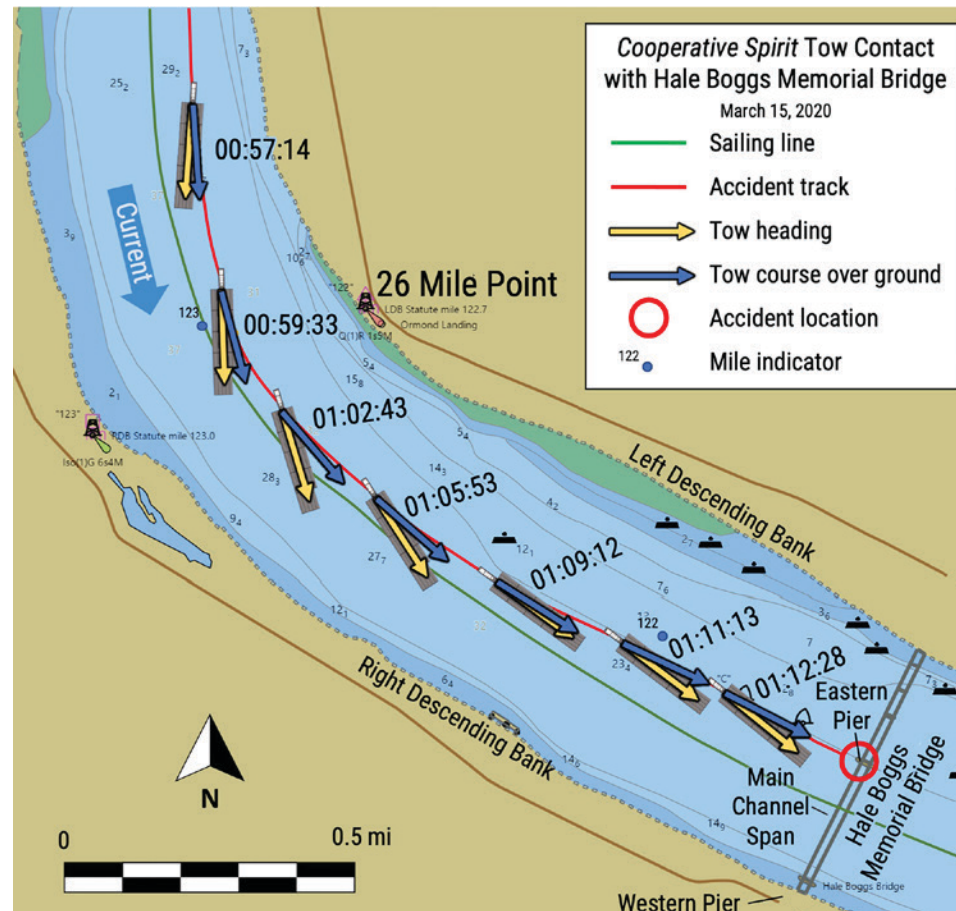
The pilot stated that, as the tow came out of the turn at 26 Mile Point, the stern of his vessel was too close to the left descending bank, and the current was setting the tow into the bridge pier. About 3 minutes before the accident, the tow's heading was 124°, while its course over ground was 114°, which is consistent with the pilot's statement. Due to high-water conditions, the current was stronger than normal (6 mph), and an eddy may have formed upriver of the bridge along the left descending bank, making maneuvering more difficult.

Figure 58. Track of *Cooperative Spirit* tow as it flanked the bend at 26 Mile Point and maneuvered prior to the accident.

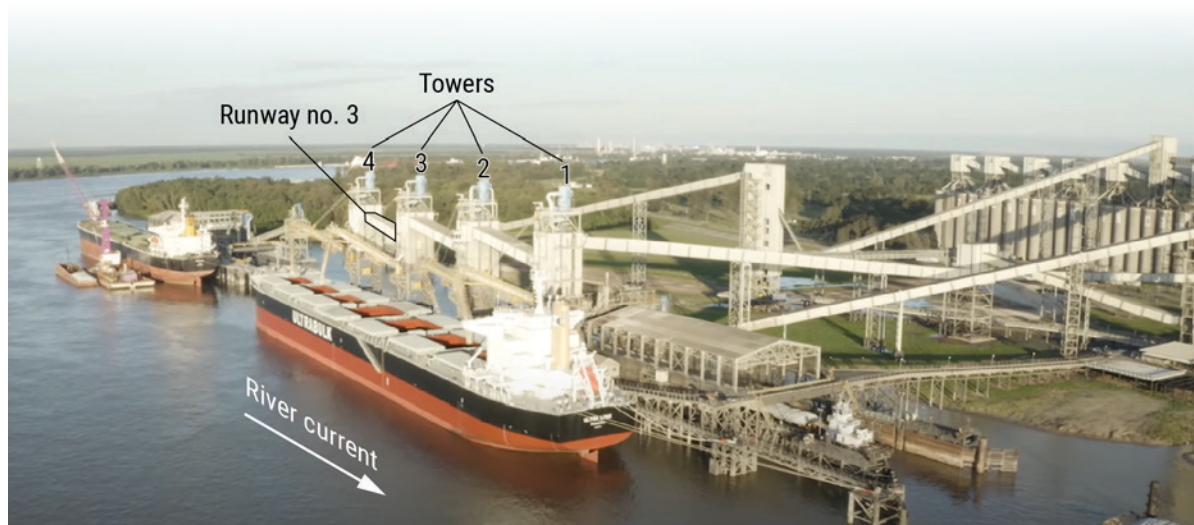
Figure 60. The ZGC shoreside facility before the accident. An unknown vessel, similar to the *GH Storm Cat*, is pictured. Runway no. 3 is noted between towers 3 and 4. BACKGROUND SOURCE: ZGC

On November 11, 2020, about 0910 local time, the bulk carrier *GH Storm Cat*'s no. 1 crane boom contacted the Zen-Noh Grain Corporation (ZGC) facility in Convent, Louisiana, while the crew was completing corn-loading operations. The vessel was moored starboard side to with a crew of 19. No pollution or injuries were reported. The vessel's crane was undamaged; damage to the shoreside conveyor gallery was estimated to be \$481,006.

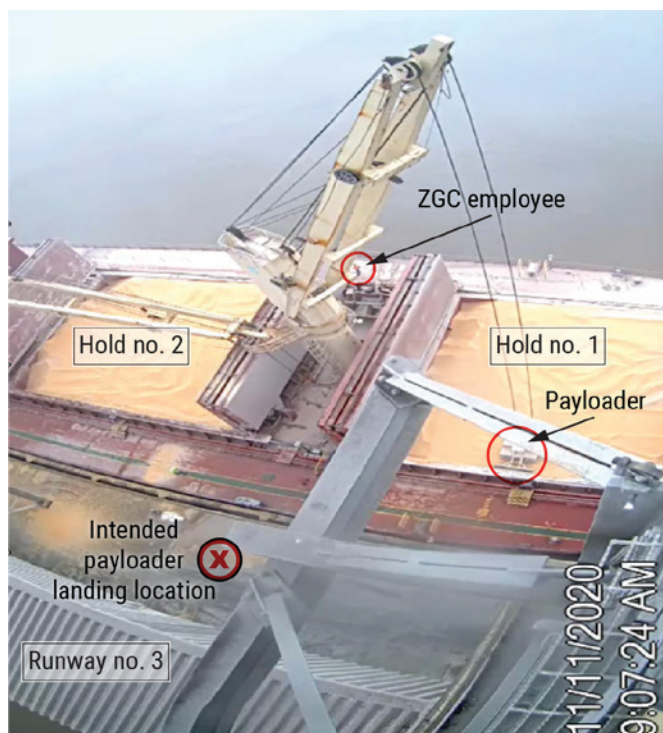
stopping the lift and establishing communications with the signalman, as industry recommends, he continued to slew the load over the dock and lower the boom. After positioning the crane boom perpendicular to the vessel and suspending the payloader above the pier, the crane operator began lowering the boom of the crane to position the payloader to be landed on the pier. While lowering the crane boom to land the payloader on the pier, the boom tip penetrated shoreside facility runway no. 3. Had the crane operator stopped the lift and attempted to establish communications when he lost visual contact with the ZGC employee, he would have discovered that he was operating without the aid of a signalman, who likely would have noticed the proximity of the crane boom to the runway and could have intervened to prevent the crane striking the structure.

Figure 62. Video footage still image of the *GH Storm Cat*'s crane during the initial sequence of the accident lift (lifting the payloader out of ship's no. 1 cargo hold).
BACKGROUND SOURCE: ZGC

The probable cause of the *GH Storm Cat*'s crane contact with the Zen-Noh grain facility runway was the absence of a dedicated signalman, which led to the ship's crane operator's misjudgment of the location of the crane boom while lowering the payloader to the pier.

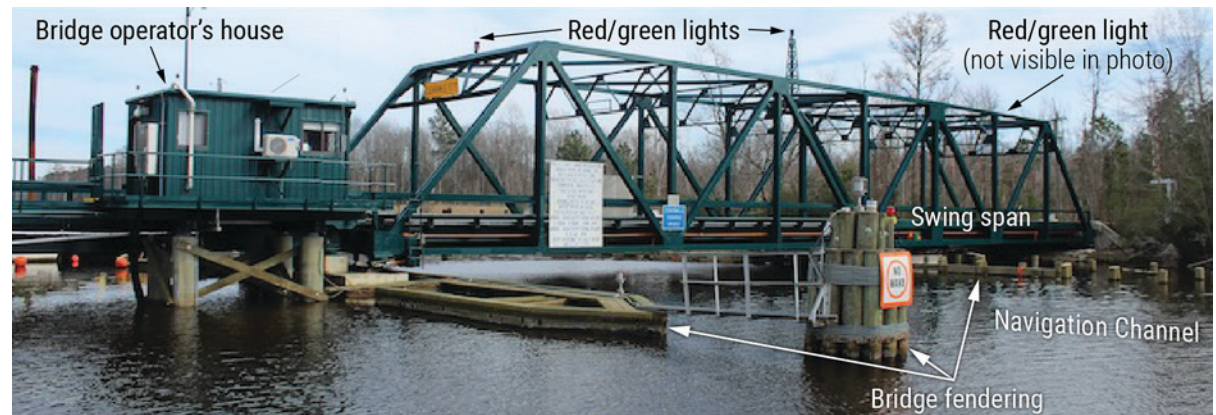
Figure 66. Centerville Turnpike Bridge in the closed position. BACKGROUND SOURCE: CITY OF CHESAPEAKE

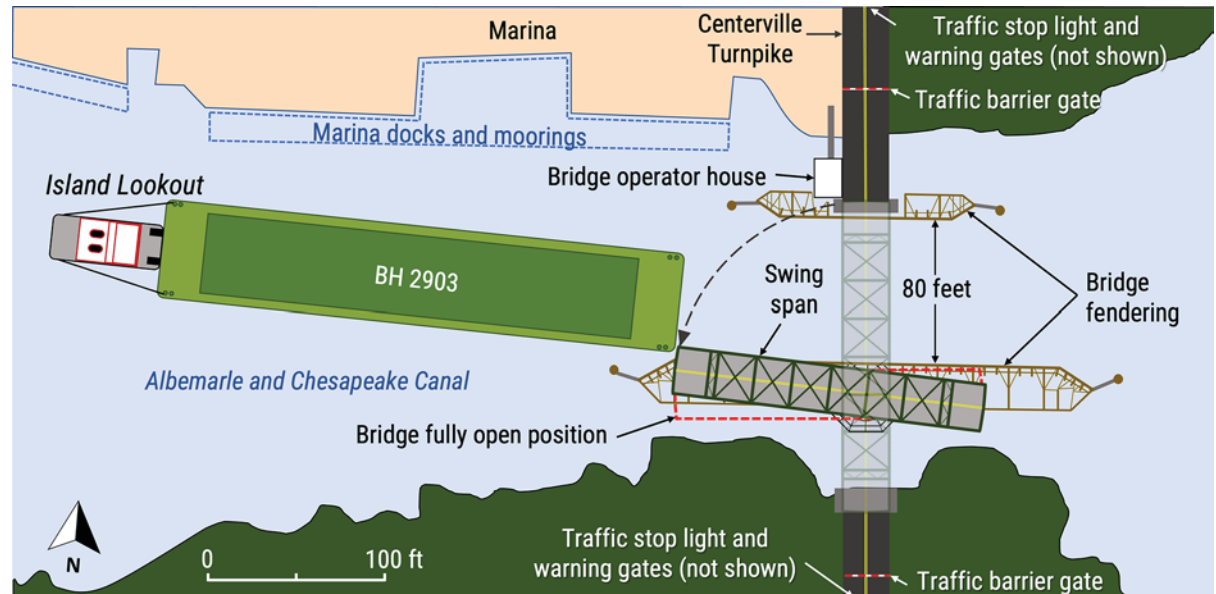
The probable cause of the contact of the *Island Lookout* tow with the Centerville Turnpike Bridge was the mate's misjudgment of the tow's speed of approach relative to the status of the swing bridge opening, which resulted in insufficient time to slow the tow and avoid striking the bridge before it was fully open and safe to navigate.

Figure 67. Illustration of the Centerville Turnpike Bridge at the time of the accident.

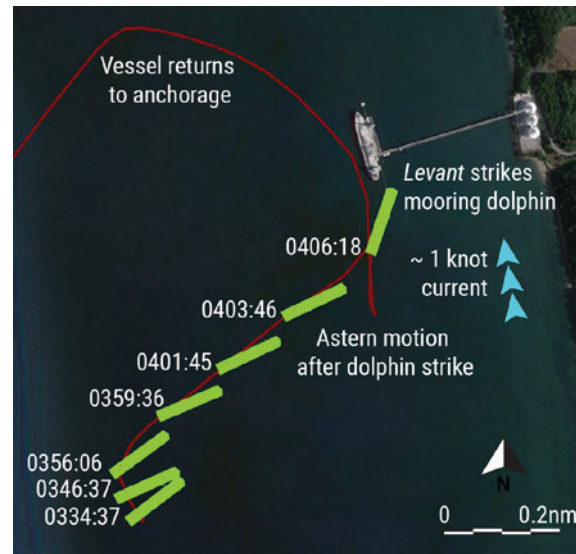
The probable cause of the contact of the liquid petroleum gas carrier *Levant* with a mooring dolphin at the Petrogas Ferndale Wharf was the pilot's approach with excessive speed and at too steep an angle, resulting from the pilot's and bridge team's poor bridge resource management.

Figure 70. The *Levant's* positions as it moved from the anchorage to the Petrogas Wharf, based on AIS data. Vessel scale approximate; vessel at pier was not present at the time of the accident.

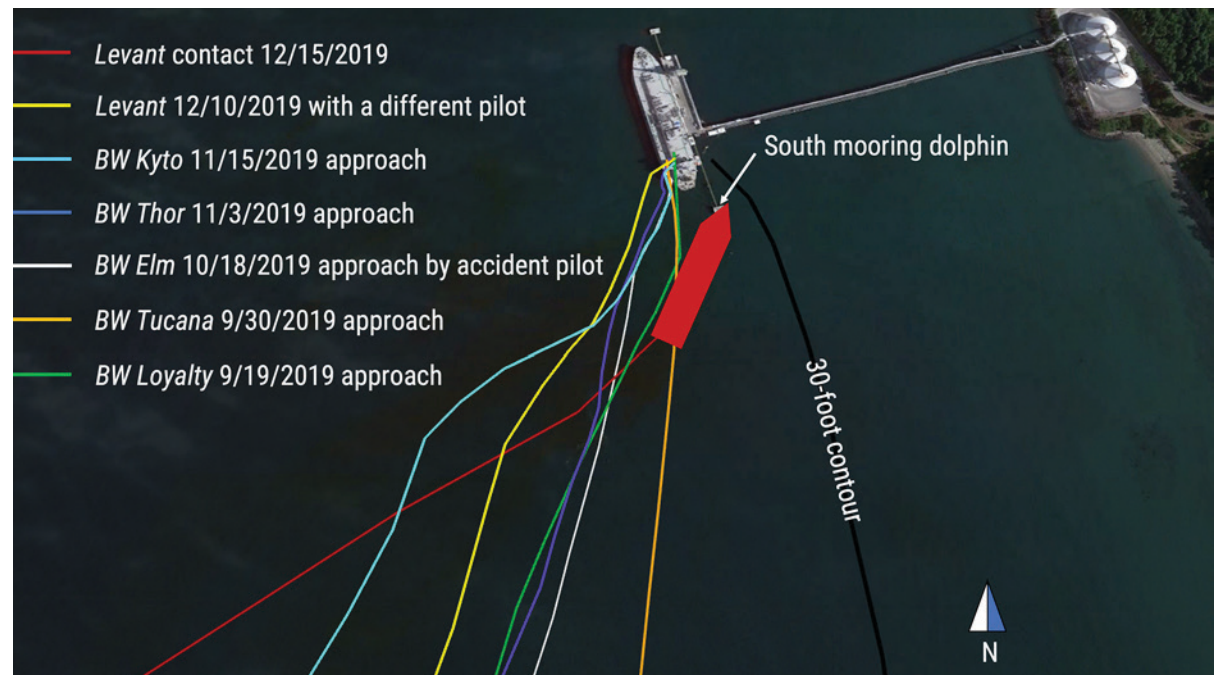
Figure 71. Below: AIS tracks of all liquid petroleum gas carrier approaches to the Petrogas Wharf from September 19 to December 15, 2019. Included is the initial approach of the *Levant* to the wharf on December 10 (yellow line), and the accident pilot's last approach to the wharf on October 18 (white line). *Levant* scale approximate; vessel at pier was not present at the time of either approach.

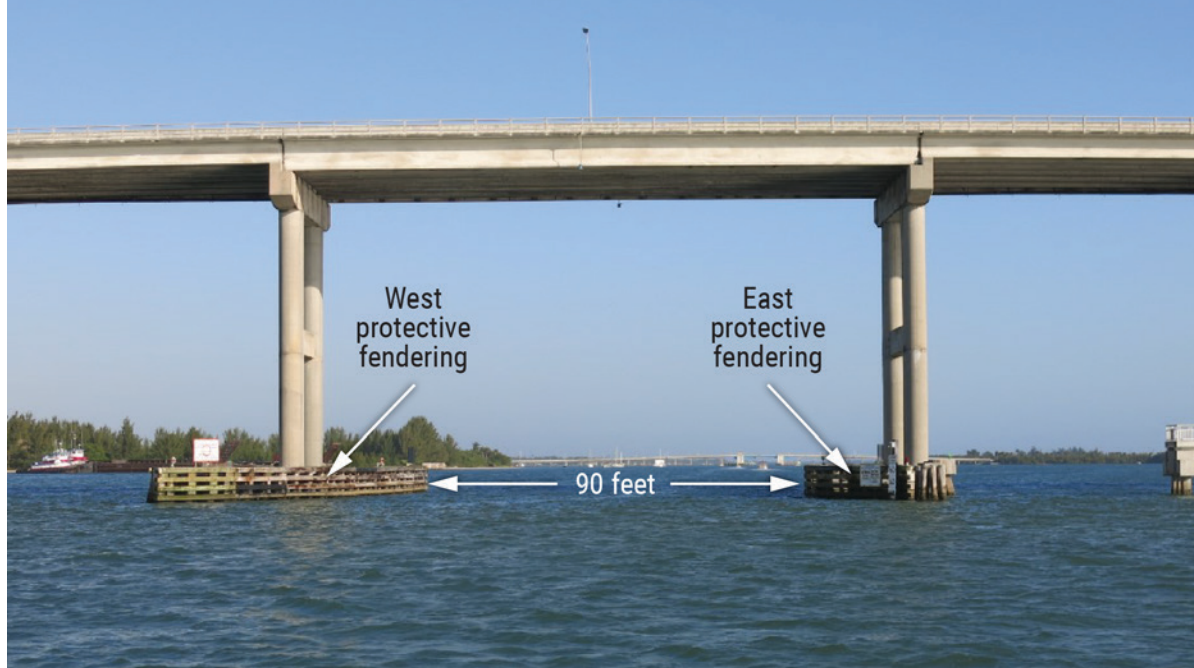
Figure 73. The ICW approach to the Peter P. Cobb Memorial Bridge from the south.

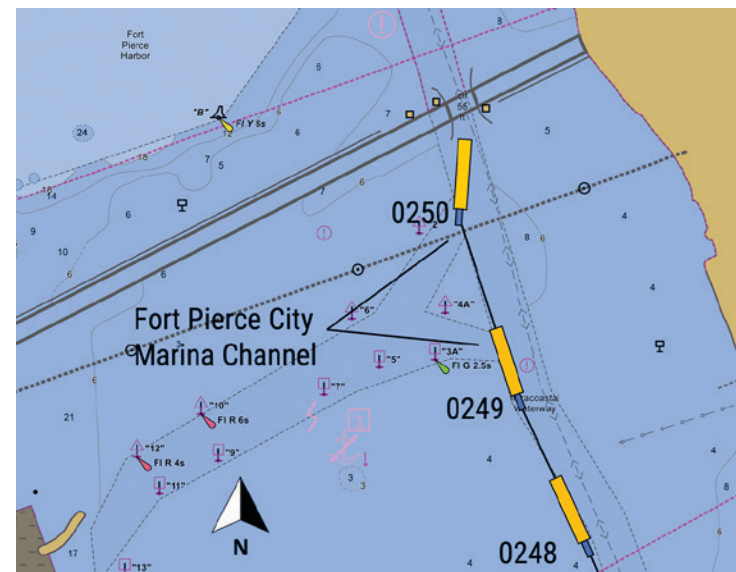
At 0248, about a quarter mile from the bridge, both the *Old Glory* and *Cole* were now outside the channel's western limit by about 65 feet. The relief captain explained that the current took the head of the tow to the west (port), which he was not expecting; he applied rudder correction to starboard. At 0249, the tow had returned to the channel's western limit with a speed of 6.1 mph. The relief captain observed the current again set the tow to the west just before the vessel reached the bridge.

Figure 75. AIS trackline of the *Old Glory* and *Cole* outside of and alongside the western boundary of the ICW.

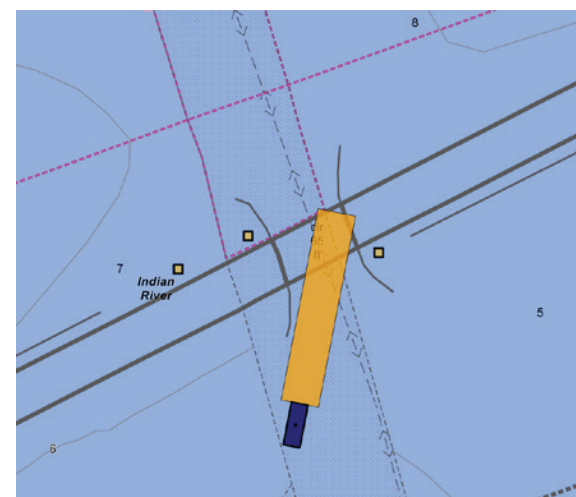
The tow became wedged under the bridge, where the vessel owner, and the crew replaced the starboard face wire. According to the relief captain, "when the tide finally changed," the tow "straightened itself out" under the bridge and floated out to the south with the rising tidal flow, and the tow was back under way and passed through the bridge at 0635.

Figure 76. The approximate position of the tow after striking the protective fendering system under the Peter P. Cobb Memorial Bridge.

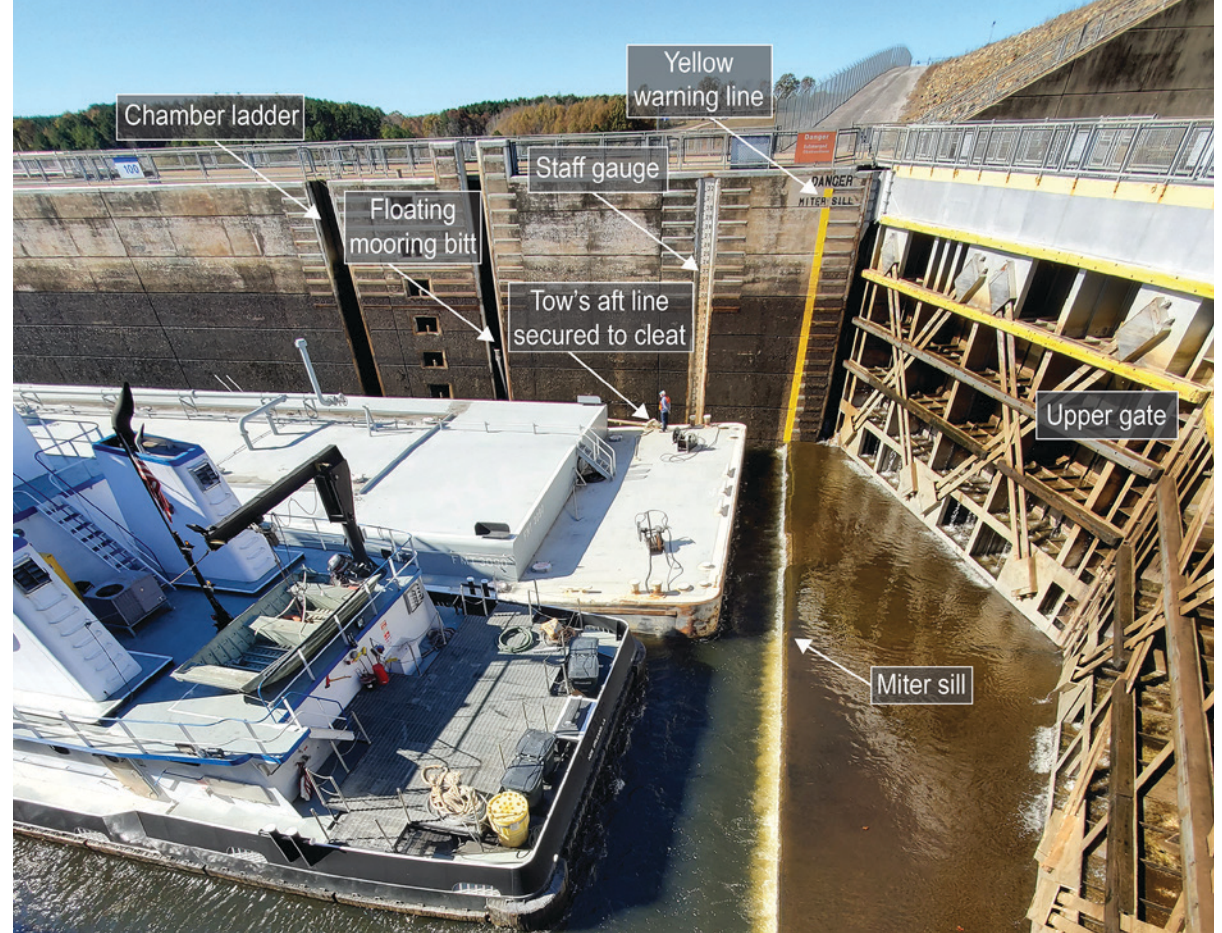
Figure 78. A tow with a similar arrangement to the *Savage Voyager* locking down in the lock chamber after the accident, with newly repainted warning line. BACKGROUND SOURCE: US ARMY CORPS OF ENGINEERS

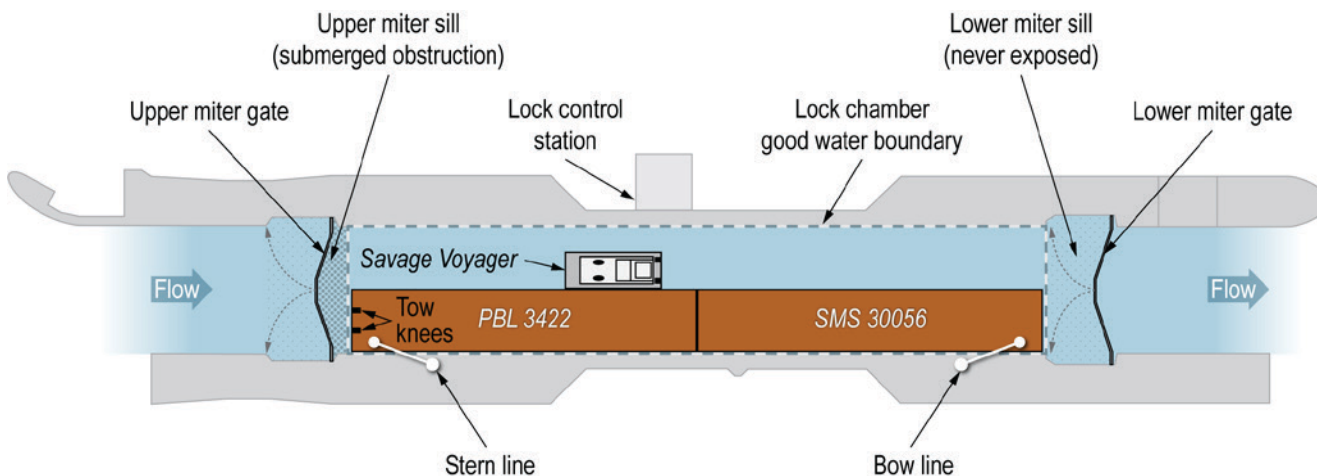
Figure 79. Depiction of *Savage Voyager* tow prior to locking down (towboat position approximate).

The on-watch deckhand and tankerman followed the Corp of Engineers' standard operating procedures and used two lines (one forward and one aft) to secure the two barges inside the lock chamber. The 678.5-foot-long tow would not fit in the lock chamber, so the crew "knocked out" the *Savage Voyager* and secured the towboat alongside the barges, ensuring the tow did not cross the yellow warning line that marked the upper gate's submerged miter sill.

The probable cause of the contact of the *Savage Voyager*'s tow with the Jamie Whitten Lock & Dam was the tow moving out of position in the lock chamber while locking down when the crew did not effectively monitor and maintain the vessel's position during its descent, resulting in the aft barge becoming hung on the upper gate miter sill.

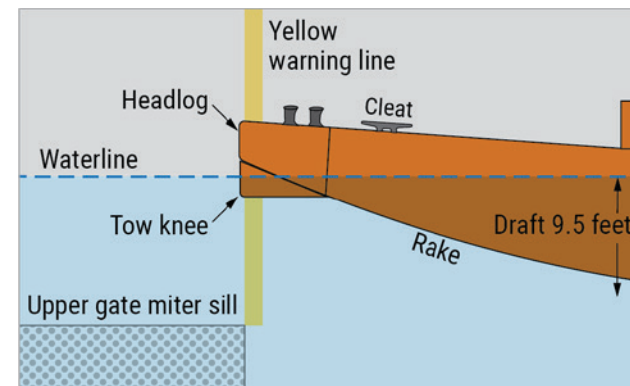
Figure 80. Depiction of the *PBL 3422* in lock chamber during lock operations (not to scale).

Once the *PBL 3422*'s rake became hung on the concrete miter sill, the deckhand notified the pilot, who sounded the towboat's general alarm and radioed the lock operator to halt the locking process. However, since it took over 2 minutes for the emptying valves to fully close, the water continued to rapidly descend in the lock chamber, and the barge became hung on the sill, bending the rake and breaching the forward cargo tank before the barge dropped into the water.

Although locking operations can seem routine, the margins for safety are frequently low. Maintaining vessel position and communication with the lock operator are critical practices to ensure safe lockage. Crews should avoid complacency and vigilantly monitor lines at all times to prevent "running" in a lock.

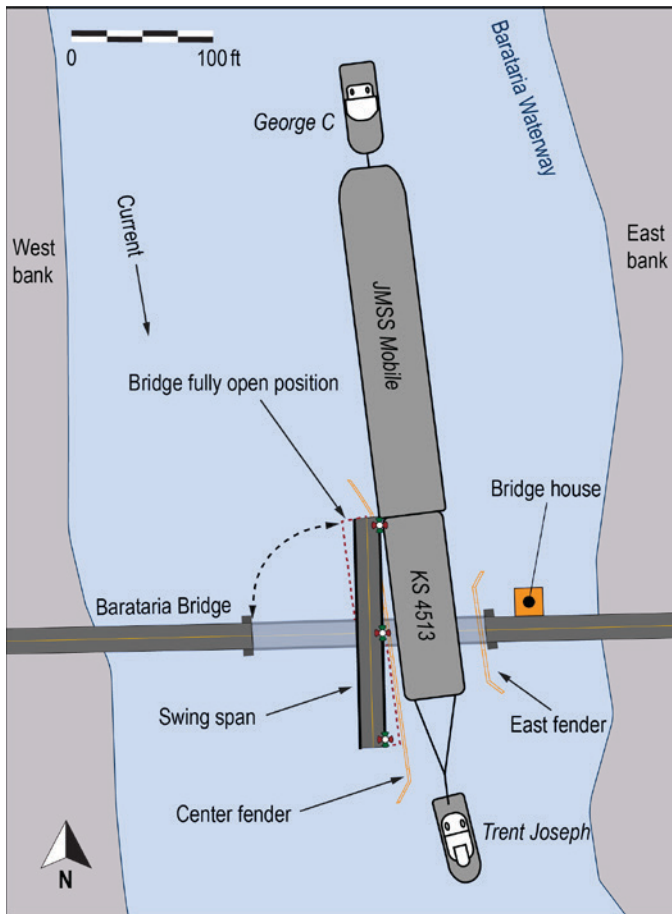
Figure 83. Estimated position of the *Trent Joseph* tow as it passed through the Barataria Bridge and approximation of the contact of barge *JMSS Mobile* with the northeast corner of the swing span. (Navigation lights not to scale.)

Photos taken at the scene and a postaccident survey report confirmed that the swing span's beam was struck by the aft port corner of the aft barge. By design, the protective fender was in place to shield the swing span from being struck when rotated to the open position. As such, if the swing span had been behind the fender as it should have been, the tow would have contacted the fender instead of striking the swing span. Although the fendering system contained previous damage, if the tow had contacted the fender, damage (if any) to the fendering would have been minimal due to the tow's low speed.

The probable cause of the contact of the tow of the *Trent Joseph* with the Barataria Bridge was a corner of the bridge's swing span protruding outside of its protective fendering into the navigable channel after recently attempted repairs to the limit switch system that controlled the swing span's rotation limit.

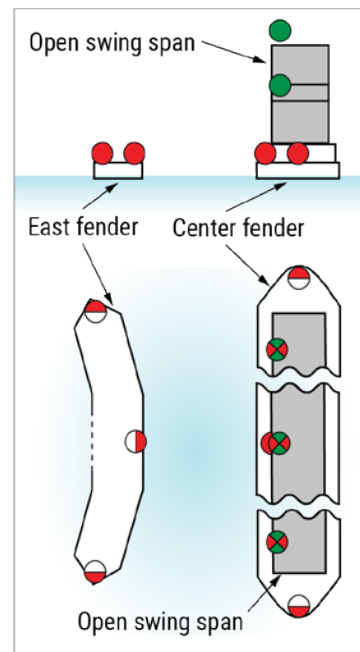
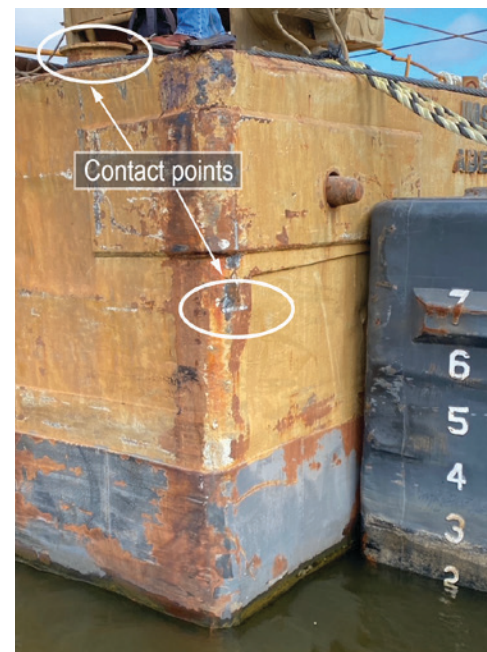
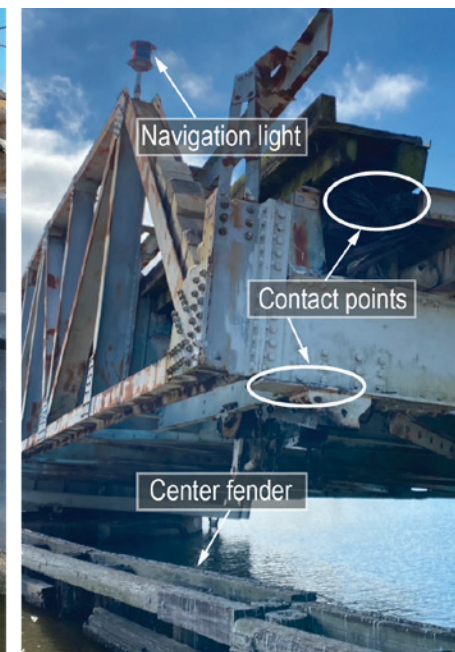
Louisiana DOTD maintenance records indicated that, 2 days before the accident, work had been conducted on the bridge's limit switches (which prevent the movement of the swing span beyond a predetermined point). Additionally, work had previously been performed on the limit switches on four occasions dating back to October 2019. Although no detail was provided in the maintenance records as to what sort of work and return-to-service testing was conducted, these records indicate a recent issue with the span's opening rotation limit.

Figure 84. Left: Simple representation of fendering and swing span lighting; profile (top) and plan (bottom) views. BACKGROUND SOURCE: COAST GUARD. Middle and Right: Postaccident damage to the corner of barge *JMSS Mobile*, with damage markings and scrapes about 6 feet above the waterline, and to the northeast corner of the Barataria Bridge, with points of contact with the barge *JMSS Mobile* indicated. SOURCE: ANONYMOUS.

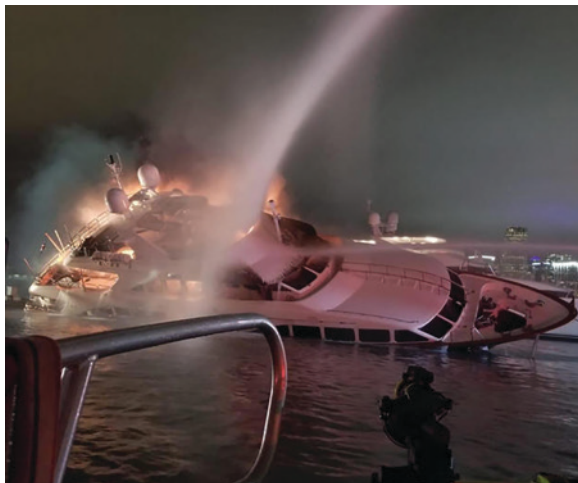
Figure 85. *Andiamo* listing to starboard as fireboats attempt to extinguish the fire. SOURCE: MIAMI-DADE FIRE RESCUE

The probable cause of the fire aboard the private yacht *Andiamo* was burning candles left unattended that resulted in an undetected fire in a guest cabin. Contributing to the severity of the fire was the crew’s failure to complete timely repairs to a fire-detection and alarm system known to be inoperable for two months.

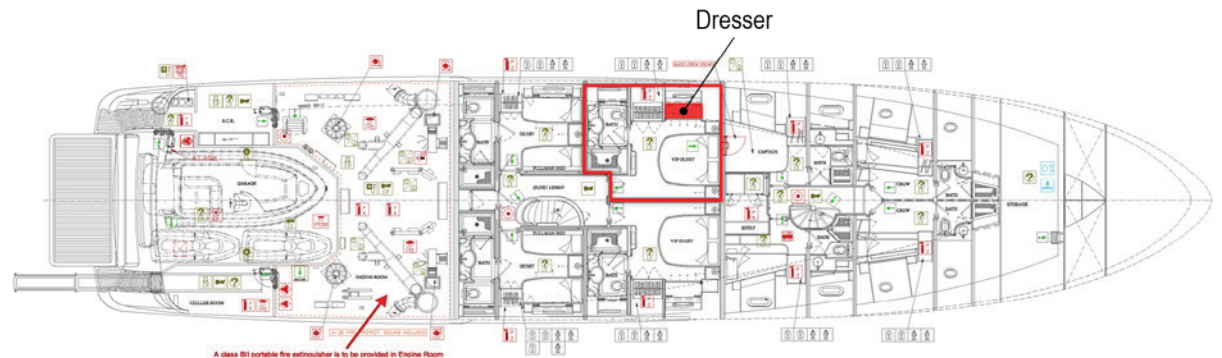
Figure 87. Plan view of the lower deck showing the dresser in the port VIP suite where the candles were lit. SOURCE: BENETTI FIRE & SAFETY PLAN

The postaccident fire report revealed the fire originated in the port VIP suite. As the *Andiamo*’s flag state warned, “leaving open flames such as...candles unattended” poses a fire risk. The candles also had not been secured on candle holders or any other type of secondary containment to ensure they would remain stationary, a precaution particularly important on a vessel likely to sway even within its berth. As the open flames burned, the curtains hanging above the dresser nearby likely provided the combustible material that started the fire. The vessel’s interior spaces were framed in wood with veneer, as well as outfitted and furnished with wood and other flammable materials, allowing the fire to spread upward.

According to the National Fire Protection Association, burning candles results in hundreds of millions of dollars in damages ashore in the United States, including injury and loss of life. Candle usage on a vessel, whether attended or not, also poses a fire risk. Given the dynamic environment of a vessel, candles can move, and their open flames can ignite combustible materials. The abundance of flammable materials on board can allow a fire to quickly spread out of control. Flashlights and battery-powered lighting are safer alternatives to use during a loss of electrical power.

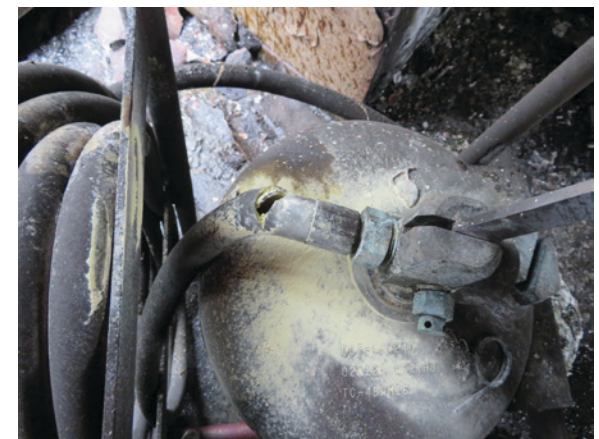
The doors from the weather deck to the engine room were closed since the vessel was under way, but the exterior windows were open for engine room ventilation. The crew was unable to close them due to heat and smoke from the fire. The steel door between the rudder room and the upper engine room was open, and fire spread aft to that space. The two semi-portable extinguishers, stowed on each side of the upper engine room, were the only means for the crew to fight the conflagration. However, the portside extinguisher was inaccessible due to the flames, and the hose on the starboard extinguisher failed proximate to the extinguisher.

Figure 91. Semi-portable extinguisher in starboard engine room following the fire.

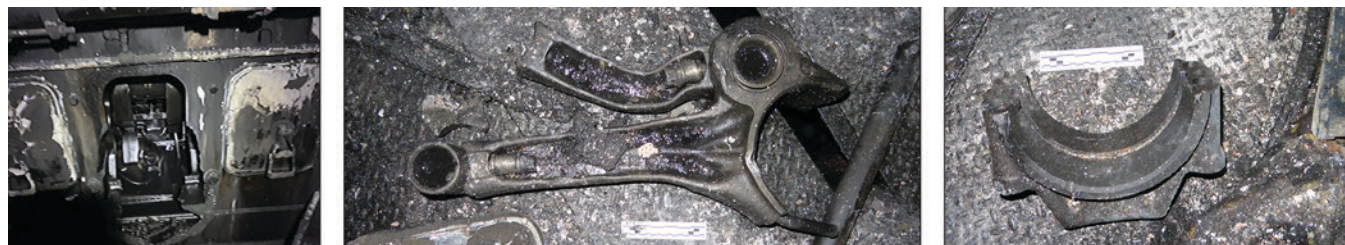
During a postaccident examination of the wreckage, the no. 4 left and right cylinder master connecting rods and articulating rods were found still attached to each other outside the crankcase, and the piston pin and connecting rod clamp were missing. Therefore, the initial failure was likely of the connecting rod clamp or the bolt that held the piston pin. Regardless, the force of the connecting rods driven loose inside the engine was enough to puncture a hole in the side of the crankcase on the port side and eject the piston head through the no. 4 right cover on the starboard side.

The failure of the connecting rod and subsequent catastrophic damage to the crankcase likely allowed hot pressurized fuel and oil to spread to the lower engine room and thereby ignite. The significant heat and smoke damage to the upper engine room indicated that the fire spread up the port side of the engine room, then aft in the upper engine room, and eventually to the rudder room. The air drawn through the open windows in the upper engine room likely further exacerbated the fire's spread.

Figure 93. Holed crankcase at no. 4 left cylinder inspection cover (left), no. 4 left and no. 4 right connecting rods (middle), and connecting rod clamp (right).

The probable cause of the fire aboard the towing vessel *City of Cleveland* was the catastrophic failure and crankcase breach of the port main engine resulting from the failure of a connecting rod assembly. Contributing to the severity of damage to the vessel was the lack of a fixed fire-extinguishing system for the engine room, as well as the loss of electrical power to the single fire pump.

Engine rooms contain multiple fuel and ignition sources, making the spaces especially vulnerable to rapidly spreading fires. Designers and operators of towing vessels should evaluate fire hazards and provide effective means to mitigate them. Operators should have equipment and procedures in place to quickly contain and suppress engine room fires before they can spread to other spaces and/or cause a loss of propulsion and electrical power.

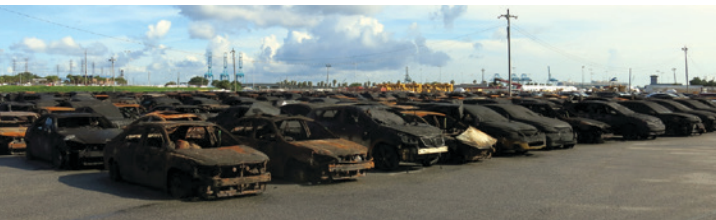
Figure 95. Thermally damaged vehicles after removal from the *Höegh Xiamen*, Blount Island, Jacksonville, Florida, July 23, 2020.

Grimaldi Deep Sea, the vessel's charterer, provided SSA Atlantic stevedores with their battery disconnect procedure. However, after the accident, Coast Guard investigators examined several of the used vehicles loaded on board the vessel and found improperly secured batteries. Stevedores stated that some of the vehicles stored on decks 7 and 8 had sustained so much damage

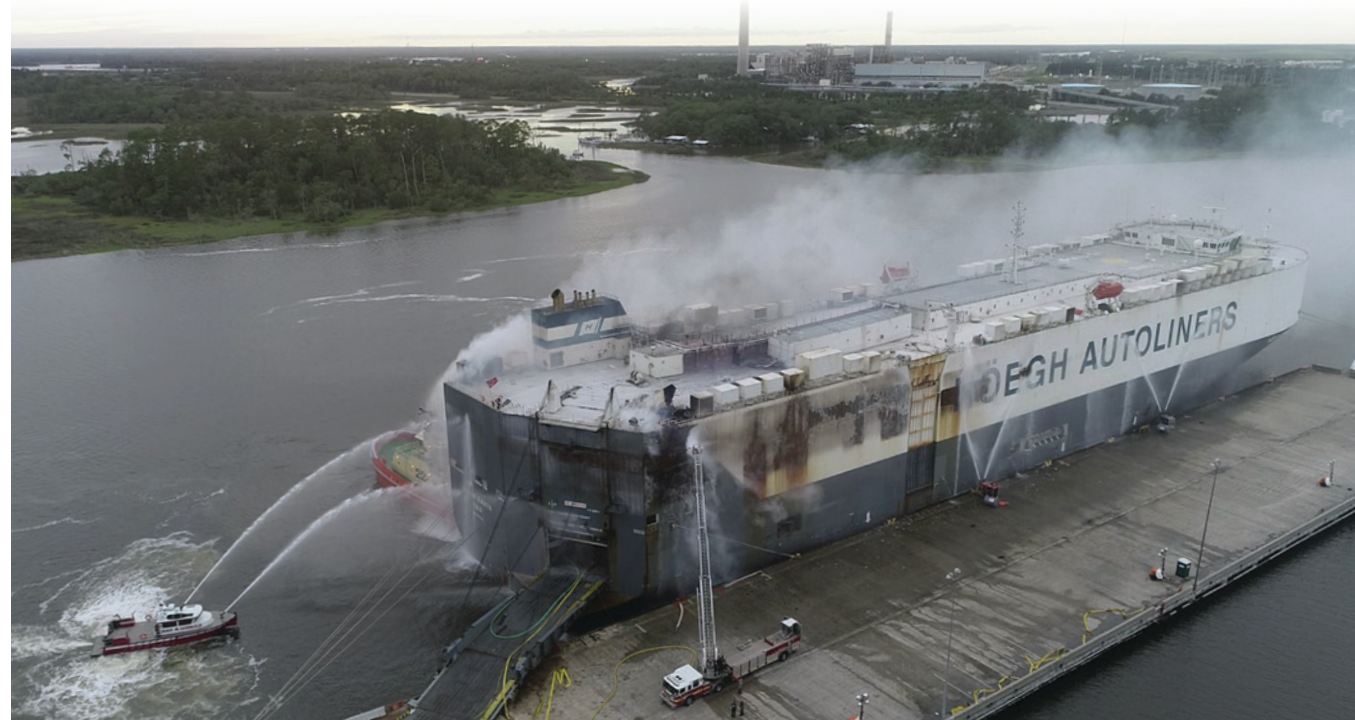
Figure 96. Firefighters conducting exterior boundary-cooling the day after the fire was discovered. SOURCE: JACKSONVILLE FIRE AND RESCUE DEPARTMENT

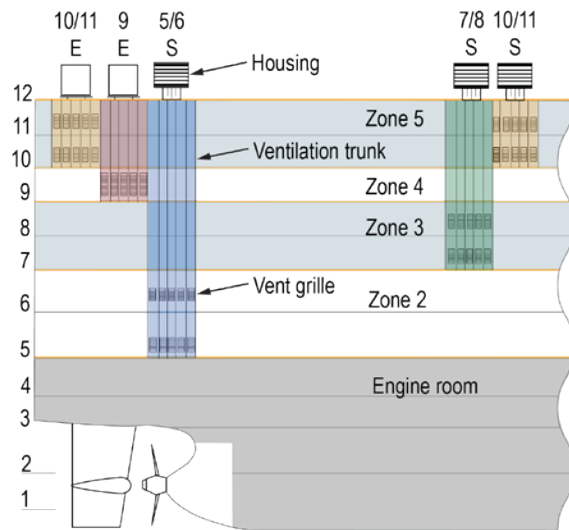
Crewmembers discovered a fire on cargo deck 8. The chief mate sent the vessel's electrician to close the remotely controlled ventilation dampers, which slowed but did not stop the smoke (the ventilation system's manually operated dampers remained open). The crew attempted to fight the fire but were repelled by heavy smoke. The master instructed the chief mate to close all the manual cargo deck ventilation housing dampers on deck 12 (the weather deck).

Figure 97. Arrangement of portside aft cargo ventilation trunks on deck 12. Each exhaust is marked with an “E,” and each supply is marked with an “S.” This only represents a portion of the exhaust and supply ventilation trunks.

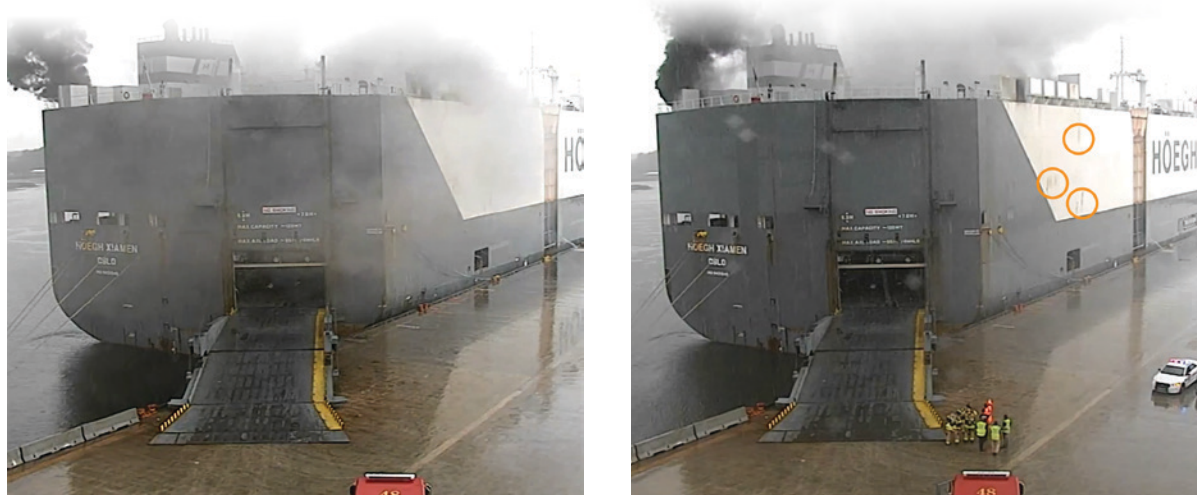
Figure 100. Left: Engine 48 arriving on scene about 1603. Starboard vents 10/11E and 7/8E and port vents 10/11E and 9E exhibit smoke flow. **Right:** About 1608, 5 minutes after Engine 48's arrival, the white paint on the starboard side of the vessel exhibits thermal discoloration (circled in orange). Starboard vents 10/11E and 7/8E and port vents 10/11E and 9E exhibit smoke flow. SOURCE: JACKSONVILLE PORT AUTHORITY

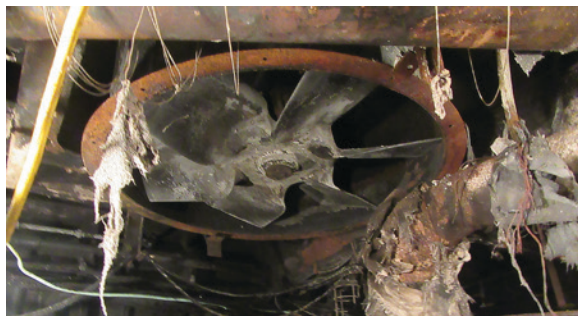
Figure 105. Starboard exhaust trunk fan (post-fire) located above the No. 1 generator. SOURCE: COAST GUARD

number one generator was directly under the starboard exhaust fan (which was secured) and had a fire cloth over it for protection from falling sparks that could come down the exhaust trunk. The shipyard foreman examined the generator room at approximately 0930 and determined that the space was safe, since there was no indication of fire or smoke.

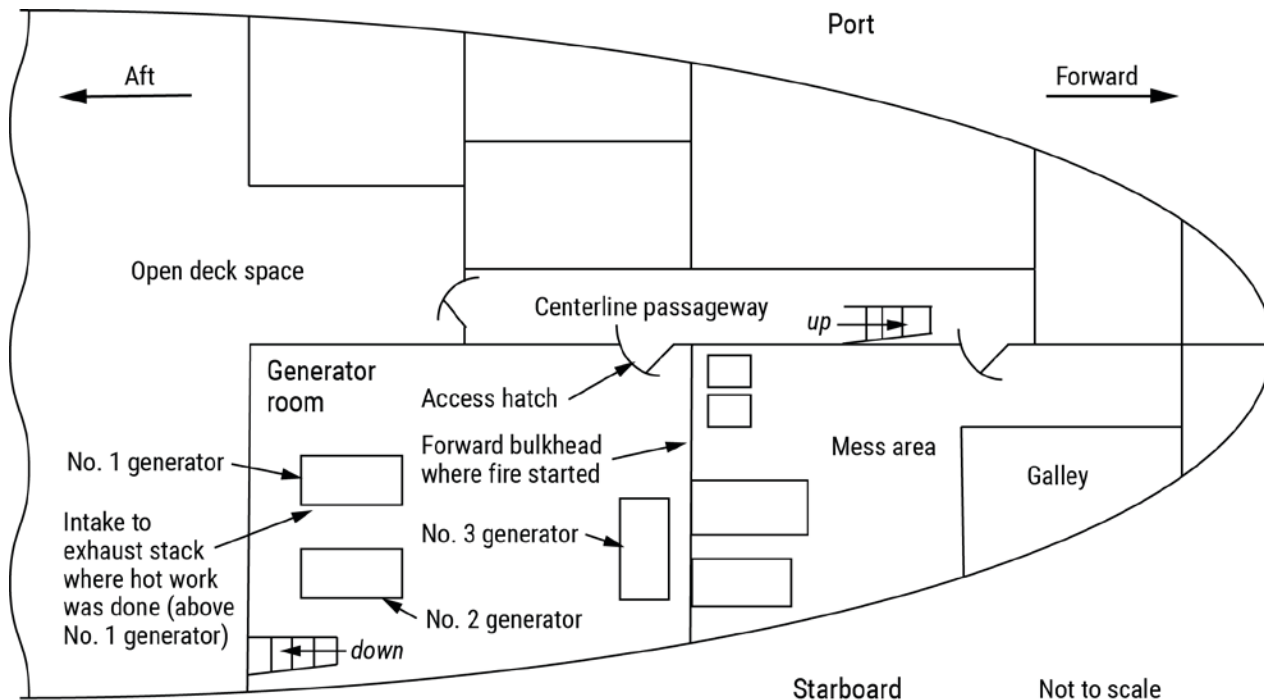
Figure 107. General layout of the *Iron Maiden* generator room and surrounding main deck spaces with area fire started as identified by the LaFourche Parish Fire District.

significant damage to the passageway outside the generator room and living quarters (above the generator room). They also noted smoke damage to the mess area and the galley (forward of the generator room) and the interior stern section of the pilothouse (two decks above the generator room), as well as sections of burned exterior paint around the starboard smoke trunk and pilothouse. Within the generator room, the most severe damage was observed on the forward bulkhead near the access hatch from the passageway.

The probable cause of the fire aboard the dive support vessel *Iron Maiden* was an electrical short from an unidentified source located on the forward bulkhead within the generator room. Contributing to the undetected propagation of the fire was the lack of continuous monitoring of the vessel while it was docked at the shipyard.

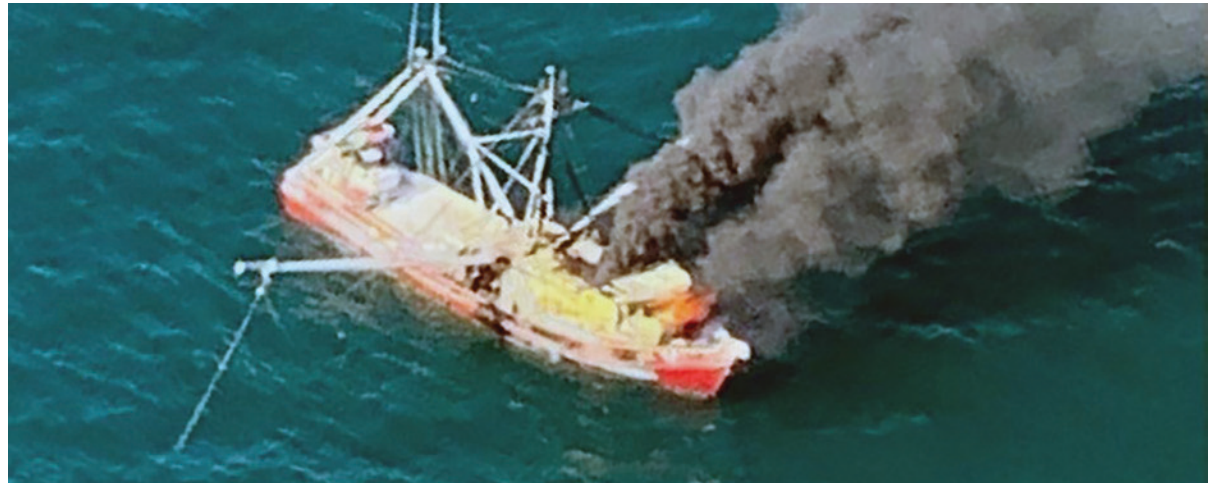
Figure 108. *Lucky Angel* on fire, December 11. SOURCE: COAST GUARD

The probable cause of the engine room fire aboard the fishing vessel *Lucky Angel* was the deterioration or chafing of wiring insulation, which caused arcing that ignited nearby combustible materials.

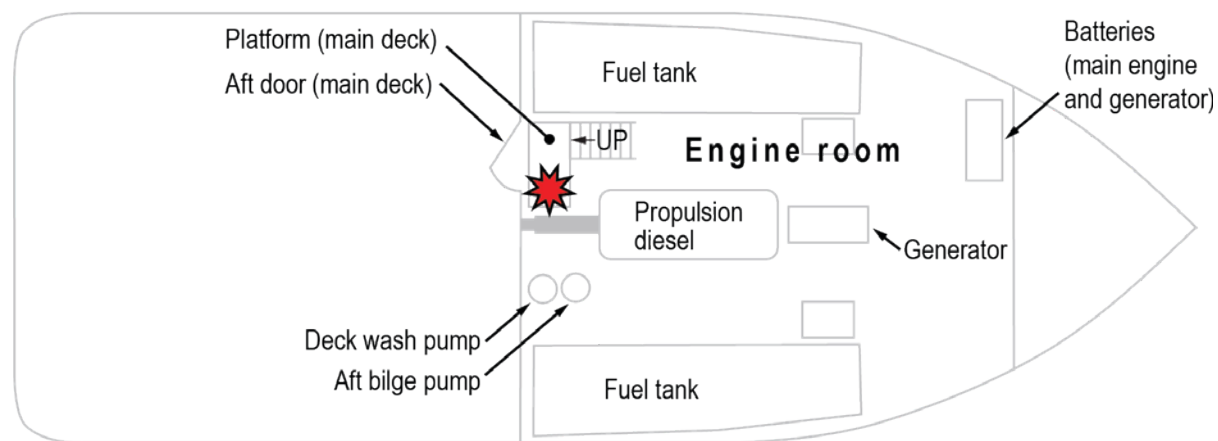
Without maintenance records or a pre- or post-purchase survey, investigators were unable to determine the condition of the wiring bundle. If the wiring was original, dating back to 1968, it may have deteriorated due to decades of being subjected to the atmosphere and chemicals found in a hot engine room environment. Chafing from the material used to support the wiring could have also caused the wires' insulation to fail. In either case, a failure in the floodlights and aft bilge pump wiring insulation likely caused arcing, which was the ignition source to the ensuing fire. The arcing would have ignited some form of nearby combustible material to initiate and sustain combustion. The fire then likely spread from the engine room to other combustibles in the house of the *Lucky Angel*.

Figure 111. Engine room layout and area where captain observed sparking.

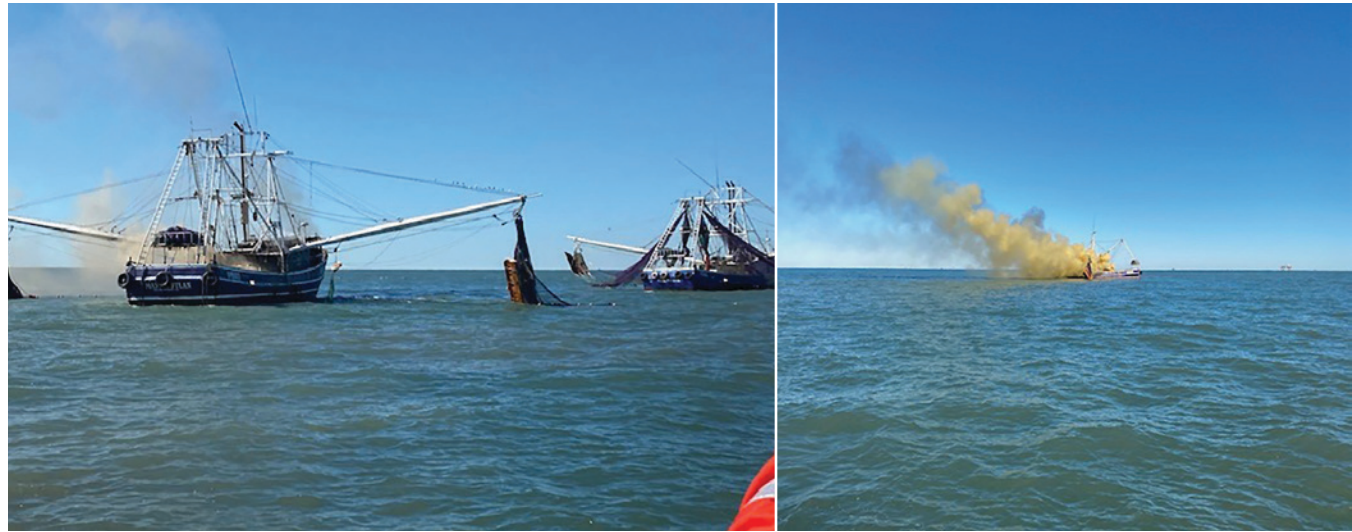
Figure 112. Photos taken from the Coast Guard small boat showing the *Master Dylan* aground after being towed by the *Master Dustin II* (left) and the burning *Master Dylan* cloaked in smoke (right). SOURCE: COAST GUARD

It is likely that the vessel's engine room hoses, connected to hull fittings to main engine cooling water systems, generator cooling water systems, and salt water service systems, failed due to the long-term exposure to the heat of the fire, which most likely resulted in the sinking of the vessel. As the hoses failed, water would have entered the hull, causing the vessel to lose stability, roll, and sink.

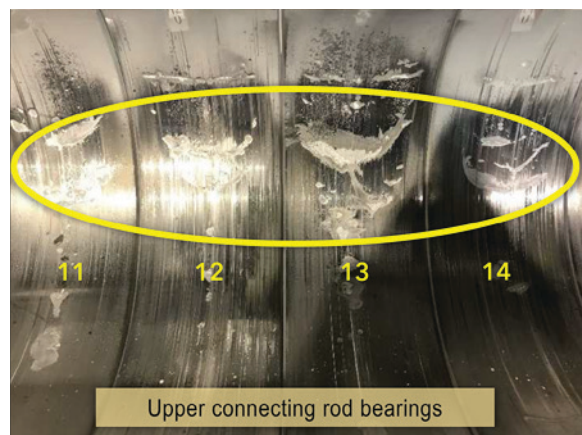
During the postaccident forensic teardown of the no. 3 DG, factory-trained technicians were able to identify the most likely sequence of events that led to the failure of the engine but were unable to determine the root cause due to several unknown preconditions of the engine. The possibility of fluid, such as cooling water or fuel oil entering the cylinder, causing a loss of clearance on the connecting rod bearing and starting the failure sequence was considered as a viable scenario; however, this theory could not be verified due to damaged components and operational alarms not activating before the failure. The condition of the connecting rod bearings, showing signs of cavitation erosion (some considered excessive) was another possible root cause of the failure. If the cavitation erosion became excessive enough, as found on cylinder no. 13's connecting rod bearing by technicians, it could have caused the bearings to fail due to increased tolerances between the components and excessive movement outside of these tolerances.

Figure 116. Cavitation erosion in upper connecting rod bearings from the no. 3 DG in cylinder nos. 11, 12, 13, and 14, encircled. SOURCE: OCEANEERING INTERNATIONAL, INC.

The probable cause of the diesel generator engine failure aboard the offshore supply vessel *Ocean Intervention* was a cylinder's connecting rod bearing adhering to the crankshaft, which led to the ejection of the connecting rod and catastrophic damage to the engine.
