NATIONAL TRANSPORTATION SAFETY BOARD

2021

SAFER SEAS Digest

Lessons Learned from
Marine Investigations

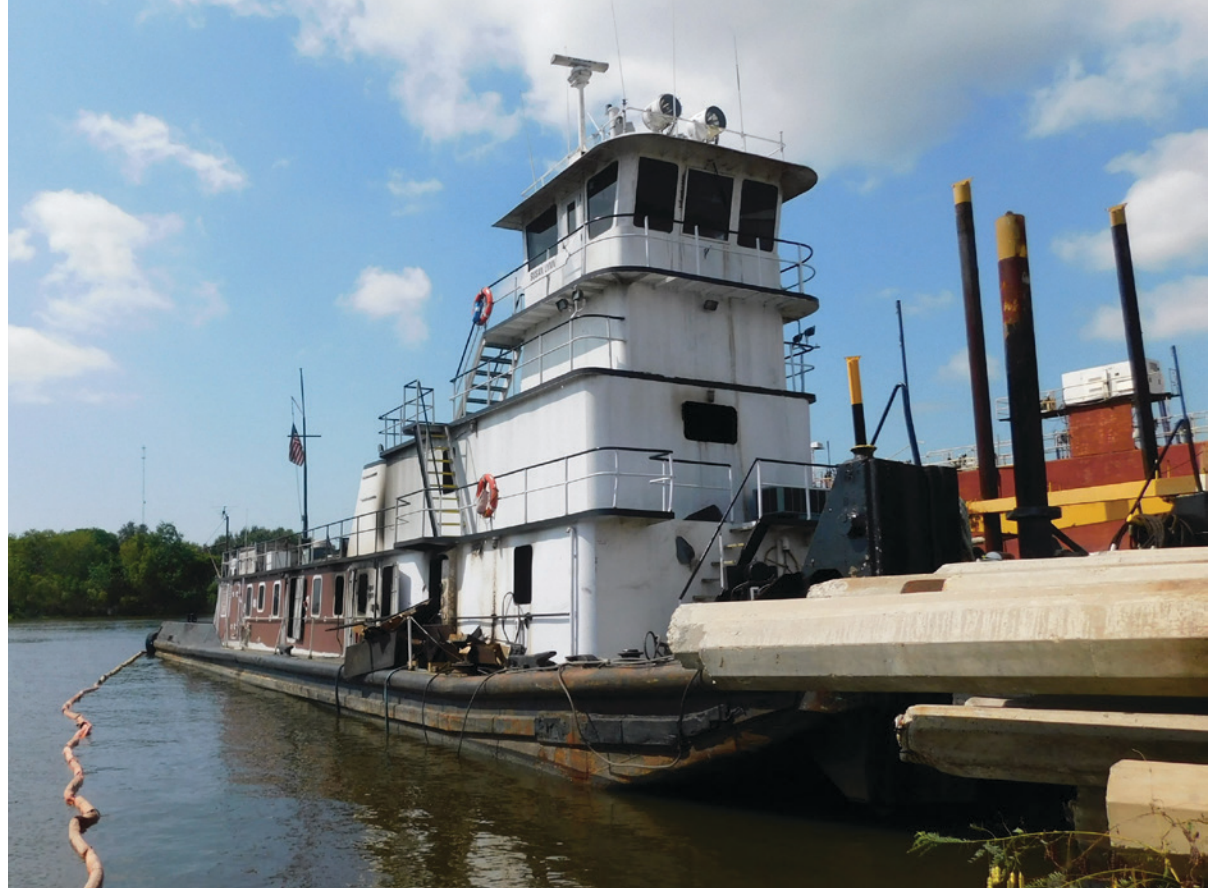
Figure 119. The *Susan Lynn* at its berth following the fire.

The heaviest fire damage was in the engine room, near the generators, with additional damage on the main and second decks forward of the galley. The fire's spread beyond the engine room was likely the result of the open position of the interior forward and aft centerline upper engine room doors, which had been left open while the vessel was in layup and remained open throughout the fire. While the vessel was in layup, the engine room doors should have been closed as a fire safety measure.

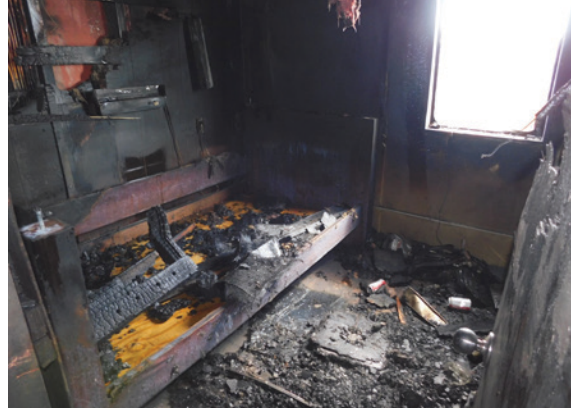
Figure 122. Crew quarters on board the *Susan Lynn*.
SOURCE: LOUISIANA OFFICE OF STATE FIRE MARSHAL

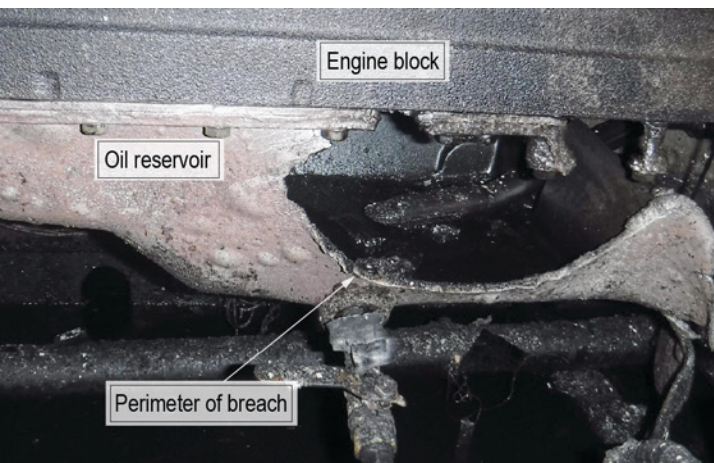
Because of the limited evidence, the exact cause of the fire and the generator's engine failure cannot be determined. However, the rupture of the oil reservoir may have been caused when part(s) of the failing connecting rod and/or a piston struck the inside wall of the oil reservoir. A rod and/or piston striking and then rupturing the oil pan would have released oil into the engine room under heat and pressure. This ejected lube oil mist may have ignited off a hot surface, potentially the generator's unlagged (not insulated) exhaust components. The intensity and duration of the fire was likely exacerbated by the melting of the bowl on the bottom of the generator's Racor fuel filter combined with the vessel's fuel shutoff valves not being closed, allowing additional fuel for the fire.

Figure 121. Ruptured *Susan Lynn* port generator oil reservoir. BACKGROUND SOURCE: COAST GUARD

Examinations of the vessel by Coast Guard investigators and inspectors, a Louisiana State fire marshal investigator, and the *Susan Lynn's* operator provided limited evidence to identify the cause of the engine failure and subsequent fire. They noted significant damage to the port generator oil reservoir, including a hole in it, and that the generator engine exhaust piping had no lagging installed. The fire marshal investigator could not identify the cause of the fire, saying he could not "rule out mechanical/electrical failure" nor identify the heat source that ignited "combustible materials and ignitable liquid fuel." The vessel operator told investigators that he noticed the connecting rod had separated from piston number 3 and was hanging down through the hole of the ruptured oil reservoir and still connected to the crankshaft. Detailed evidence was not available because a forensic examination of the port generator engine was not conducted, nor was the engine rebuilt.

The probable cause of the fire on board the *Susan Lynn* was a catastrophic engine failure resulting in an oil reservoir breach and an ensuing fire initiated by ejected lube oil igniting off a hot surface. Contributing to the extent of the fire were the open engine room doors and the unsecured fuel shutoff valves.

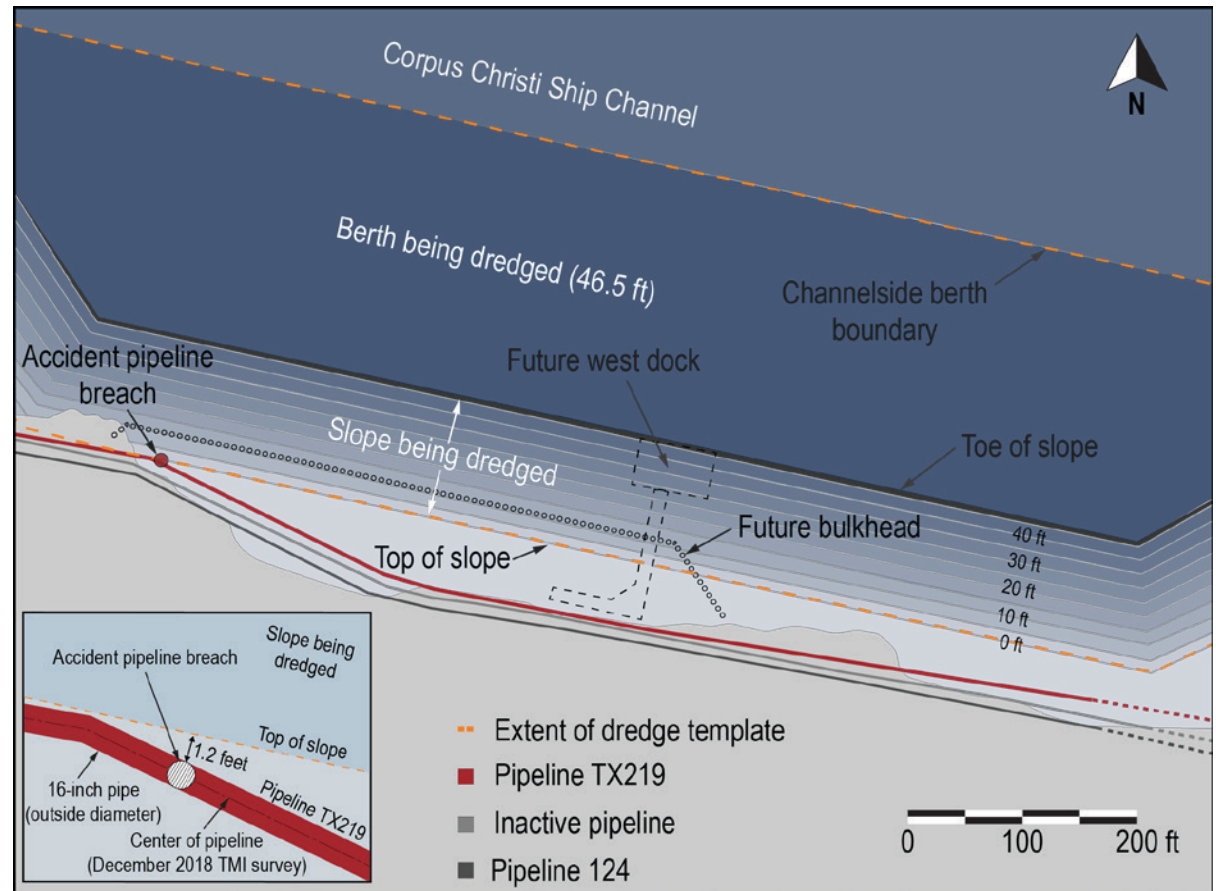
As a result of their assessment of plans and information provided by the project engineer, Enterprise technicians closed the one-call tickets, believing pipeline TX219 would be clear of the project and there would be no dredging near the shoreline. Thus, technicians concluded that no marking or other protective measures would be required because the dredging boundary exceeded the Enterprise damage prevention program 50-foot distance limit for mandatory marking.

Figure 127. NTSB depiction showing comprehensive view of dredge template and pipeline locations.

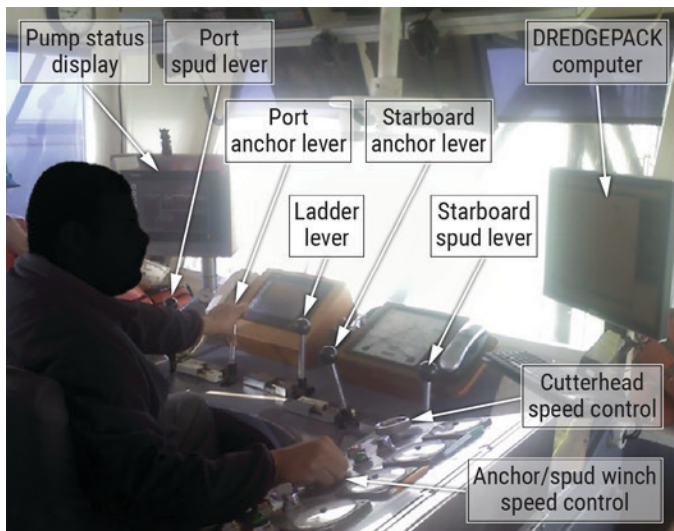
Figure 132. Above: *Waymon Boyd* lever room postaccident.

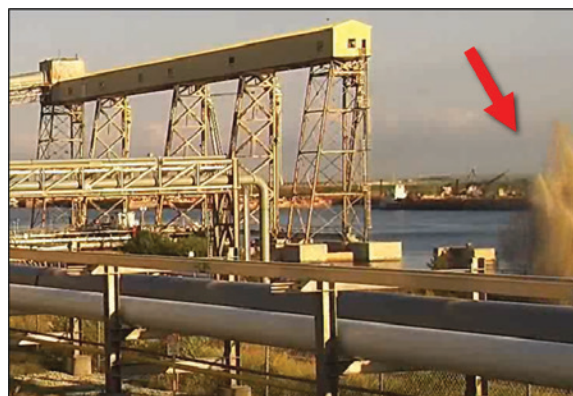
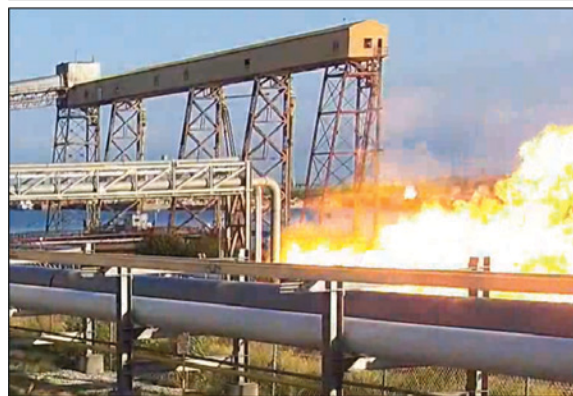
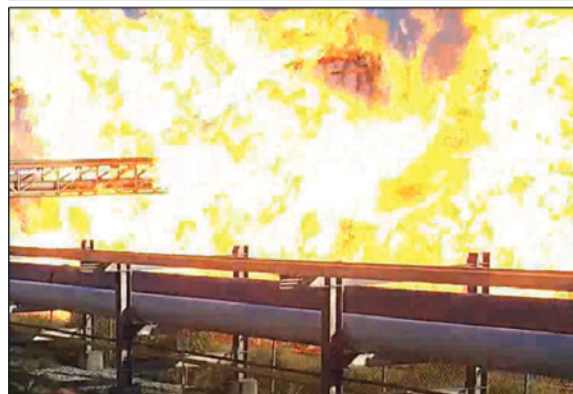
Figure 134. Screen captures from security camera footage showing (top to bottom) the water and gas eruption before the explosion (as noted by red arrow), the initial explosion, and the ensuing fireball. The *Waymon Boyd* is outside of the frame of the camera.

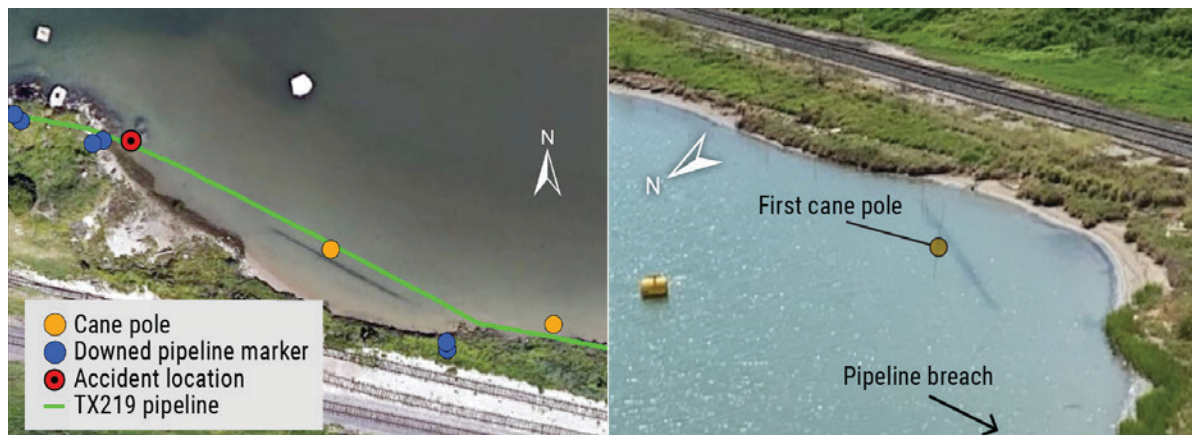
Figure 137. Postaccident temporary and permanent pipeline marker survey locations, accident location, and pipeline TX219 (left); preaccident photo of marking cane pole (right).

Proper line locating and marking by the pipeline operator following a one-call notification are necessary to ensure that an excavation will be sufficiently clear of buried pipelines. Although Enterprise courtesy-marked the pipelines with cane poles, the markers did not meet pipeline excavation damage protection standards, nor were they required to, based on the incorrect information provided by Orion, and therefore were insufficient to visually warn the leverman of the danger of the pipeline. Further, a technique known as white-lining (the placement of white paint or flags to delineate the boundary of proposed excavation areas) could have been used on this project as an added measure of communicating the precise location of proposed excavation/dredging activity to pipeline technicians in advance of their one-call review. Project boundary marking requirements for dredging projects (equivalent to land-based white-lining requirements) would provide utility operators with additional visual

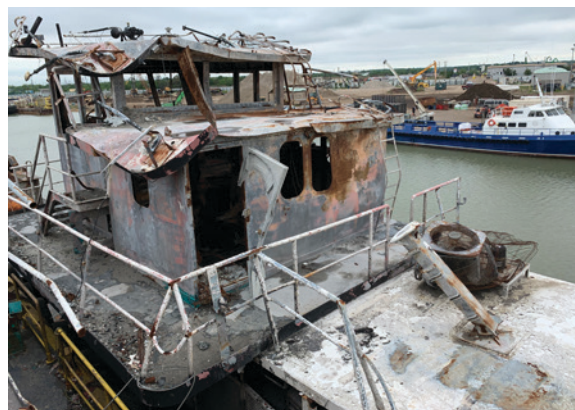
Figure 138. Post-salvage images of the *Waymon Boyd* lever room and captain's office (above) and engine room portside bulkhead, bowed outward (right).

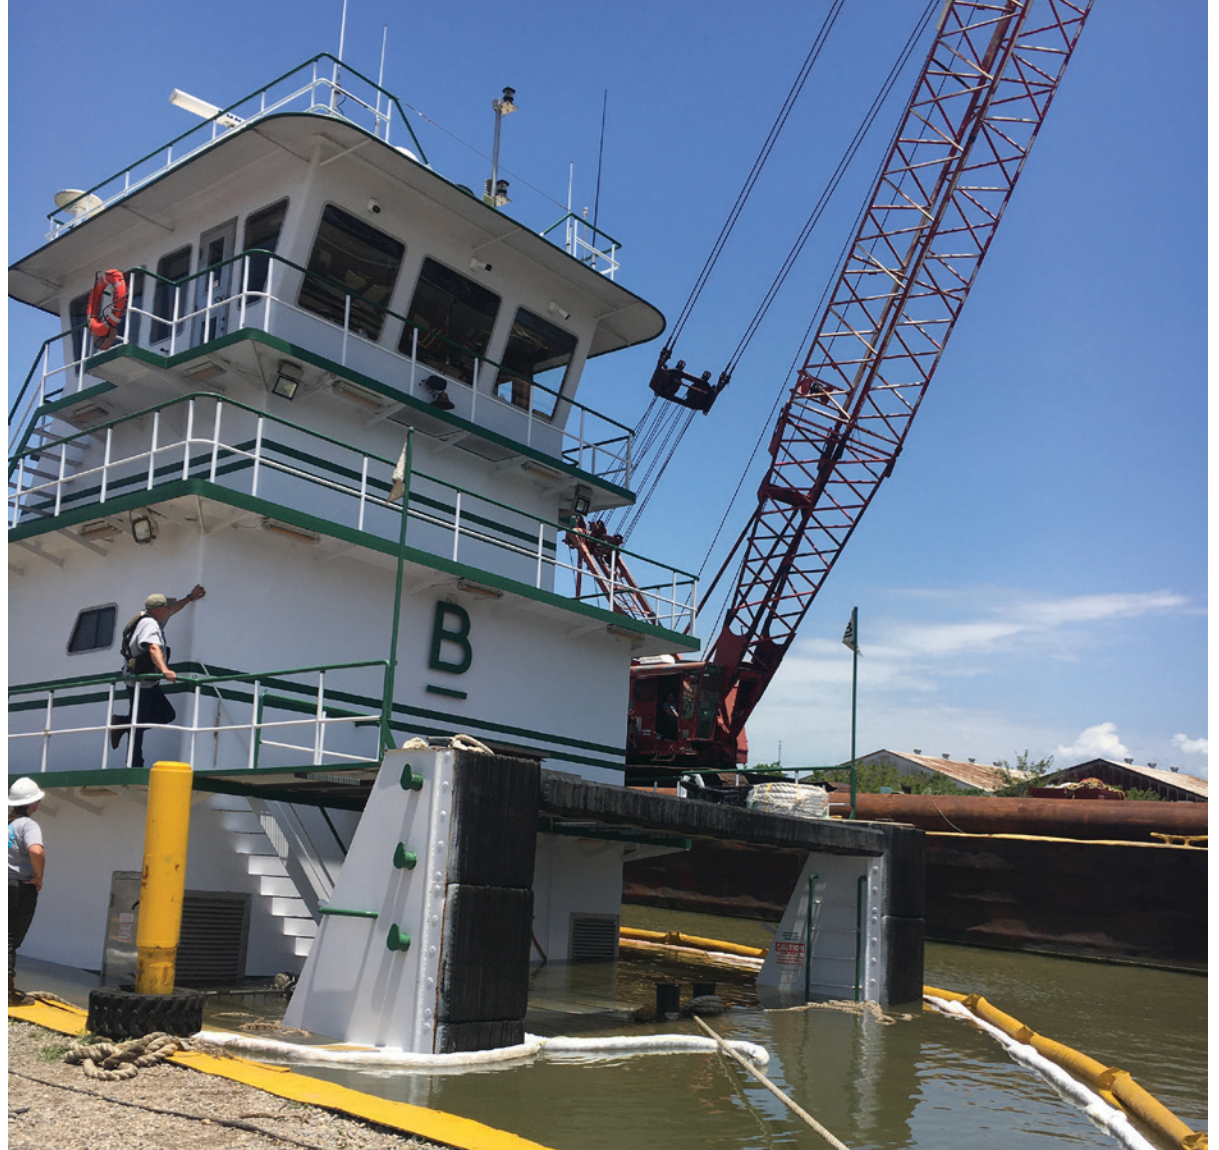
Figure 140. *Alton St. Amant*, partially submerged, on the morning of May 18. SOURCE: COAST GUARD

The general manager found the *Alton St. Amant* partially submerged and resting on the bottom of the canal alongside the pier. The engine room was flooded, and the main deck was partially submerged. The general manager noticed the potable water hose connected to the vessel was charged; he then closed the potable water supply valve on the pier manifold. Fresh water had been filling the potable water tanks for over 20 hours.

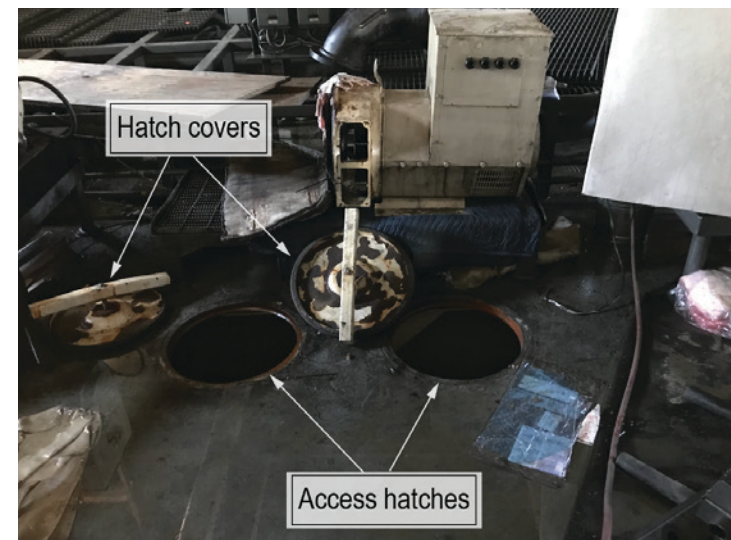
Figure 142. Open access hatches and their covers for the two potable water tanks in the rudder room.

The probable cause of the flooding of the towing vessel *Alton St. Amant* was the absence of shipyard pre-inspection and monitoring procedures for water transfer, which resulted in potable water tanks overflowing through their open access hatches during an unmonitored transfer.

Crew and shipyard personnel designated to conduct liquid transfers must be aware of the status of a vessel's tanks, including their access hatches and associated piping systems, whether ashore or at sea. When filling a tank, open access hatches create a risk of unintended flooding. Pre-inspection and monitoring of transfers provide the opportunity to identify and remedy any issues in order to ensure they are safely completed

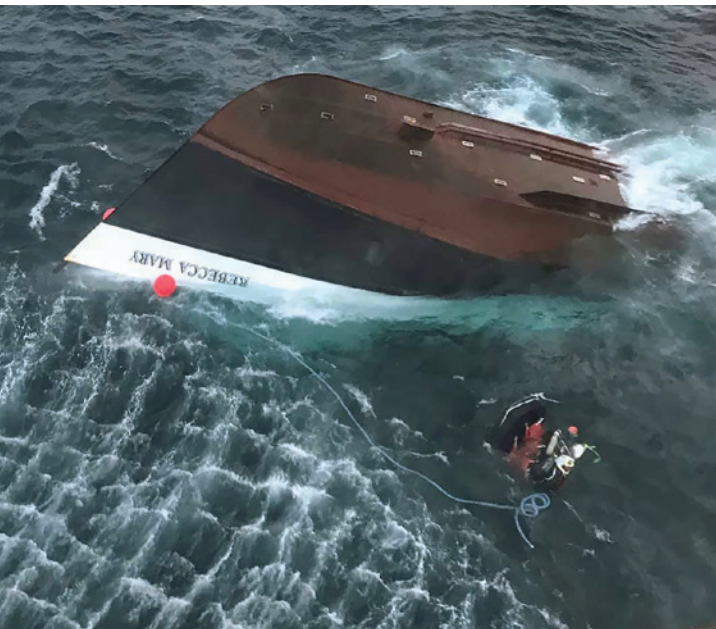
Figure 145. Inverted and mostly submerged *Rebecca Mary* during rescue operations on the morning of the sinking. SOURCE: COAST GUARD

The probable cause of the flooding and sinking of the fishing vessel *Rebecca Mary* was undetected flooding of the lazarette, likely through a non-watertight raised hatch.

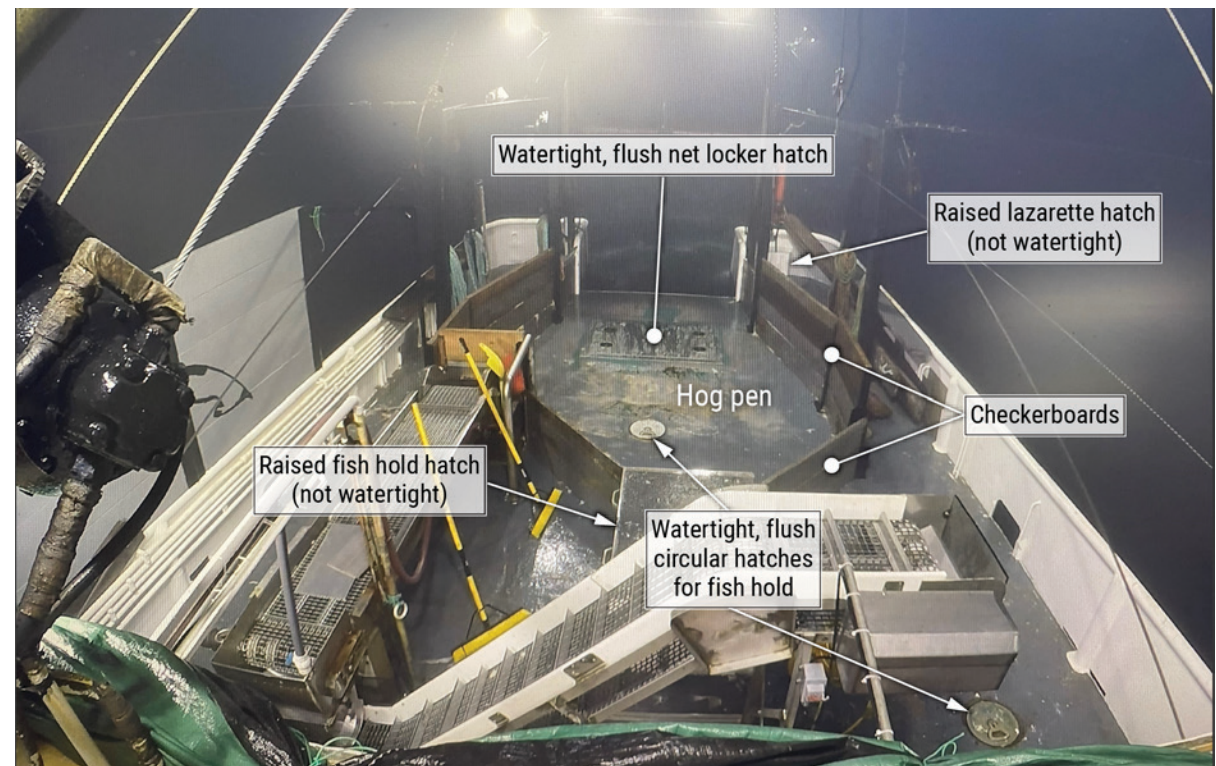
About 0400, the fish hold high-level bilge sump alarm sounded, which, according to the deckhand, was typical during a watch, due to melting ice. Crewmembers observed that the stern was sitting low enough that seawater began washing over and covering the non-watertight, raised lazarette hatch, which was equipped with a cover that could not be latched closed. The captain believed the cover for the lazarette was no longer sitting on top of the hatch after the water level rose above it. It is likely that seawater displaced the lazarette cover, causing the lazarette to flood through the open hatch. As seawater entered the lazarette, the vessel's freeboard would have been reduced further.

Figure 146. Working deck of *Rebecca Mary*. BACKGROUND SOURCE: KEVIN RALPH

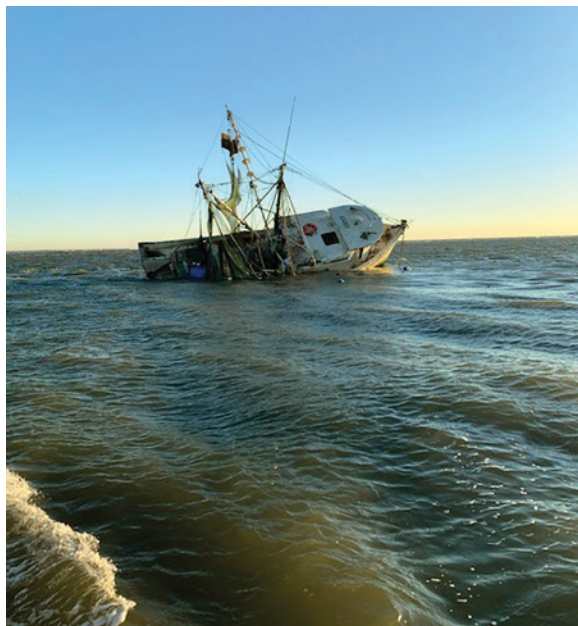
Figure 147. *Miss Annie* shortly after all three crew were rescued. SOURCE: COAST GUARD

The probable cause of the *Miss Annie* stranding and subsequent loss was the vessel striking an unmarked wreck, whose position had shifted from its previous known position and was yet to be charted or announced in the notice to mariners.

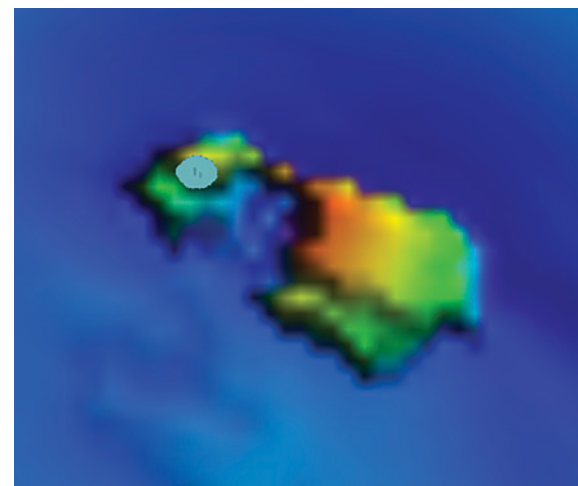
Figure 149. Image of wreck from NOAA Danger to Navigation Report. SOURCE: NOAA

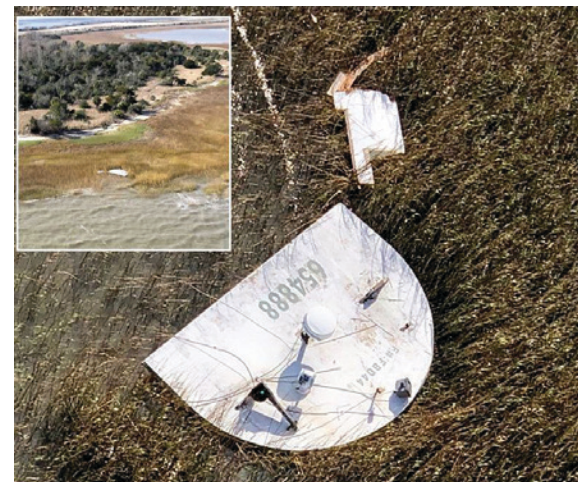
Figure 150. *Miss Annie* top of wheelhouse and debris washed ashore. SOURCE: COAST GUARD

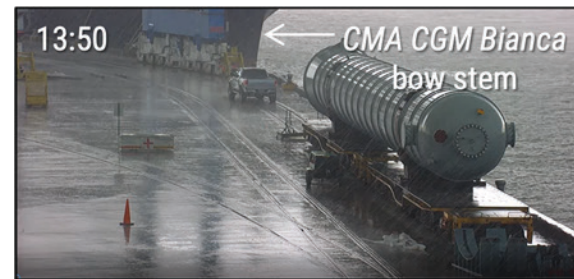
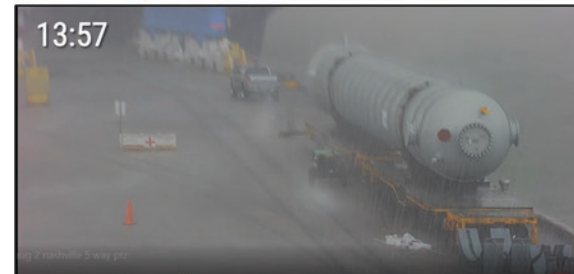
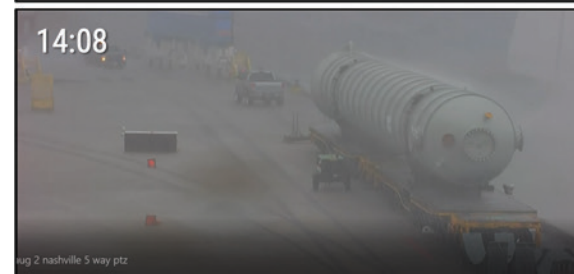
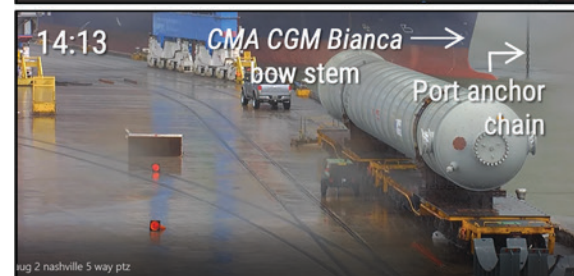
The probable cause of the breakaway of the containership *CMA CGM Bianca* from the Napoleon Avenue Container Terminal wharf and the ensuing equipment damage was the sudden onset of unforecasted severe winds likely originating from the outflow of a thunderstorm-generated downburst.

Figure 153. Right: Security camera footage of Napoleon Avenue Container Terminal pier during accident.

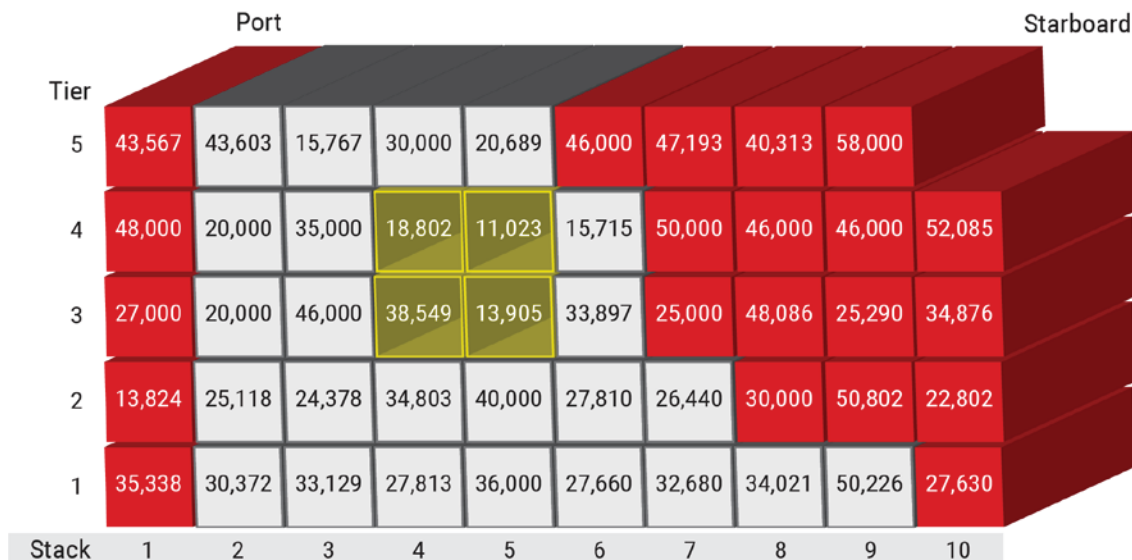
Figure 157. Portion of stow plan showing container weights of the toppled container row. All weights are estimated gross weights in pounds. Red containers went overboard. Flatracks are indicated by yellow squares: tare weight is 11,023; gross weight cannot exceed 54,000 pounds.

Even though machine operators stated they tried to stack containers with heavy containers on the bottom and light ones on top, neither the barge team member job descriptions nor the company-provided Container Lashing Tips included instructions pertaining to the order in which to stack containers. Instead, heavy containers were often loaded over lighter containers, and stacks 1, 7, 8, and 10 were loaded almost exactly in reverse

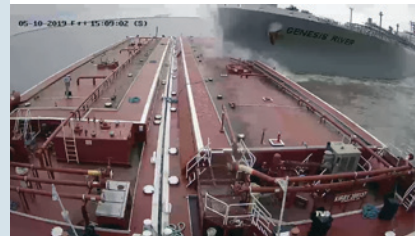
Transiting a narrow channel at sea speed was a factor in the *Genesis River* casualty.

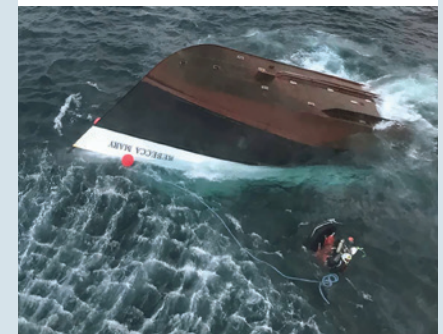
Distress Communications and Preparations for Abandonment

Early distress communication and the crew's preparation to abandon ship in the *Rebecca Mary* casualty contributed to their survival.

An ineffective emergency distress call was a factor in the severity of the *Hoegh Xiamen* casualty.

A successful emergency response is contingent on early distress notification and clear, effective communication. Additionally, preparing to abandon ship by donning survival suits or personal flotation devices increases the likelihood of survival when experiencing significant flooding, fire, or other emergencies.

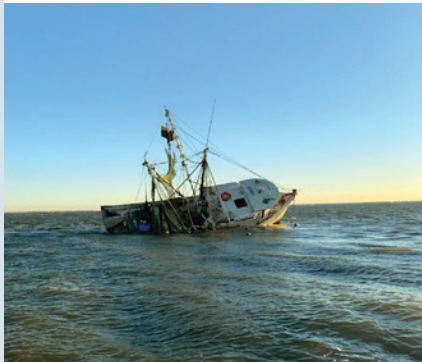
Identifying Navigational Hazards

A failure to identify navigational hazards was a factor in the *Old Glory* and *Miss Annie* casualties.

Situational awareness demands a mariner should be alert for new hazards that can appear along their intended route. It is important to check the Coast Pilot and navigational charts when developing voyage plans to improve knowledge of an area and prepare for a safe passage.

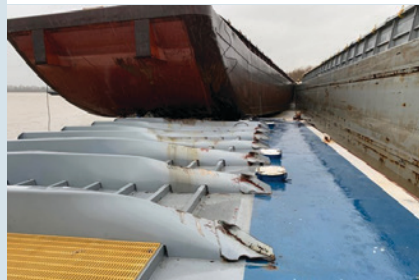
AIS Data Input for Towing Operations

Broadcasting inaccurate AIS information was a factor in the *Cooperative Spirit/RC Creppel* casualty.

To enhance others' situational awareness and alleviate possible misinterpretation, the combined dimensions of a vessel and its tow, reflecting the overall area covered by the tow, should be entered into AIS and broadcasted while under way.

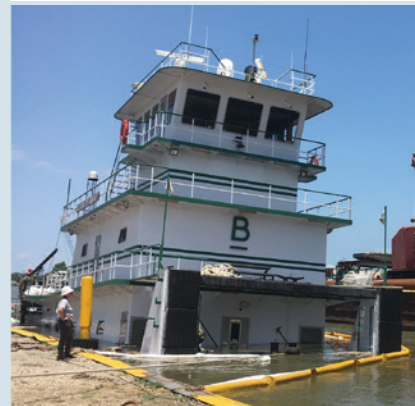
Continuous Monitoring of Unmanned Vessels

A lack of continuous monitoring was a factor in the *Alton St. Amant* and *Iron Maiden* casualties.

Fire and flooding are risks not only for crewed vessels, but those unattended as well. To protect personnel, property, and the environment, it is good marine practice for owners, operators, and shipyard managers to coordinate and implement some form of continuous monitoring for vessels undergoing maintenance in a shipyard, in lay-up, or in some other inactive period without regular crews aboard. Continuous monitoring can consist of scheduled security rounds and/or active monitoring with sensing and alarm systems.

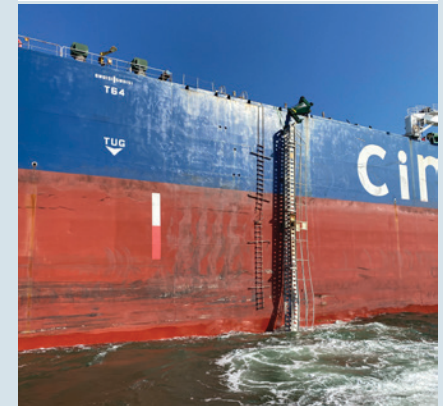
Sufficient Handover Period

An insufficient crew handover period for a was a factor in the *Atina* casualty.

Fatigue is a longstanding issue that continues to adversely affect the safety of marine operations. Failing to get adequate sleep is a high-risk practice that leads to casualties. When joining vessels, crewmembers must often travel long distances, including internationally, and may have little time for rest. It is critical that vessel operating companies ensure that joining crewmembers have the opportunity to obtain adequate rest and allow for a sufficient handover period before they take over critical shipboard duties.

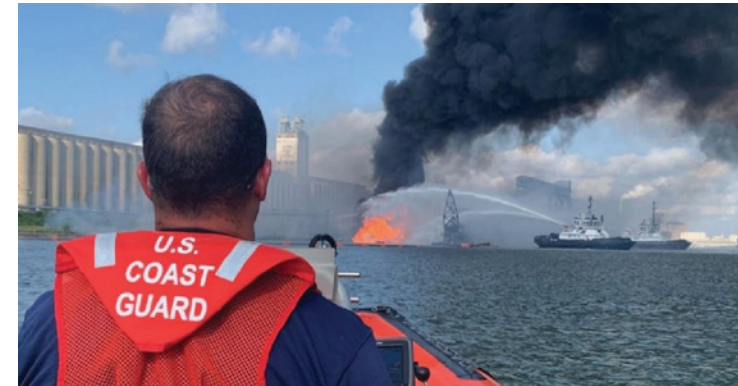
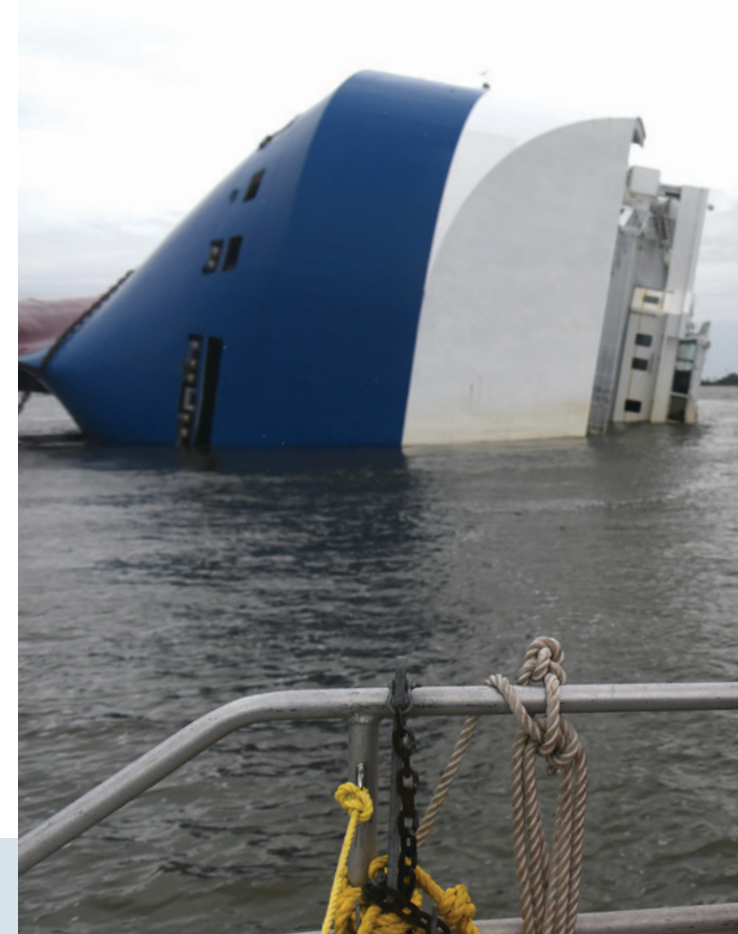
Figure 159. Coast Guard personnel observe the *Waymon Boyd* engulfed in flames (above) and the *Golden Ray* after it capsized (below and opposite page).

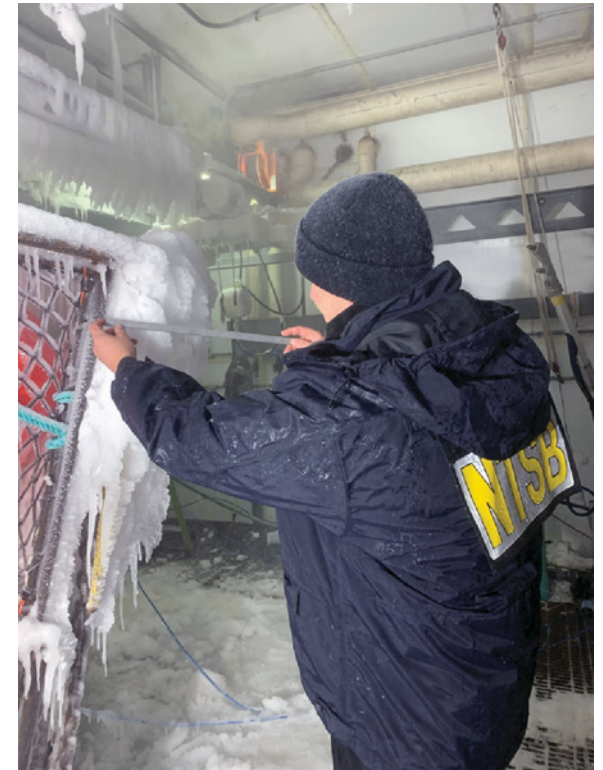
Figure 161. An NTSB investigator measures ice accretion on a crab pot during the *Scandies Rose* investigation.
