Aviation Investigation Final Report

Location:	Windsor Locks, Connecticut	Accident Number:	ERA20MA001
Date & Time:	October 2, 2019, 09:53 Local	Registration:	N93012
Aircraft:	Boeing B17	Aircraft Damage:	Destroyed
Defining Event:	Landing area undershoot	Injuries:	7 Fatal, 5 Serious, 2 Minor
Flight Conducted Under:	Part 91: General aviation - Other work use

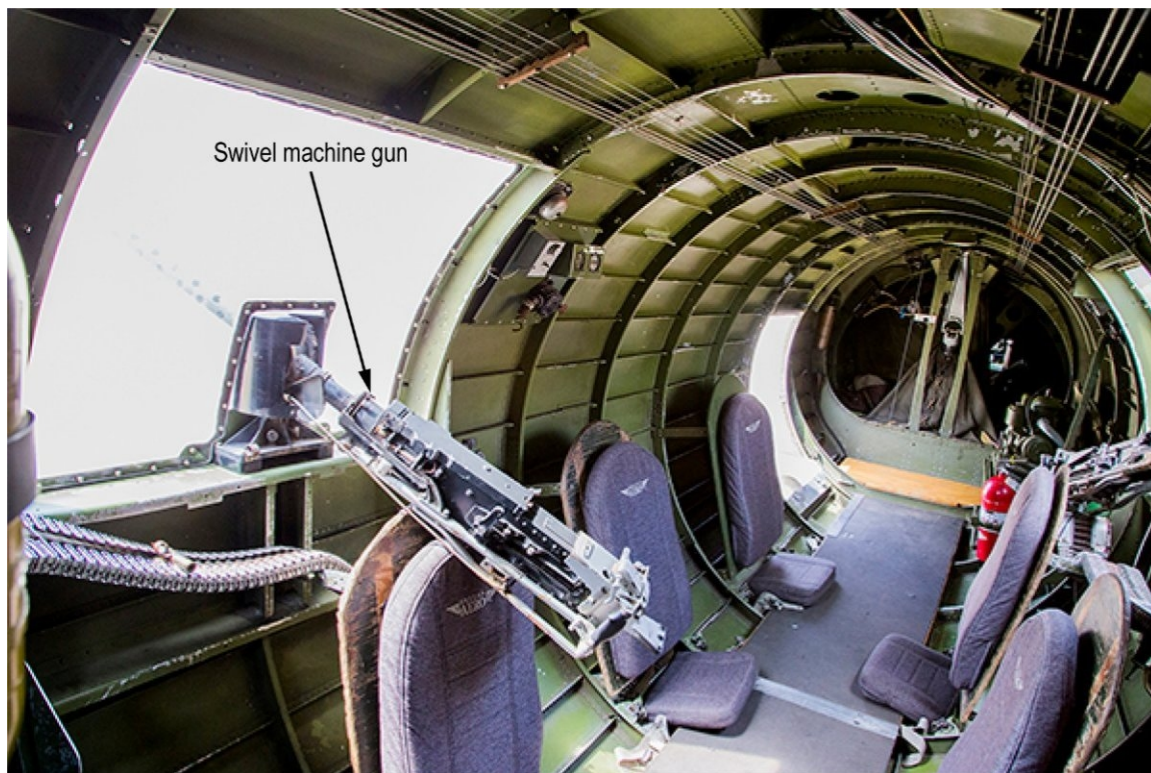
Figure 3. Accident airplane interior (forward looking aft)

The passenger seats that were not original equipment were installed in the airplane according to an engineering document that conformed with the structural requirements of *Civil Aviation Regulation 4b*. Some of the seats consisted of a 5/8-inch-thick plywood seatback attached to the airframe with aluminum angles and brackets, as shown in figure 3. The other seats were secured directly to the structure on an airplane sidewall or bulkhead. All of the passenger seats included a seatback cushion secured with hook and loop fasteners and a seat bottom cushion secured to a floor panel. The passenger seats were equipped with a two-point military/aerobatic-style lap belt affixed to either the seat or structural areas on or near the floor.
