# Aviation Investigation Final Report

<b>Location:</b>	Atlanta, Georgia	<b>Incident Number:</b>	DCA201A014
<b>Date &amp; Time:</b>	November 6, 2019, 21:15 Local	<b>Registration:</b>	N117HQ
<b>Aircraft:</b>	Embraer ERJ170	<b>Aircraft Damage:</b>	None
<b>Defining Event:</b>	Loss of control in flight	<b>Injuries:</b>	9 None
<b>Flight Conducted Under:</b>	Part 121: Air carrier - Scheduled

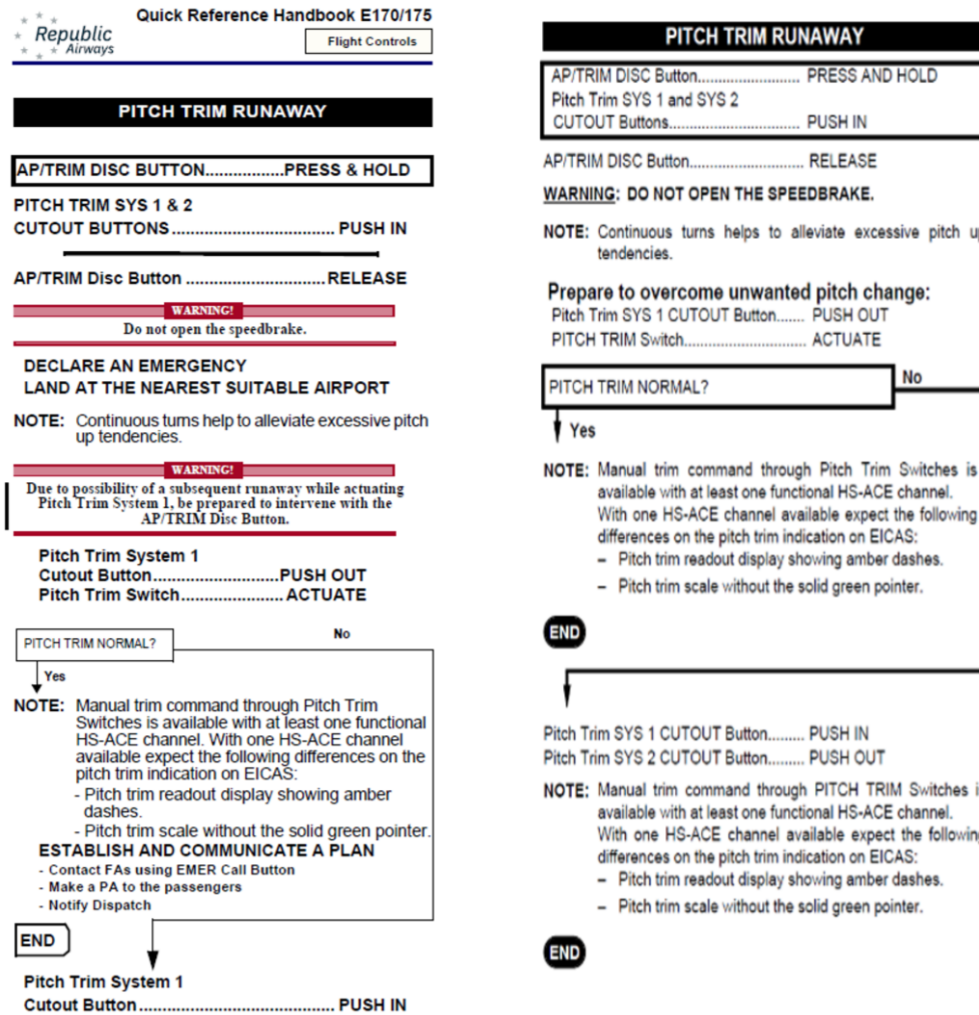
Republic Airways' quick reference handbook had one memory item for a pitch trim runaway: the autopilot/trim disconnect button was required to be pressed in and held. The Embraer 170/175 *Airplane Operations Manual* required two memory items; the autopilot/trim disconnect button

had to be pressed in and held, and both cutout buttons had to be pushed in. Figure 1 compares the two documents and shows other steps to address a pitch trim runaway.

**Figure 1.** Company and manufacturer pitch trim runaway procedures (Source: Republic Airways and Embraer).
