Aviation Investigation Final Report

Location:	Mokuleia, Hawaii	Accident Number:	ANC20FA024
Date & Time:	February 22, 2020, 09:20 Local	Registration:	N65070
Aircraft:	Cessna 305	Aircraft Damage:	Substantial
Defining Event:	Loss of control in flight	Injuries:	2 Fatal
Flight Conducted Under:	Part 91: General aviation - Instructional

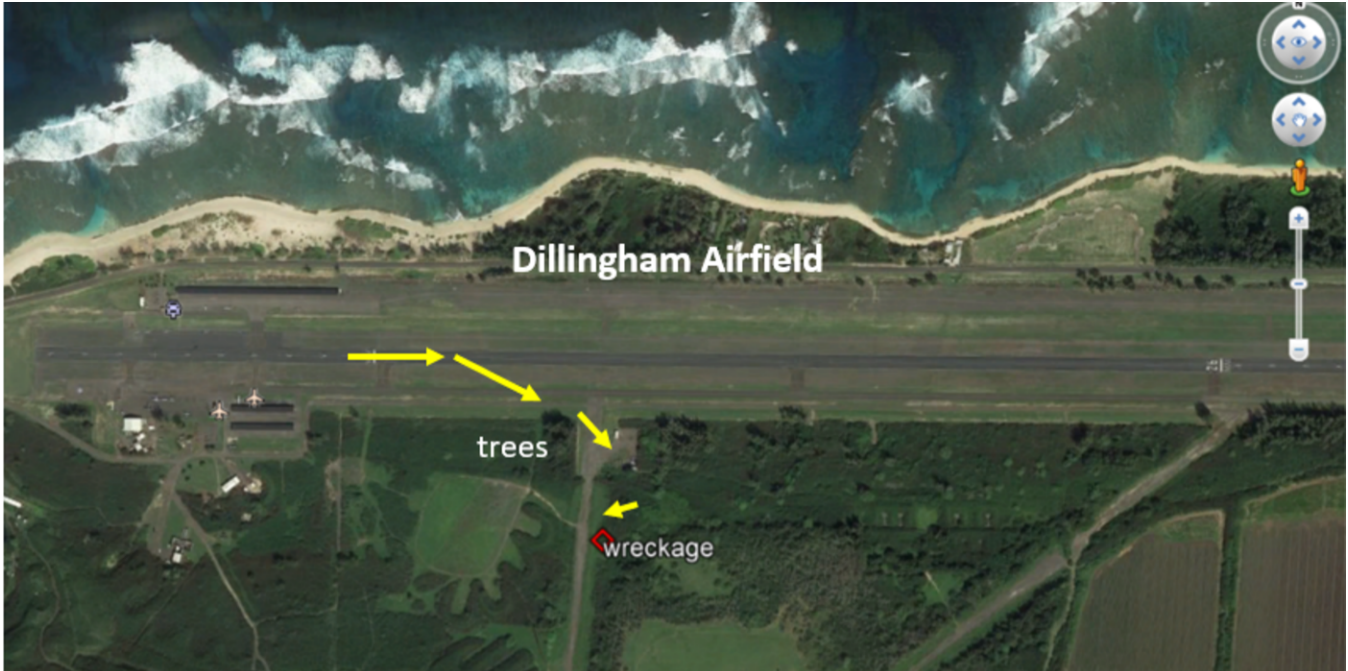
Witnesses stated that the airplane yawed to the right after becoming airborne. One witness, who was a pilot, stated that the airplane was, “very slow with an abnormal right crosswind crab with wings level” and that it appeared that “something was very wrong with the airplane that was beyond the pilot’s control.” That witness reported that the wind was light and “down the runway” at the time of the takeoff. Some witnesses reported the engine sound diminishing as the airplane approached a tree line on the right side of the runway, surge again as the airplane flew over or around the end of tree line, and then the engine sound went quiet. Other witnesses saw the airplane on a downwind leg and reported that it rolled rapidly, descended, and impacted the ground. Figure 1 shows the airplane’s estimated flightpath based on witness statements and the location of the accident site.

Figure 1. Google Earth image of runway 8 and estimated flightpath (yellow) based on witness statements.
