Aviation Investigation Final Report

Location:	Coeur d'Alene, Idaho	Accident Number:	WPR20FA206
Date & Time:	July 5, 2020, 14:22 Local	Registration:	N6373U (A1); N2106K (A2)
Aircraft:	Cessna TU206 (A1); De Havilland DHC-2 (A2)	Aircraft Damage:	Destroyed (A1); Destroyed (A2)
Defining Event:	Midair collision	Injuries:	2 Fatal (A1); 6 Fatal (A2)
Flight Conducted Under:	Part 91: General aviation - Personal (A1); Part 91: General aviation - Aerial observation (A2)

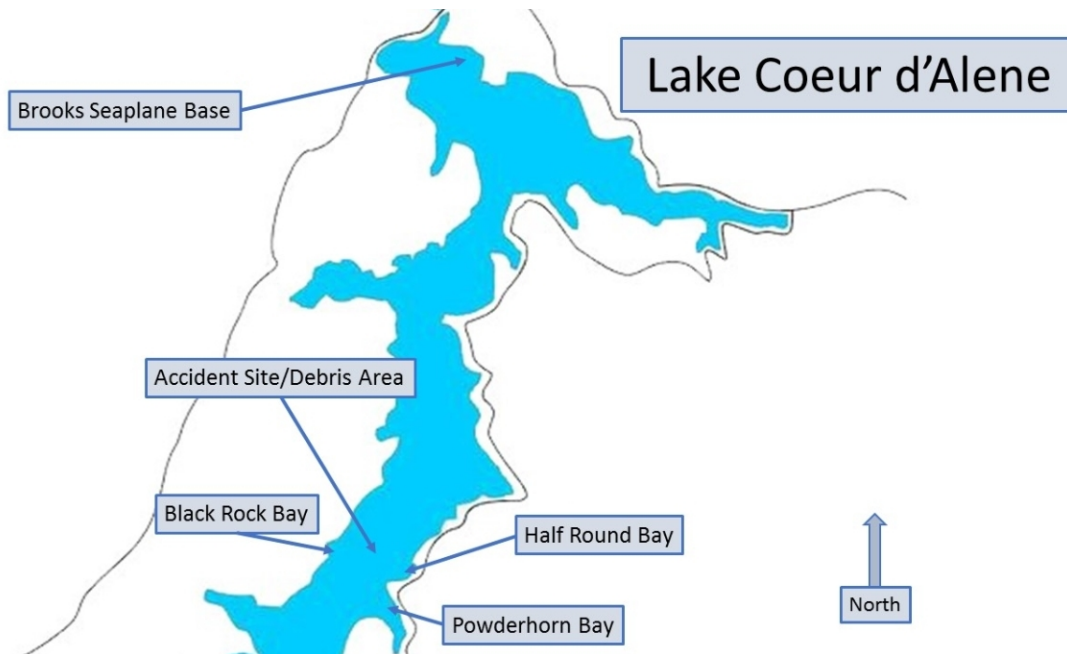
Figure 2. Accident site location.

The wreckage of both airplanes was submerged in about 130 ft of water near the center of the lake between Half Round Bay and Black Rock Bay, as indicated in figure 2. The underwater debris path was about 900 ft in length.
