Aviation Investigation Final Report

Location:	Brookshire, Texas	Accident Number:	DCA22MA009
Date & Time:	October 19, 2021, 10:00 Local	Registration:	N987AK
Aircraft:	McDonnell Douglas DC-9-87 (MD-87)	Aircraft Damage:	Destroyed
Defining Event:	Flight control sys malf/fail	Injuries:	2 Serious, 1 Minor, 20 None
Flight Conducted Under:	Part 91: General aviation - Personal

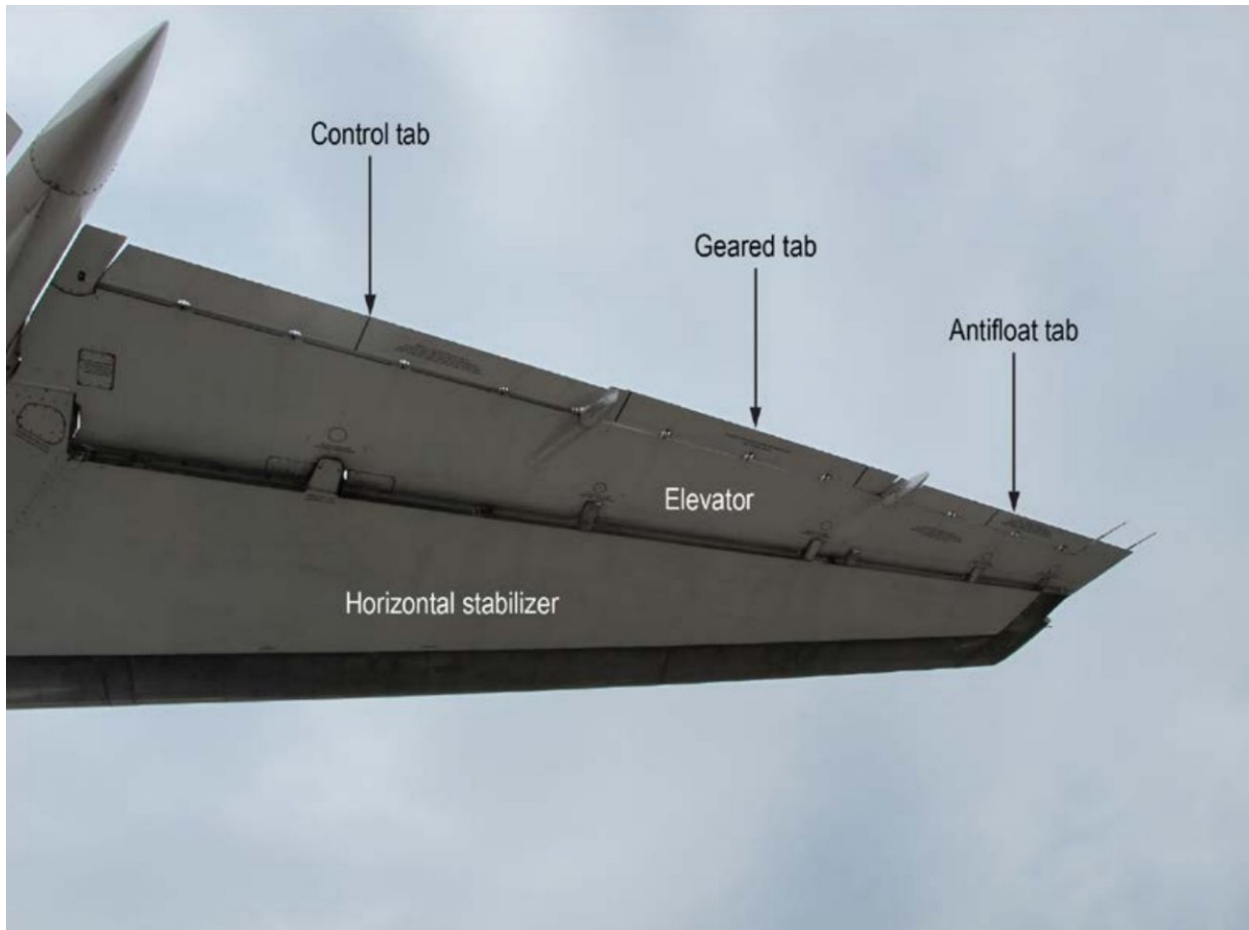
The DC-9-87 (MD-87) airplane has a T-tail design, such that the elevators and horizontal stabilizer are attached near the top of the vertical stabilizer about 30 ft above ground level (agl). The left and right elevators are attached by hinges to the rear spar of the horizontal stabilizer, and each is equipped with control, geared, and antifloat tabs attached to the trailing edge (see figure 1).

Figure 1. Exemplar airplane (viewed from the ground looking up) showing respective locations of right horizontal stabilizer, elevator, control tab, geared tab, and antifloat tab. (Source: Boeing)

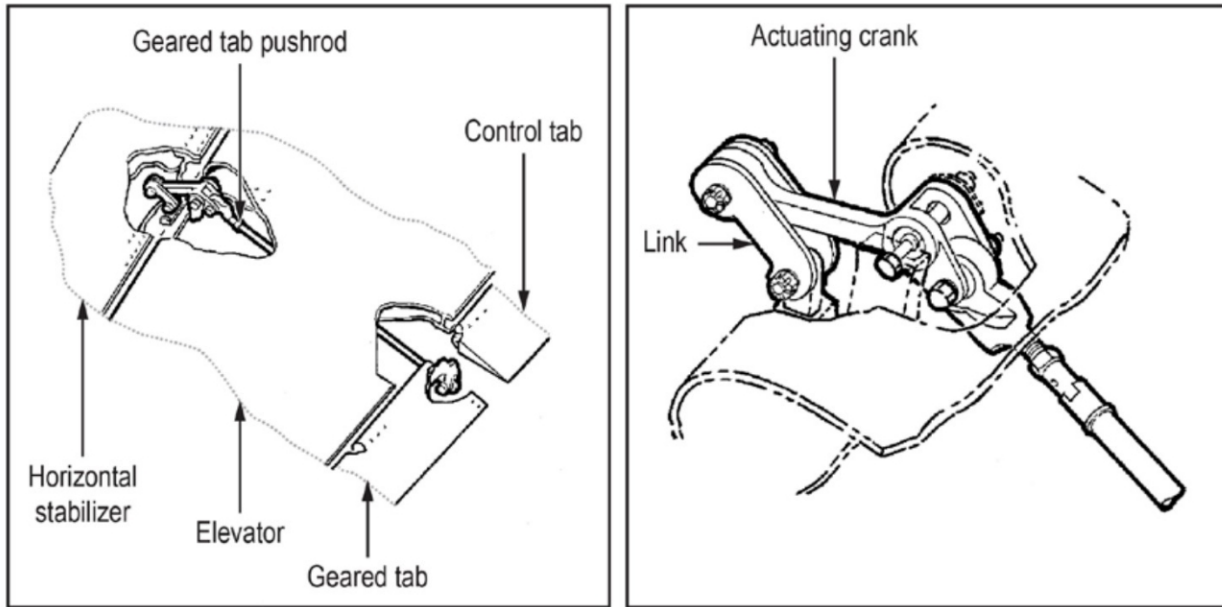
The investigation determined that, at some point during the 6 months since the airplane was last flown, the inboard geared tab linkages for both elevators had moved beyond their normal range of travel into an overcenter position, resulting in the jammed condition of the elevators in the trailing-edge-down position. No evidence of any other mechanical malfunction, elevator or pitch control system failure, structural failure, or actions by the flight crew or maintenance personnel was identified that could have resulted in the jammed condition. Further, the jammed condition was not detectable during the flight control check the first officer performed during taxi; the elevator control system design is such that, even with this type of jammed elevator condition, the control column feel and travel would be normal during taxi (when the aerodynamic forces on the elevator control tabs would be minimal).

Elevator geared tabs, which mechanically deflect in response to elevator movements, are attached to the horizontal stabilizer through a system of drive linkages. The geared tab drive linkage consists of a pushrod that is attached to the horizontal stabilizer spar by means of an actuating crank and links (see figure 2).

Figure 2. Installed location of geared tab linkage components (left) and closer view of the links and actuating crank (right). (Source: Boeing; some labels and revisions added by NTSB)
