Aviation Investigation Final Report

Location:	Brookshire, Texas	Accident Number:	DCA22MA009
Date & Time:	October 19, 2021, 10:00 Local	Registration:	N987AK
Aircraft:	McDonnell Douglas DC-9-87 (MD-87)	Aircraft Damage:	Destroyed
Defining Event:	Flight control sys malf/fail	Injuries:	2 Serious, 1 Minor, 20 None
Flight Conducted Under:	Part 91: General aviation - Personal

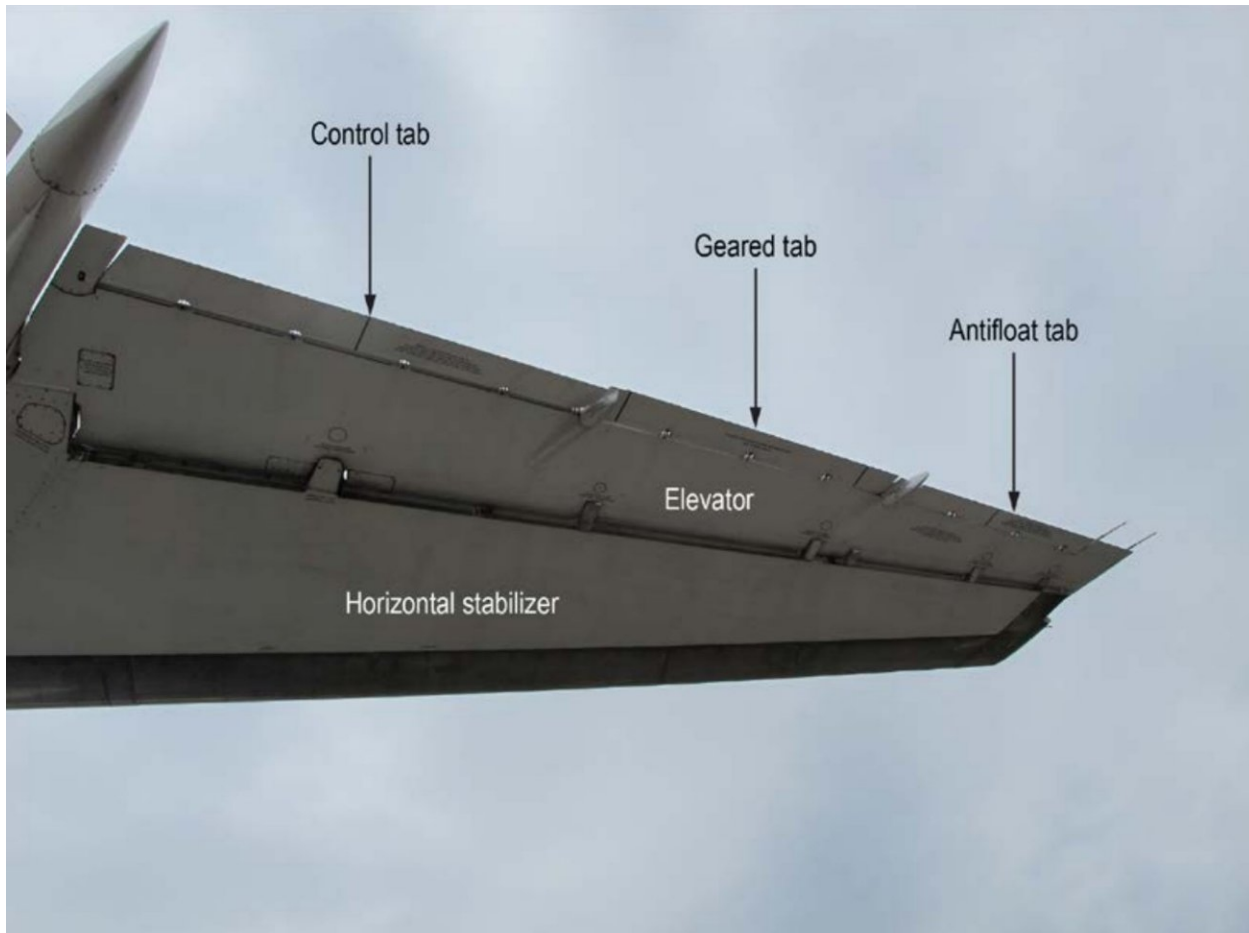
Figure 1. Exemplar airplane (viewed from the ground looking up) showing respective locations of right horizontal stabilizer, elevator, control tab, geared tab, and antifloat tab. (Source: Boeing)

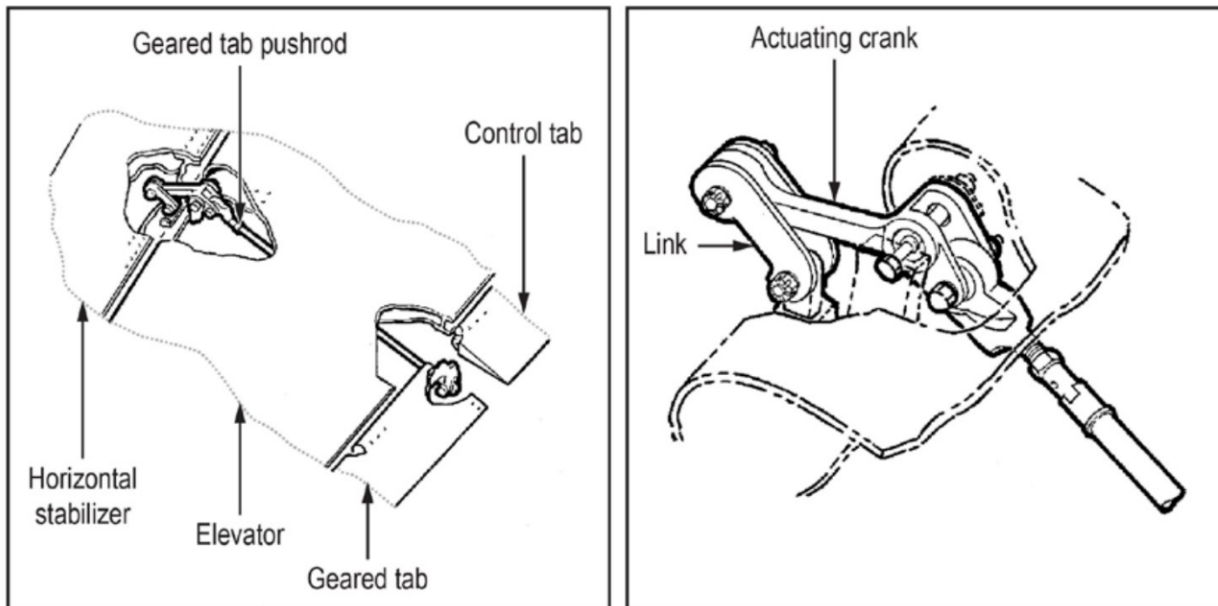
Elevator geared tabs, which mechanically deflect in response to elevator movements, are attached to the horizontal stabilizer through a system of drive linkages. The geared tab drive linkage consists of a pushrod that is attached to the horizontal stabilizer spar by means of an actuating crank and links (see figure 2).

Figure 2. Installed location of geared tab linkage components (left) and closer view of the links and actuating crank (right).
(Source: Boeing; some labels and revisions added by NTSB)
