Aviation Investigation Final Report

Location:	Houma, Louisiana	Accident Number:	CEN22LA430
Date & Time:	September 24, 2022, 18:11 Local	Registration:	N811TA
Aircraft:	Agusta AW139	Aircraft Damage:	Substantial
Defining Event:	Electrical system malf/failure	Injuries:	6 None
Flight Conducted Under:	Part 135: Air taxi & commuter - Non-scheduled

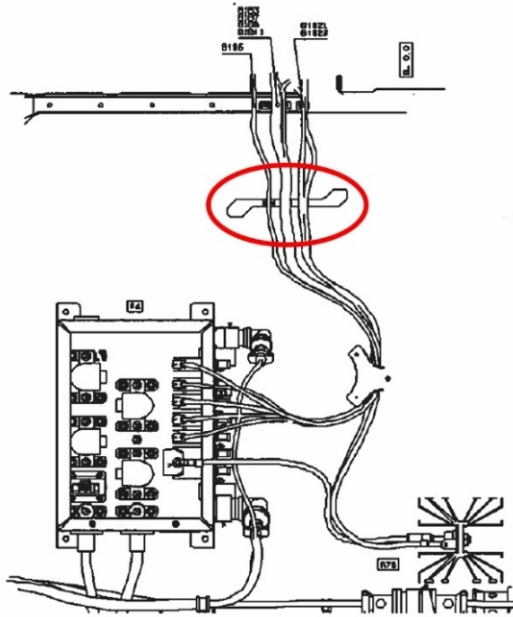
The assembly cards contained views of the left and right wiring support strip assemblies installed with power cables routed through them. In the views looking upwards (from within the cabin), the power cables were depicted as solid lines with the strip assemblies as solid lines behind them, implying that routing of the power cables were under the strip assemblies, as shown in Figure 2 and Figure 3. The shape of the left and right strip assemblies was identical on the assembly job card, despite the right strip assembly being a different shape than the left strip assembly. The assembly job cards provided no specific instruction to verify that the power cables were routed underneath the strip assemblies.

Figure 2. A detail excerpt from the Completion and Finishing of Power C/A Card showing the power cable routing under the right strip assembly. (Courtesy of Leonardo Helicopters, modified by NTSB)

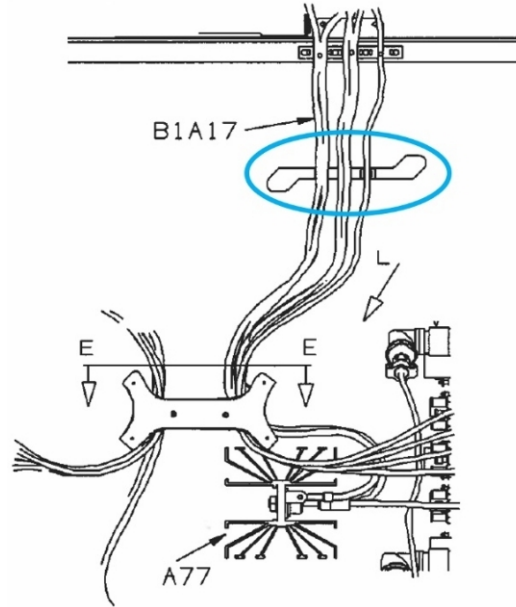
Figure 3. A detail excerpt from the Completion and Finishing of Power C/A Card showing the power cable routing under the left strip assembly. (Courtesy of Leonardo Helicopters, modified by NTSB)

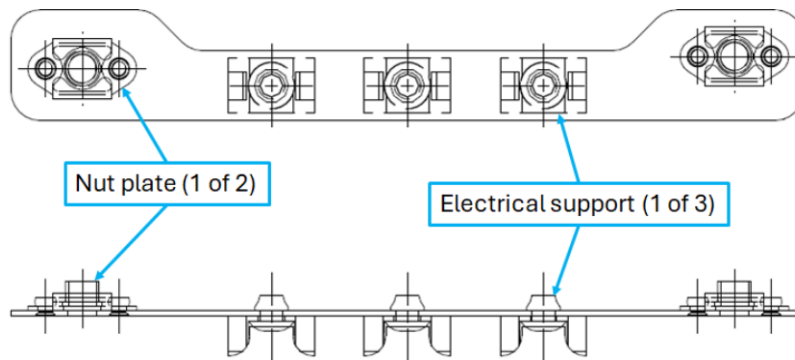
At the time of its manufacture, the manufacturing job card for the right-side wiring support strip assembly, No. 3P5315A12931, contained two views of the strip assembly, as shown in Figure 7. These two views of the strip assembly distinctly show that the electrical supports were mounted on the side opposite that of the nut plates.

Figure 7. The two views of the right strip assembly in its manufacturing job card. (Courtesy of Leonardo Helicopters, modified by NTSB)

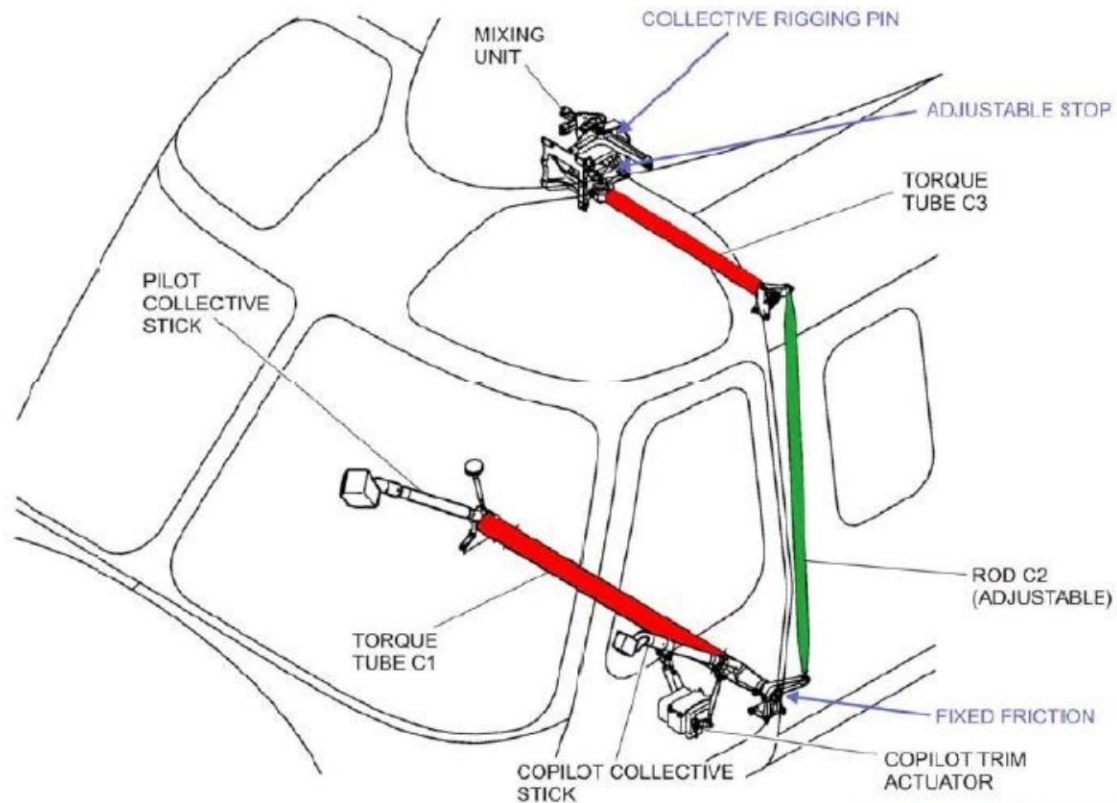
Figure 8. Collective Flight Controls

The pilot and copilot collectives are interconnected via the C1 torque tube located under the pilot seats, as shown in Figure 8. A single control rod, C2, runs vertically up the left side of the helicopter behind the left-seat pilot where it connects through a linkage to the C3 torque tube that runs laterally above and behind the right-seat pilot to the mixing unit.
