# Aviation Investigation Final Report

<b>Location:</b>	Sahuarita, Arizona	<b>Accident Number:</b>	WPR22FA361
<b>Date &amp; Time:</b>	September 28, 2022, 09:00 Local	<b>Registration:</b>	N74349
<b>Aircraft:</b>	GRUMMAN AMERICAN AVN. CORP. AA-5B	<b>Aircraft Damage:</b>	Destroyed
<b>Defining Event:</b>	Loss of control in flight	<b>Injuries:</b>	1 Fatal
<b>Flight Conducted Under:</b>	Part 91: General aviation - Personal

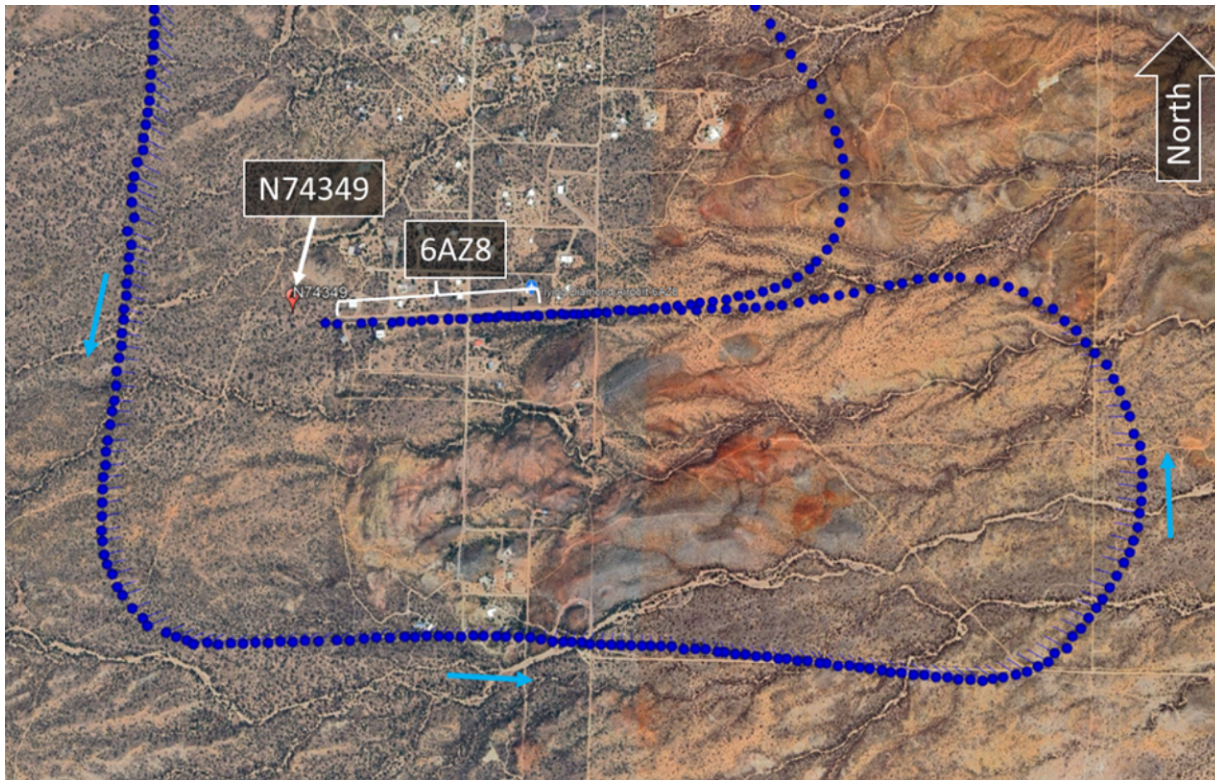
The airplane came to rest about 557 ft west of the departure end of runway 25, in vegetation-covered terrain, at an elevation of about 3905 ft mean sea level (msl) (figure 1). A post-impact fire consumed most of the fuselage and wings. The top three strands of a barbed wire fence, located at the end of the runway, were fractured. Several bushes and trees between the runway and the wreckage exhibited breaks in the branches.

Figure 1. Google Earth image with ADSB data showing the traffic pattern upon returning to 6AX8. The flight route is indicated with blue arrows.
