# Aviation Investigation Final Report

<b>Location:</b>	Kaupo, Hawaii	<b>Accident Number:</b>	ANC23FA008
<b>Date &amp; Time:</b>	December 15, 2022, 21:14 Local	<b>Registration:</b>	N13GZ
<b>Aircraft:</b>	RAYTHEON AIRCRAFT COMPANY C90A	<b>Aircraft Damage:</b>	Substantial
<b>Defining Event:</b>	Inflight upset	<b>Injuries:</b>	3 Fatal
<b>Flight Conducted Under:</b>	Part 91: General aviation - Positioning

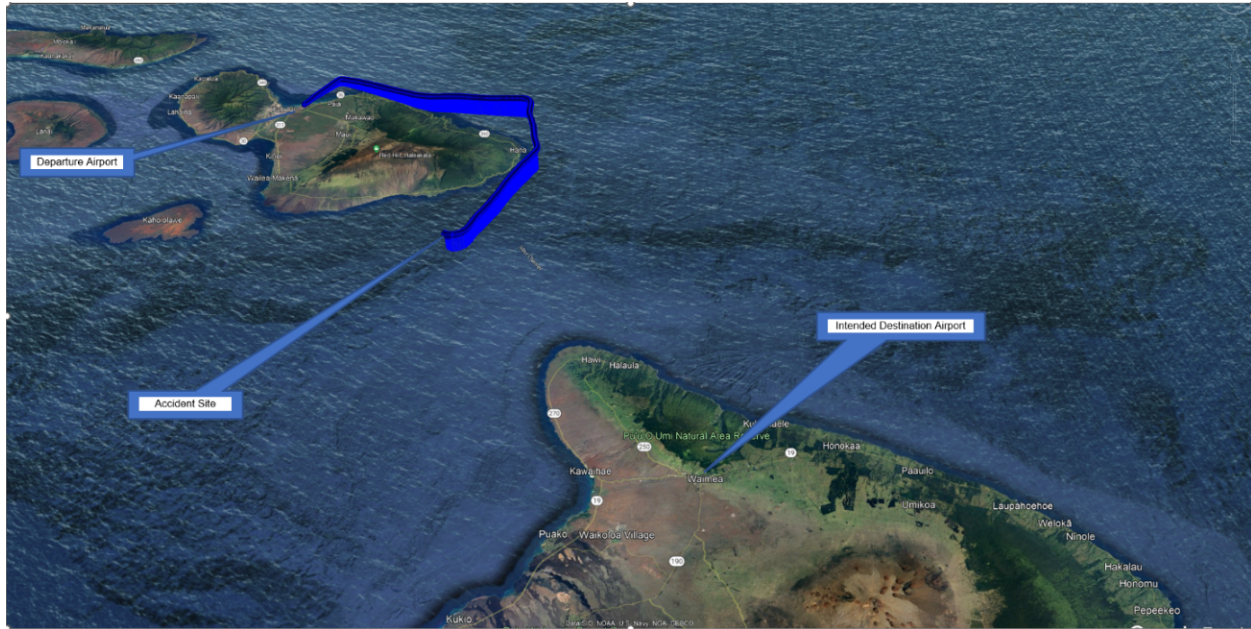
*Figure 3. Google Earth image of the flight path from the departure airport, and depicting the destination airport.*

ADS-B data stopped about 10 miles south of Kaupo, near where a witness observed the accident airplane impact the water. (Figure 3)

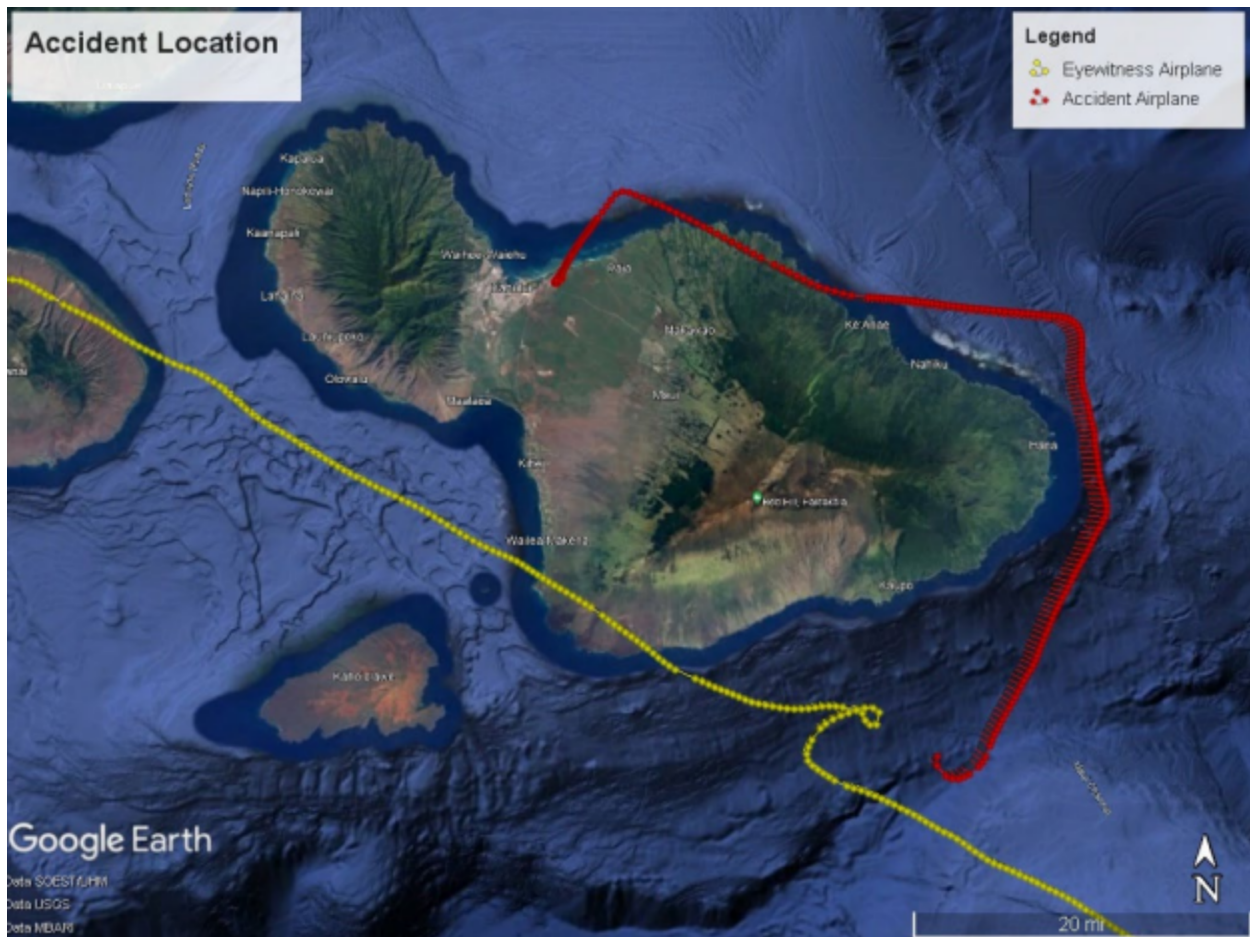
Figure 4. Google Earth image of the accident flight path and the witness's airplane flight path.

A witness, who was flying a low-wing Piper PA-44 airplane from Hilo, Hawaii, to Honolulu, reported seeing the accident airplane well above and to the north of his flight path. The ARTCC specialist reported that N13GZ was at the PA-44 pilot's 3 o'clock position at 12,000 ft msl, descending to 8,000 ft msl. The witness continued watching the lights of the airplane and said that as the airplane continued southbound it began a right turn. Then it entered a spiraling right descending turn, which steepened as the descent increased. The airplane continued to descend until it impacted the surface of the water. He lost sight of the airplane's lights shortly after the airplane impacted the water. The red flight track represents the accident airplane, and the yellow flight track represents the eyewitness airplane (see Figure 4).

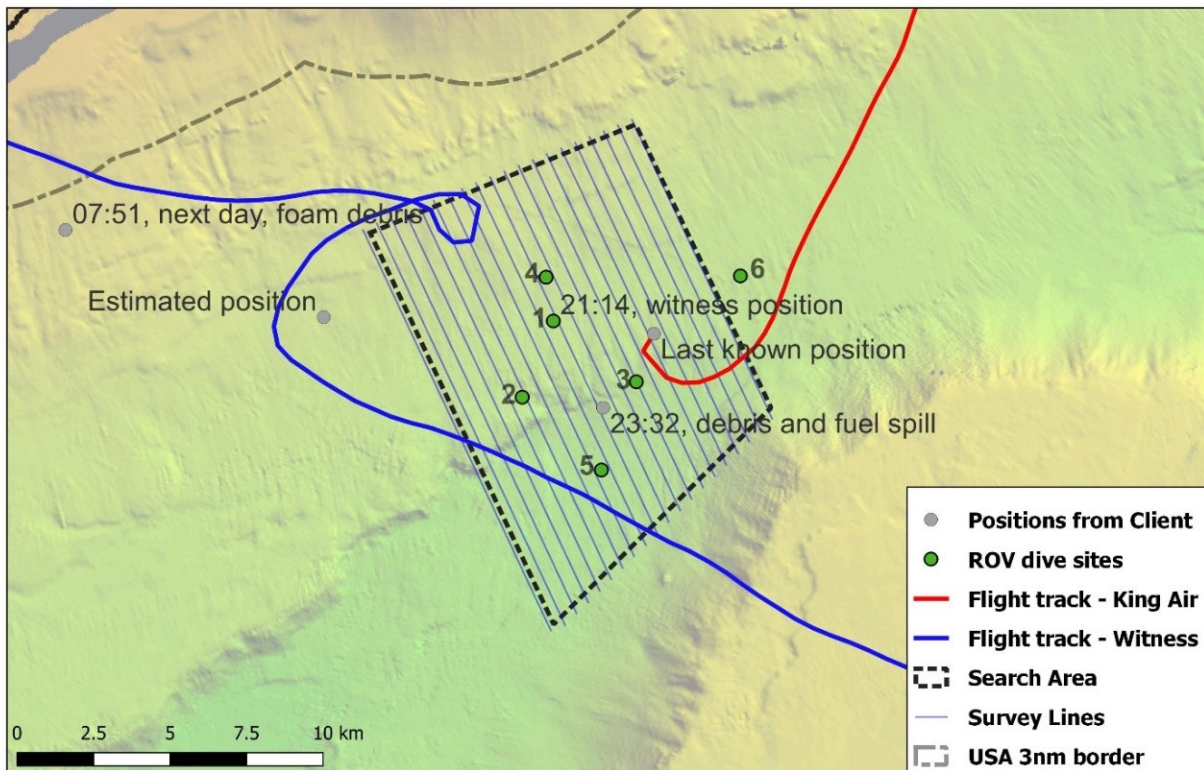
Figure 10. Map of the search grid, and points of interest. (Courtesy of Ocean Infinity)

An alert notice (ALNOT) was issued by the FAA about 2127, and an extensive search was conducted immediately after the accident by the United States Coast Guard (USCG). During the search, portions of airplane wreckage were found floating near and in the vicinity of the last known location of the accident airplane (see Figure 10). The search was officially suspended on December 19, 2022, about 0955. Significant planning was performed to define the search area and establish the water depth and current conditions with input from several state and federal agencies.
