Aviation Investigation Final Report

Location:	Riyadh,	Incident Number:	ENG22LA049
Date & Time:	March 31, 2022, 19:05 UTC	Registration:	9H-VIG
Aircraft:	Bombardier Global 7500	Aircraft Damage:	Minor
Defining Event:	Fire/smoke (non-impact)	Injuries:	
Flight Conducted Under:	Non-U.S., commercial

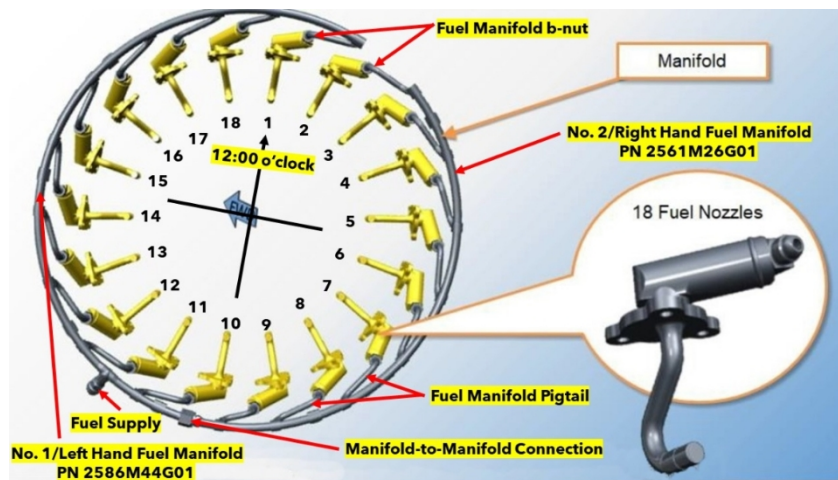
FIGURE 1: FUEL NOZZLE AND FUEL MANIFOLD DIAGRAM

The engine has 18 fuel nozzles and fuel is provided to the fuel nozzles by two fuel manifolds mounted on the outside of the combustion case (**FIGURE 1**).
