Aviation Investigation Final Report

Location:	Santa Ana, California	Accident Number:	DCA23FA417
Date & Time:	August 20, 2023, 23:15 Local	Registration:	N516AS
Aircraft:	Boeing 737-890	Aircraft Damage:	Substantial
Defining Event:	Sys/Comp malf/fail (non-power)	Injuries:	112 None
Flight Conducted Under:	Part 121: Air carrier - Scheduled

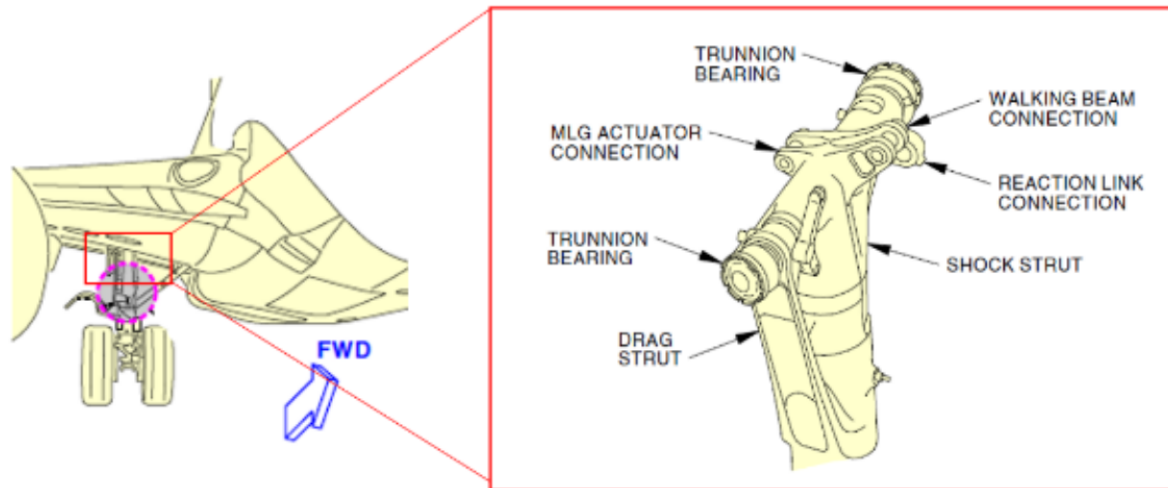
A main gear shock strut provides the primary support for each MLG (see figure 2). The shock strut consists of an integral drag strut, an outer cylinder, and an inner cylinder. When the MLG extends or retracts, the shock strut rotates about two trunnion bearings and two pins (forward and aft) at the top of the outer shock strut. The forward and aft trunnion pins extend through a

trunnion bearing and support assembly in the wing and landing gear beam. Trunnion bolts keep the trunnion pins from backing out during landing gear operation.

Figure 2. Illustration of the MLG components. (Source: Boeing. Image Copyright Boeing. Reproduced with permission.)
