# Aviation Investigation Preliminary Report

<b>Location:</b>	Portland, OR	<b>Accident Number:</b>	DCA24MA063
<b>Date &amp; Time:</b>	January 5, 2024, 17:14 Local	<b>Registration:</b>	N704AL
<b>Aircraft:</b>	Boeing 737-9	<b>Injuries:</b>	177 None
<b>Flight Conducted Under:</b>	Part 121: Air carrier - Scheduled

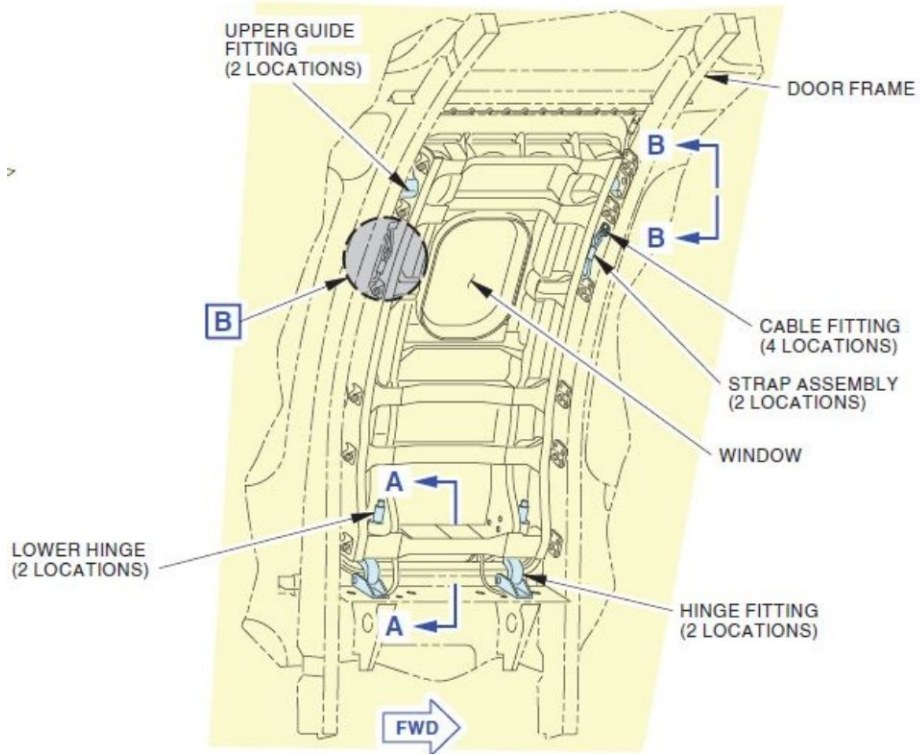
The MED plug is primarily constructed of aluminum and is installed in the fuselage by means of two upper guide fittings and two lower hinge fittings (see figures 4 and 5). The two upper guide fittings are located on the upper sides of the plug and engage with two upper guide rollers that are fixed to the upper sides of the fuselage opening (see figure 6). Two lower hinge guide fittings are fixed to the lower section of the plug and engage with the two lower hinge fittings that are attached to the bottom of the fuselage opening at the lower hinge bracket assemblies.

**Figure 4.** 737-9 Mid Exit Door Plug. (Source: Boeing. Image Copyright © Boeing. Reproduced with permission.)

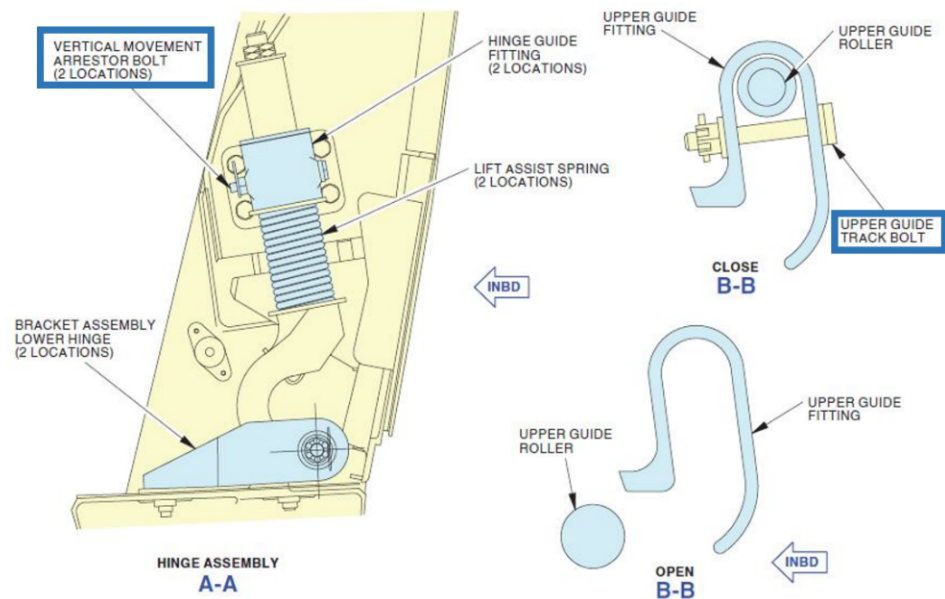
**Figure 5.** 737-9 Mid Exit Door Plug – Arrestor and Track Bolts. Boxes added for emphasis. (Source: Boeing. Image Copyright © Boeing. Reproduced with permission.)

The two vertical movement arrestor bolts, two upper guide track bolts, forward lower hinge guide fitting, and forward lift assist spring were missing and have not been recovered. See figure 5 for example of installed locations.
